CHAPTER 14

EXISTING SITE CONTAMINATION

BIRD IN HAND GOLD PROJECT

MINING LEASE PROPOSAL

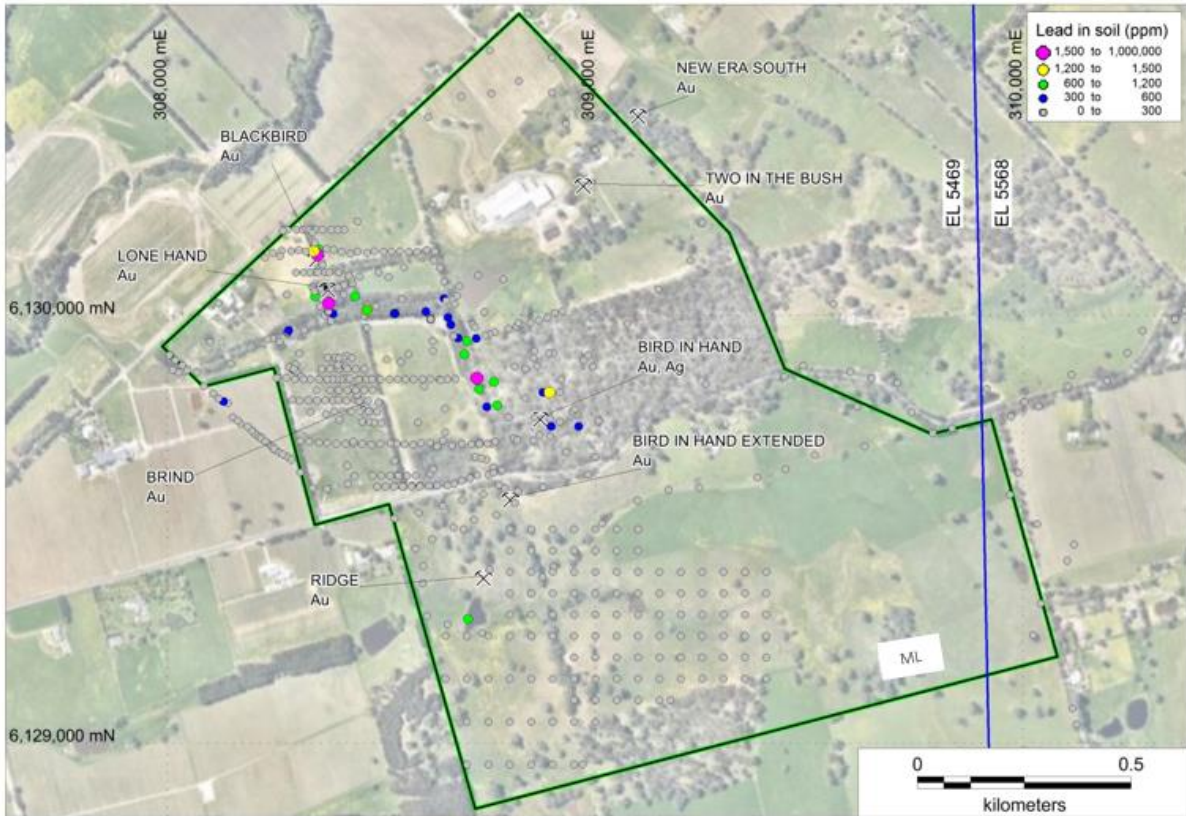
FIGURE 14-2 | LEAD IN SOIL SAMPLES

Within the proposed ML peak arsenic and lead in soil are 142ppm and 1913ppm, respectively, Table 14-1. Values over 1500ppm lead are above the HIL threshold for commercial and industrial premises as stated in the National Environment Protection (Assessment of Site Contamination) Measure April 2011, Schedule B1, Guideline on Investigation Levels for Soil and Groundwater”,

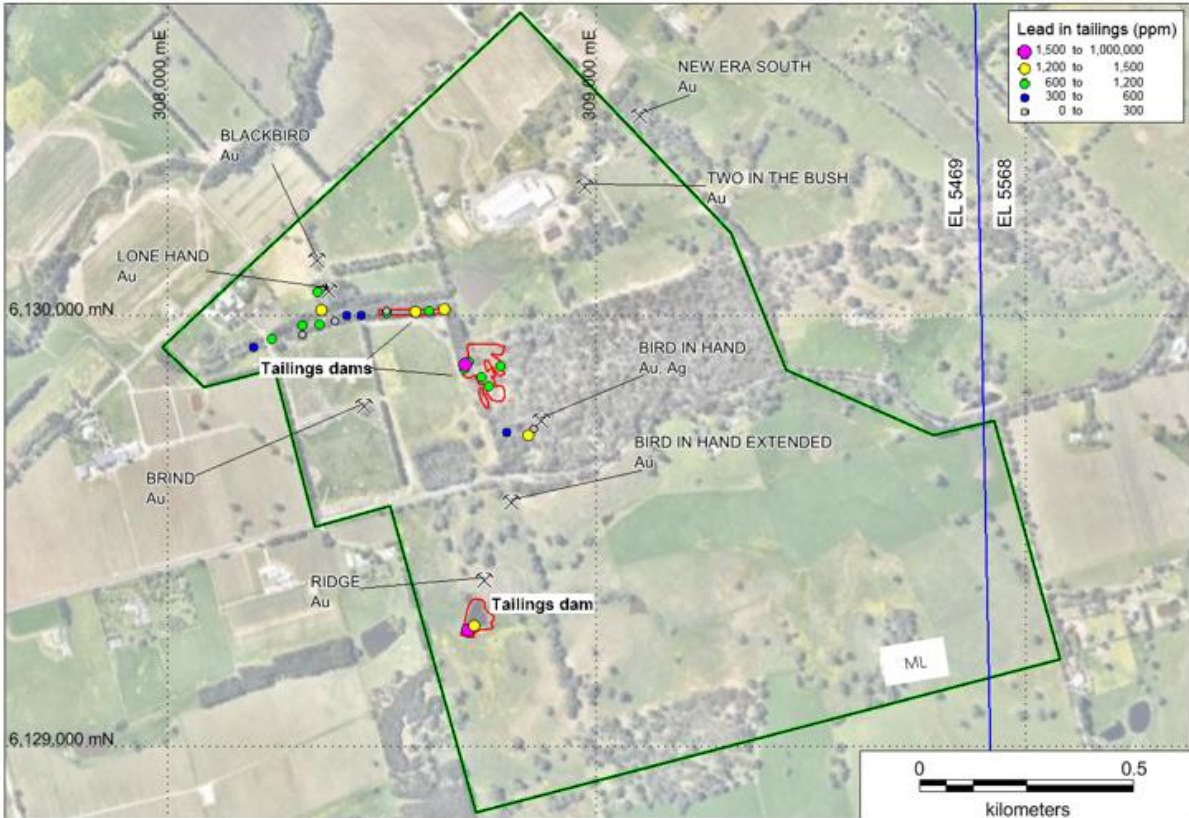
FIGURE 14-4 | LEAD IN TAILINGS

Table 14-2. There are areas where tailings are exposed at surface and have become integrated with the natural environment. Peak lead in tailings on the proposed ML is 3234ppm.

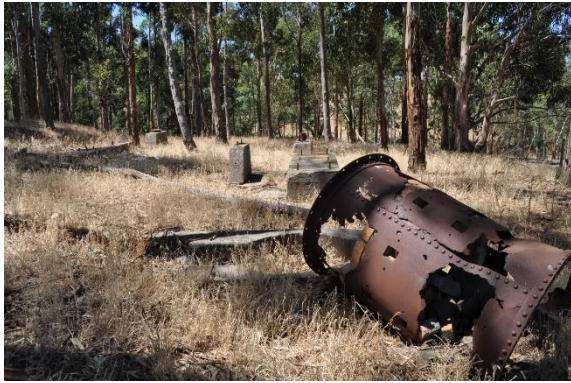
FIGURE 14-6 | LOCATION 1, REMAINS OF BLACKBIRD PROCESSING FACILITY.

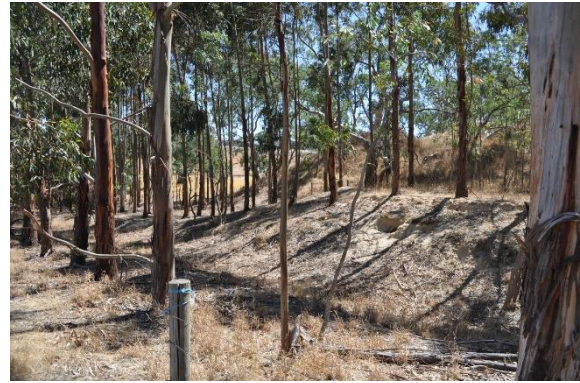
FIGURE 14-9 | LOCATION 3, - WESTERN LIMIT OF BIH TAILINGS DAM IS LOCATED ON PROPOSED OPERATING SITE.

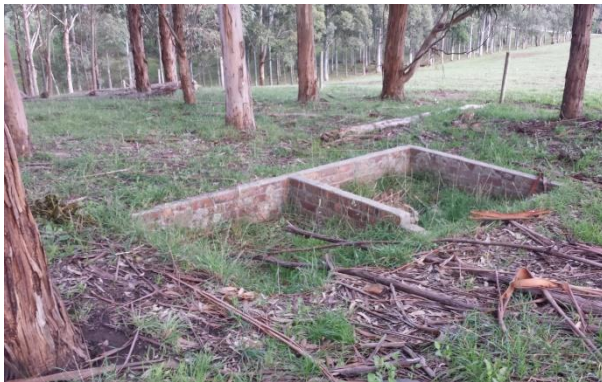
FIGURE 14-7 | LOCATION 1, REMAINS OF BLACKBIRD PROCESSING FACILITY.

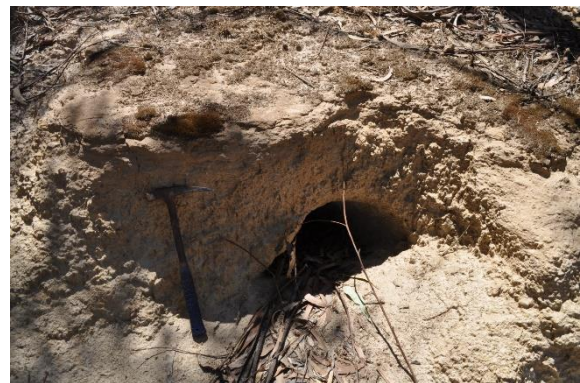
FIGURE 14-10 | LOCATION 3, RABBIT BURROW IN BIH TAILINGS DAM.

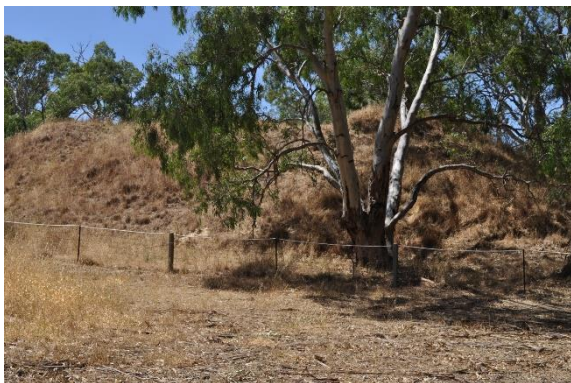
FIGURE 14-8 | LOCATION 2, - NORTH WESTERN CORNER OF BIH TAILINGS DAM

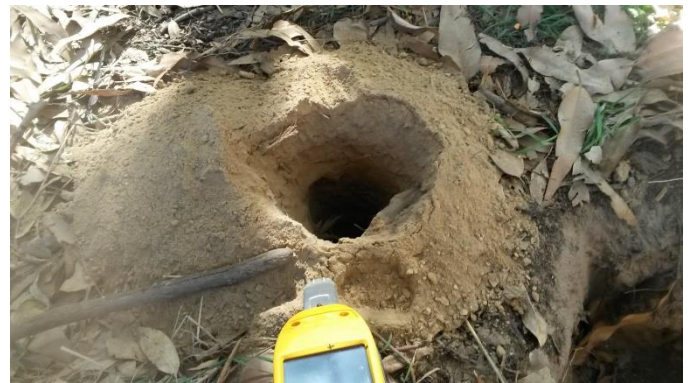
FIGURE 14-11 | LOCATION 4, TAILINGS DAM, SOUTHERN BANK OF GOLDWYN CREEK

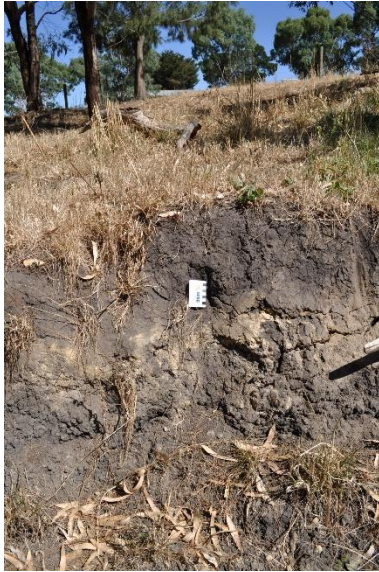
FIGURE 14-12 | LOCATION 5, TAILINGS (PALE BAND) EXPOSED IN NORTHERN BANK OF GOLDWYN CREEK

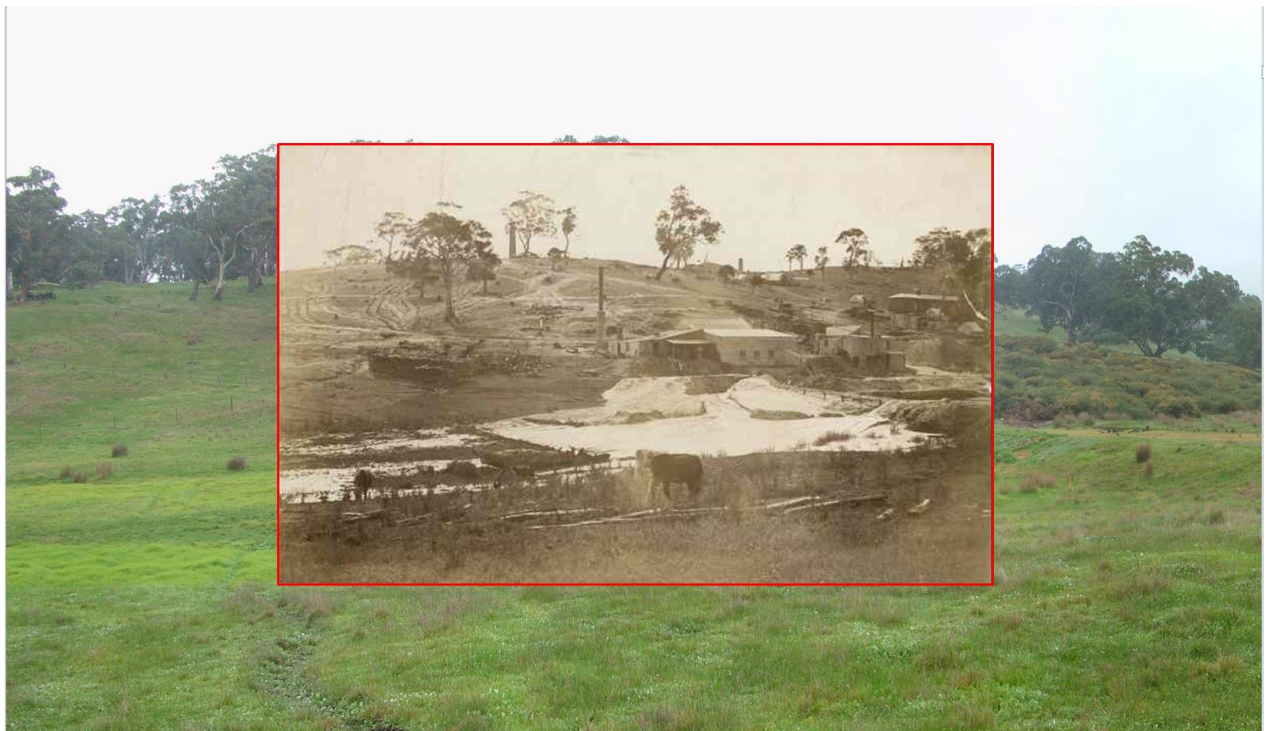
FIGURE 14-13 | LOCATION 6, CENTRAL PHOTOGRAPH SHOWS RIDGE TAILINGS DAM OVERFLOWING C1880, DPC PHOTOGRAPH B6260

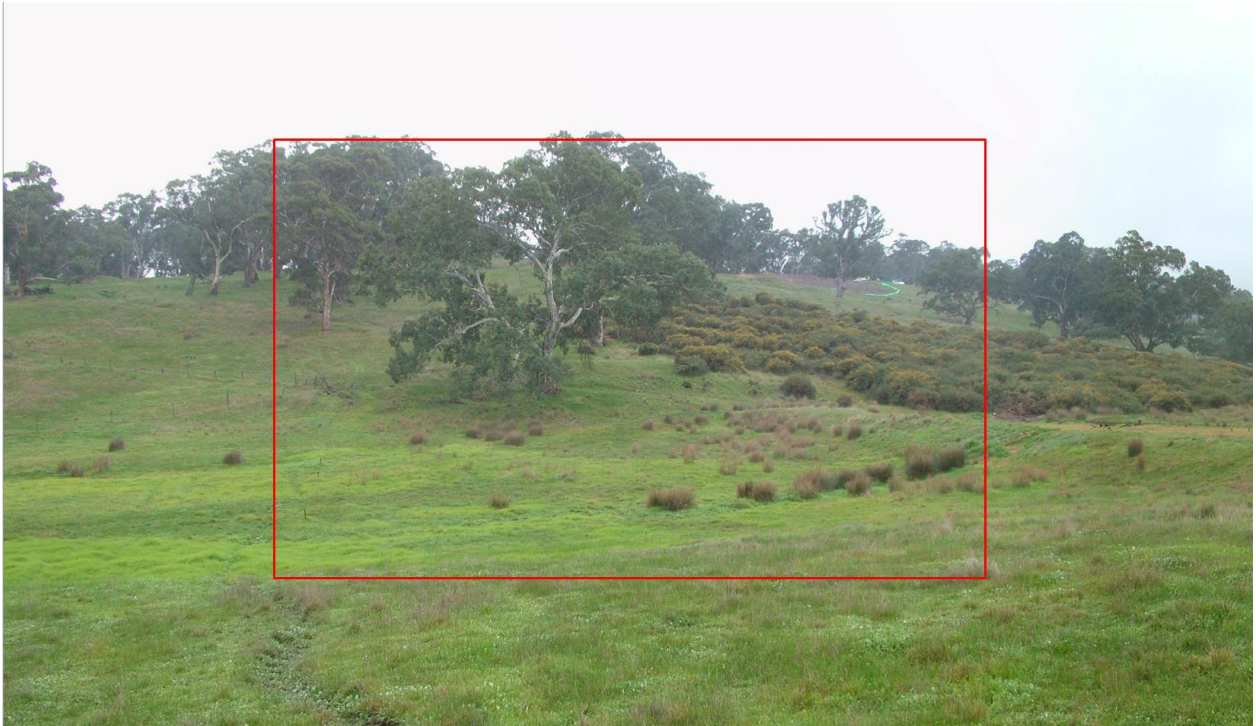
FIGURE 14-14 | LOCATION 6, RIDGE TAILINGS DAM PHOTOGRAPHED 2014 WITH THE VIEW OF B6260 OUTLINED IN RED

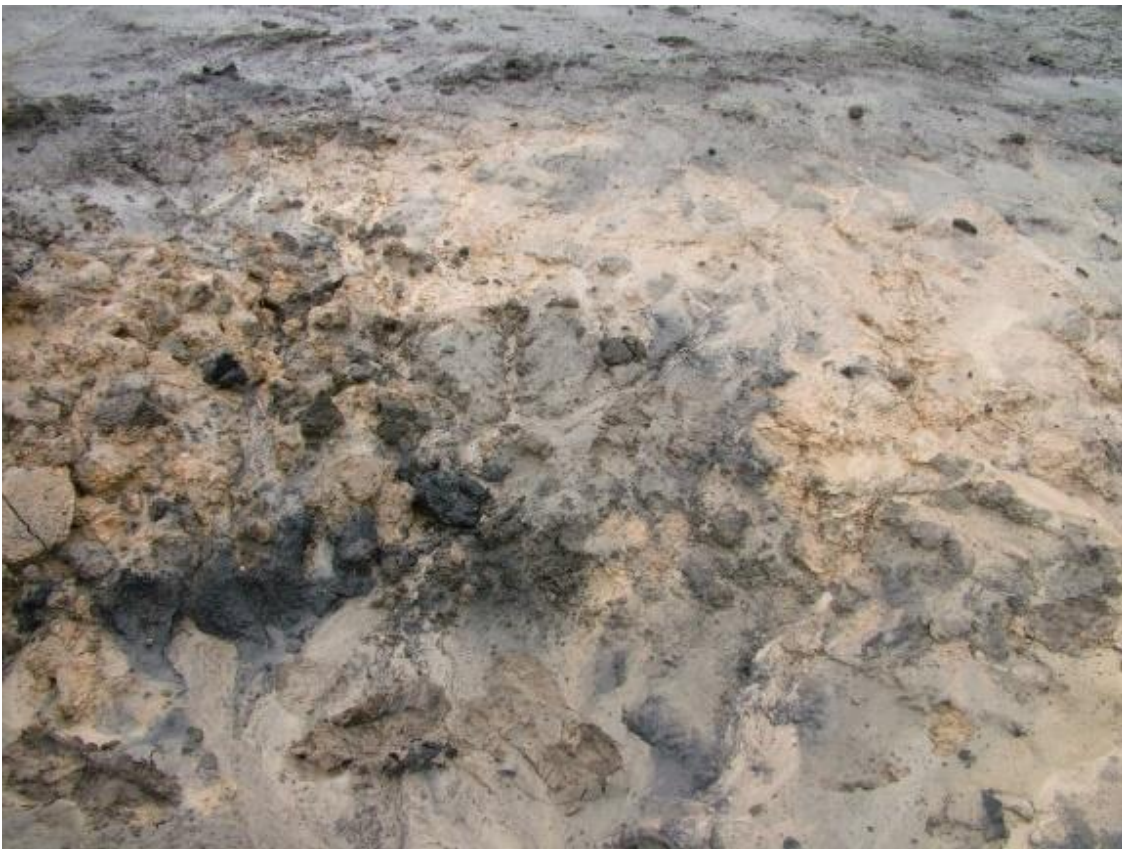
FIGURE 14-15 | TAILINGS EXPOSED IN A RECENTLY “CLEANED OUT” TAILINGS DAM PHOTOGRAPHED BY TERRAMIN 2014
(NOTE FOOT PRINTS IN MUD FOR SCALE)

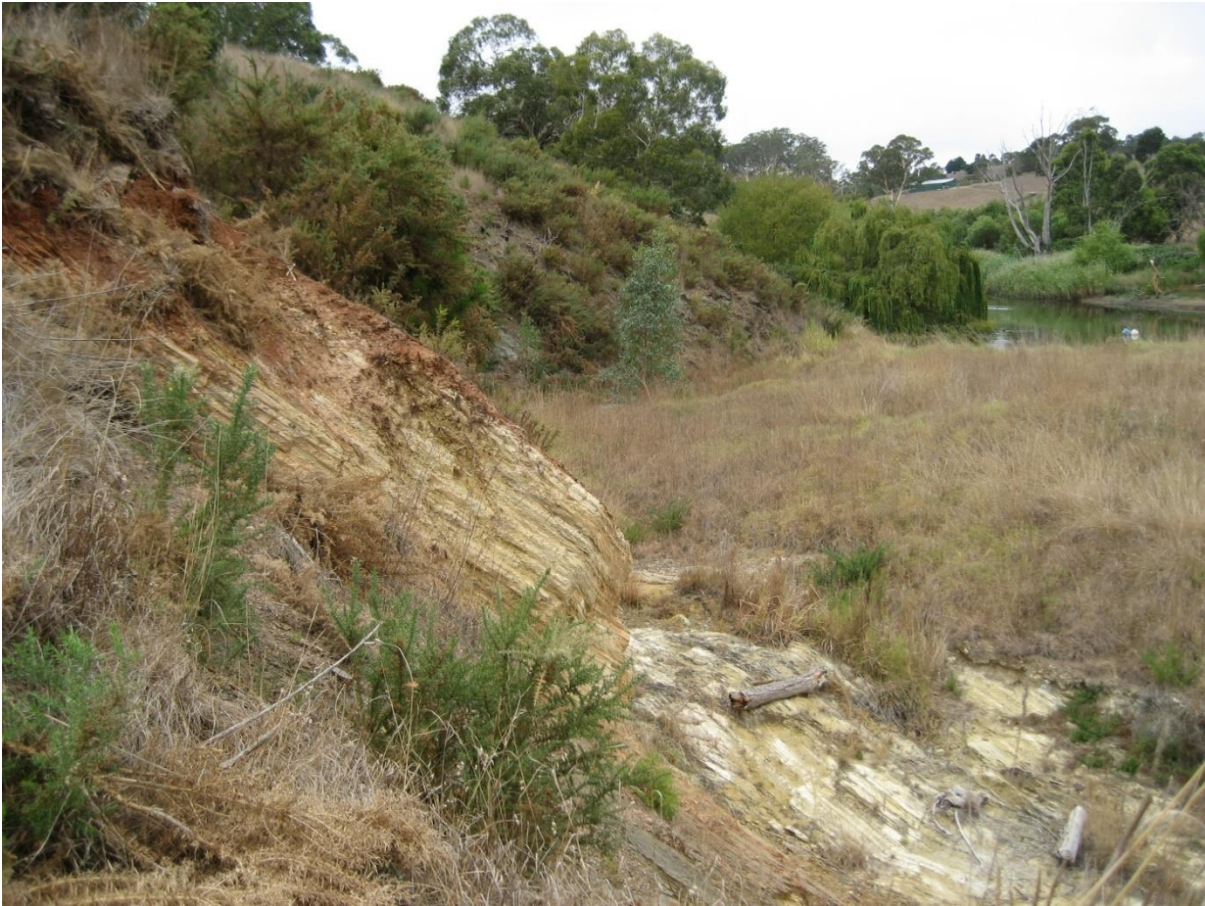
FIGURE 14-20 | LOCATION 8 - EXPOSED TAILINGS AT NEW ERA, PHOTOGRAPHED BY MAXIMUS, MARCH 2007
