Bird in Hand Gold Project
Mining Lease Application
MC 4473

CHAPTER 11

SURFACE WATER

MINING LEASE PROPOSAL

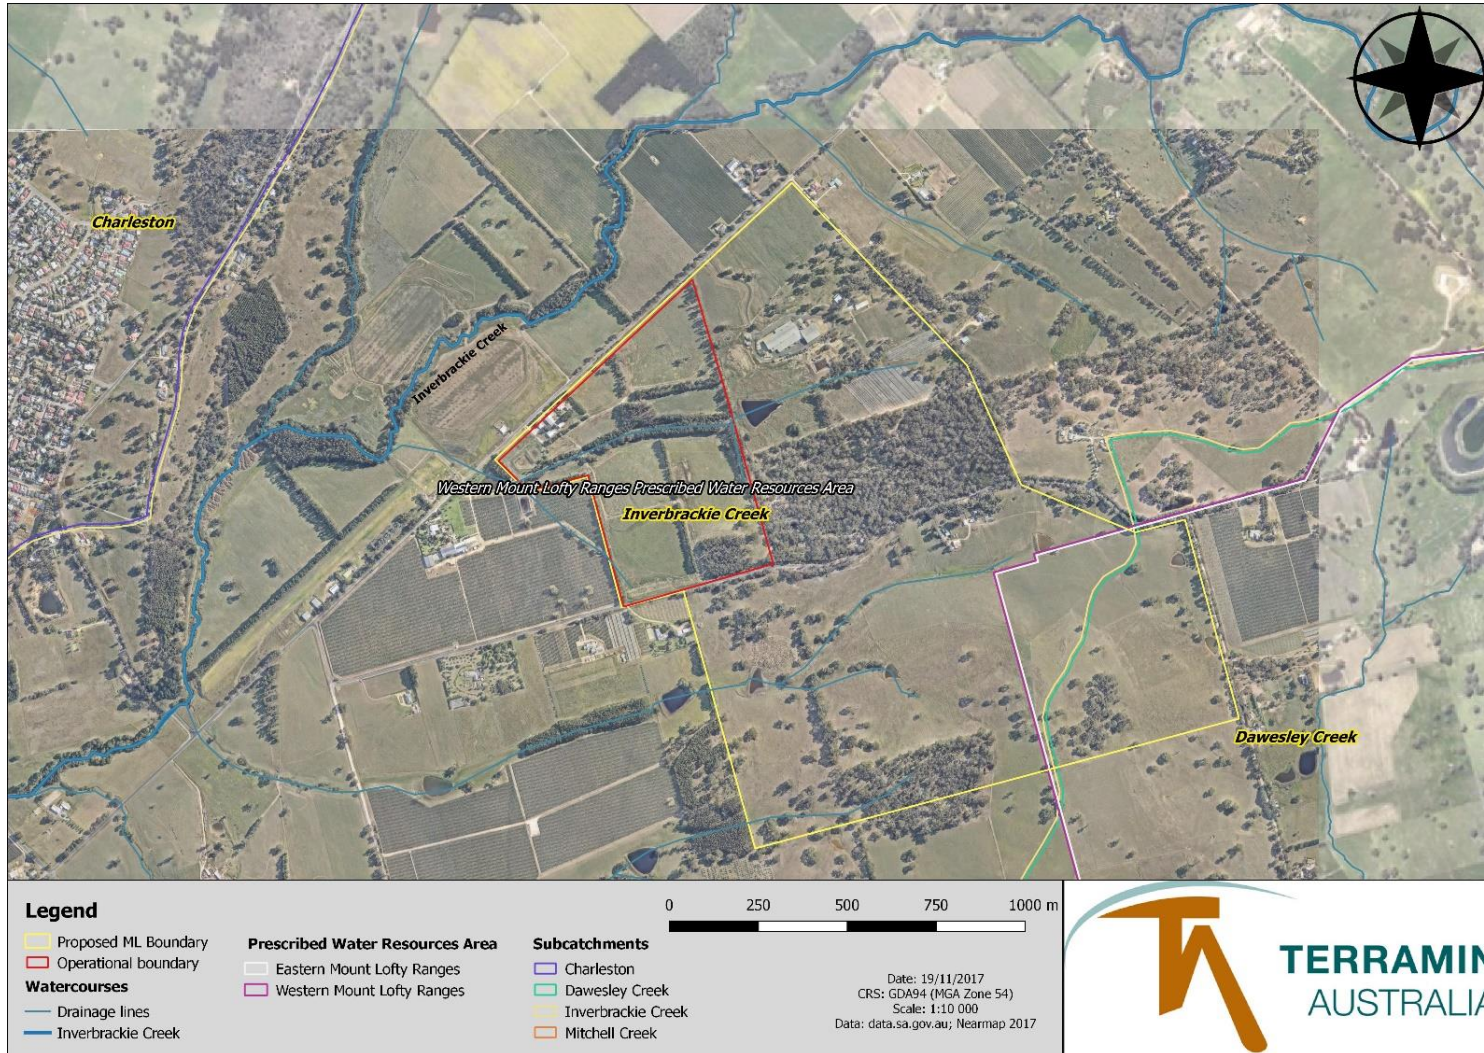
FIGURE 11-1 | SURFACE DRAINAGE LINES, SURFACE WATER SUB-CATCHMENTS AND PRESCRIBED WATER RESOURCE AREAS

The Project is located predominantly within the Western Mount Lofty Ranges Prescribed Water Resource Area. The south western corner of the ML is covered by the Eastern Mouny Lofty Ranges Prescribed Water Resource Area (prescribed by the NRM Act as shown in Figure 11-1).

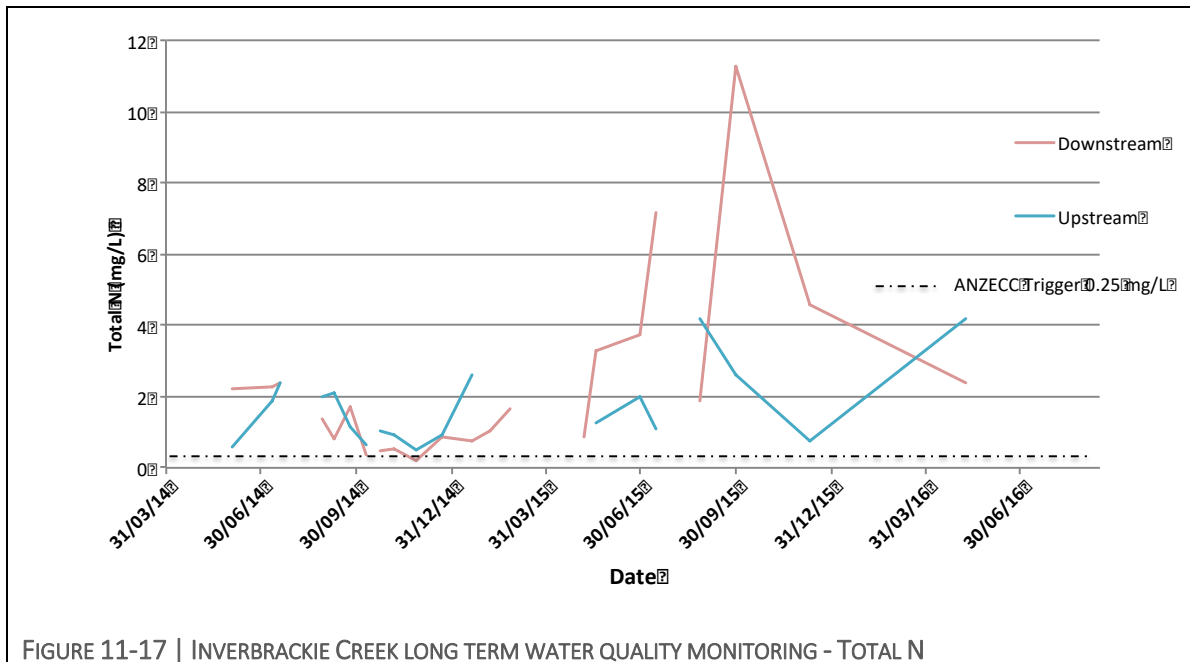
The highest concentration of total nitrogen was recorded at the downstream site in October 2015 (Figure 11-17). Similarly the highest total phosphorus was also recorded in October 2015 (Figure 11-18). Similar patterns are observed between total phosphorus and total nitrogen with regards to the higher concentrations being recorded upstream or downstream. Total P and Total N measurements are consistently above the above the ANZECC (2000) south-east Australia trigger values for the protection of 95 % of freshwater species.

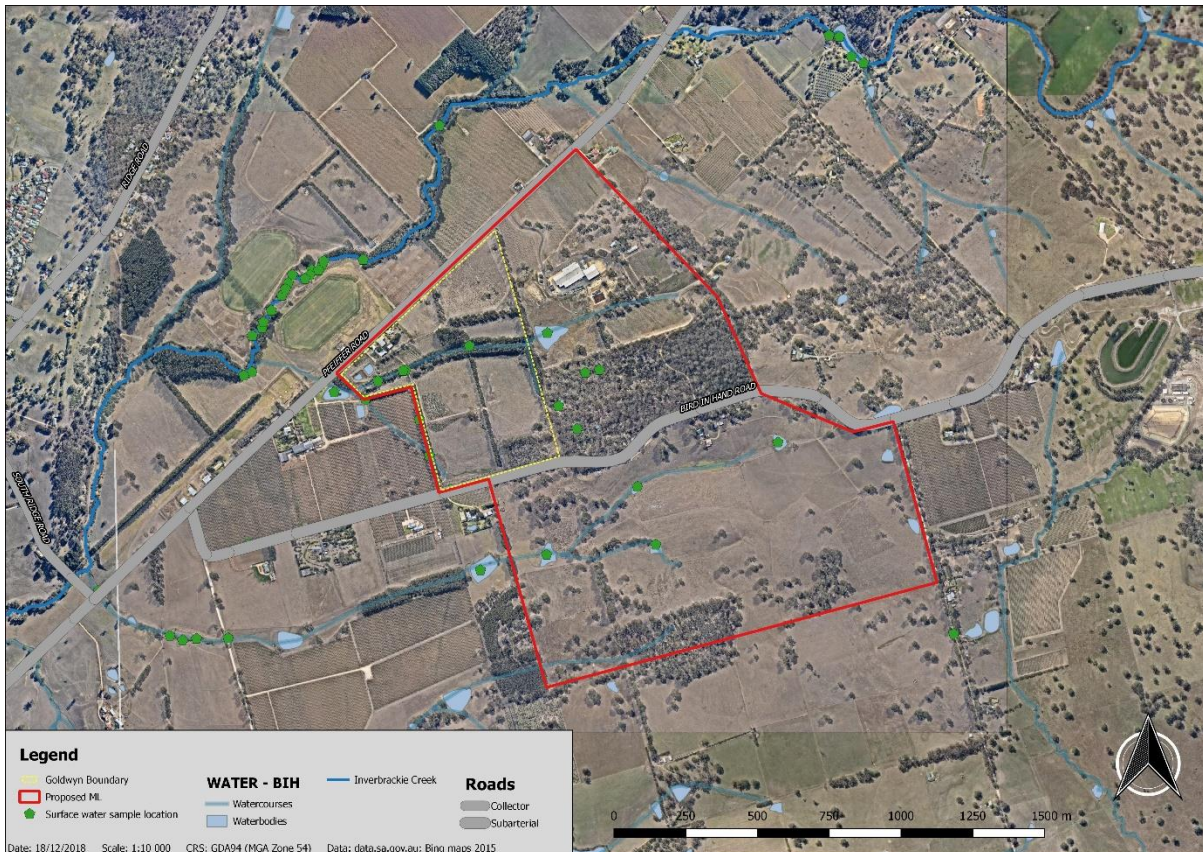
FIGURE 11-19 | SURFACE WATER SAMPLE LOCATIONS

Additionally, surface water samples have been obtained from various run off points emanating from the proposed ML between 2014 and now. This includes significant rain events in May 2016, which caused most ephemeral drainage lines to flow. Significantly, this includes the drainage line located in the southern side of the proposed ML, south of Bird in Hand Road. Locations of surface water samples taken between 2014 and 2018 are shown below in Figure 11-19.

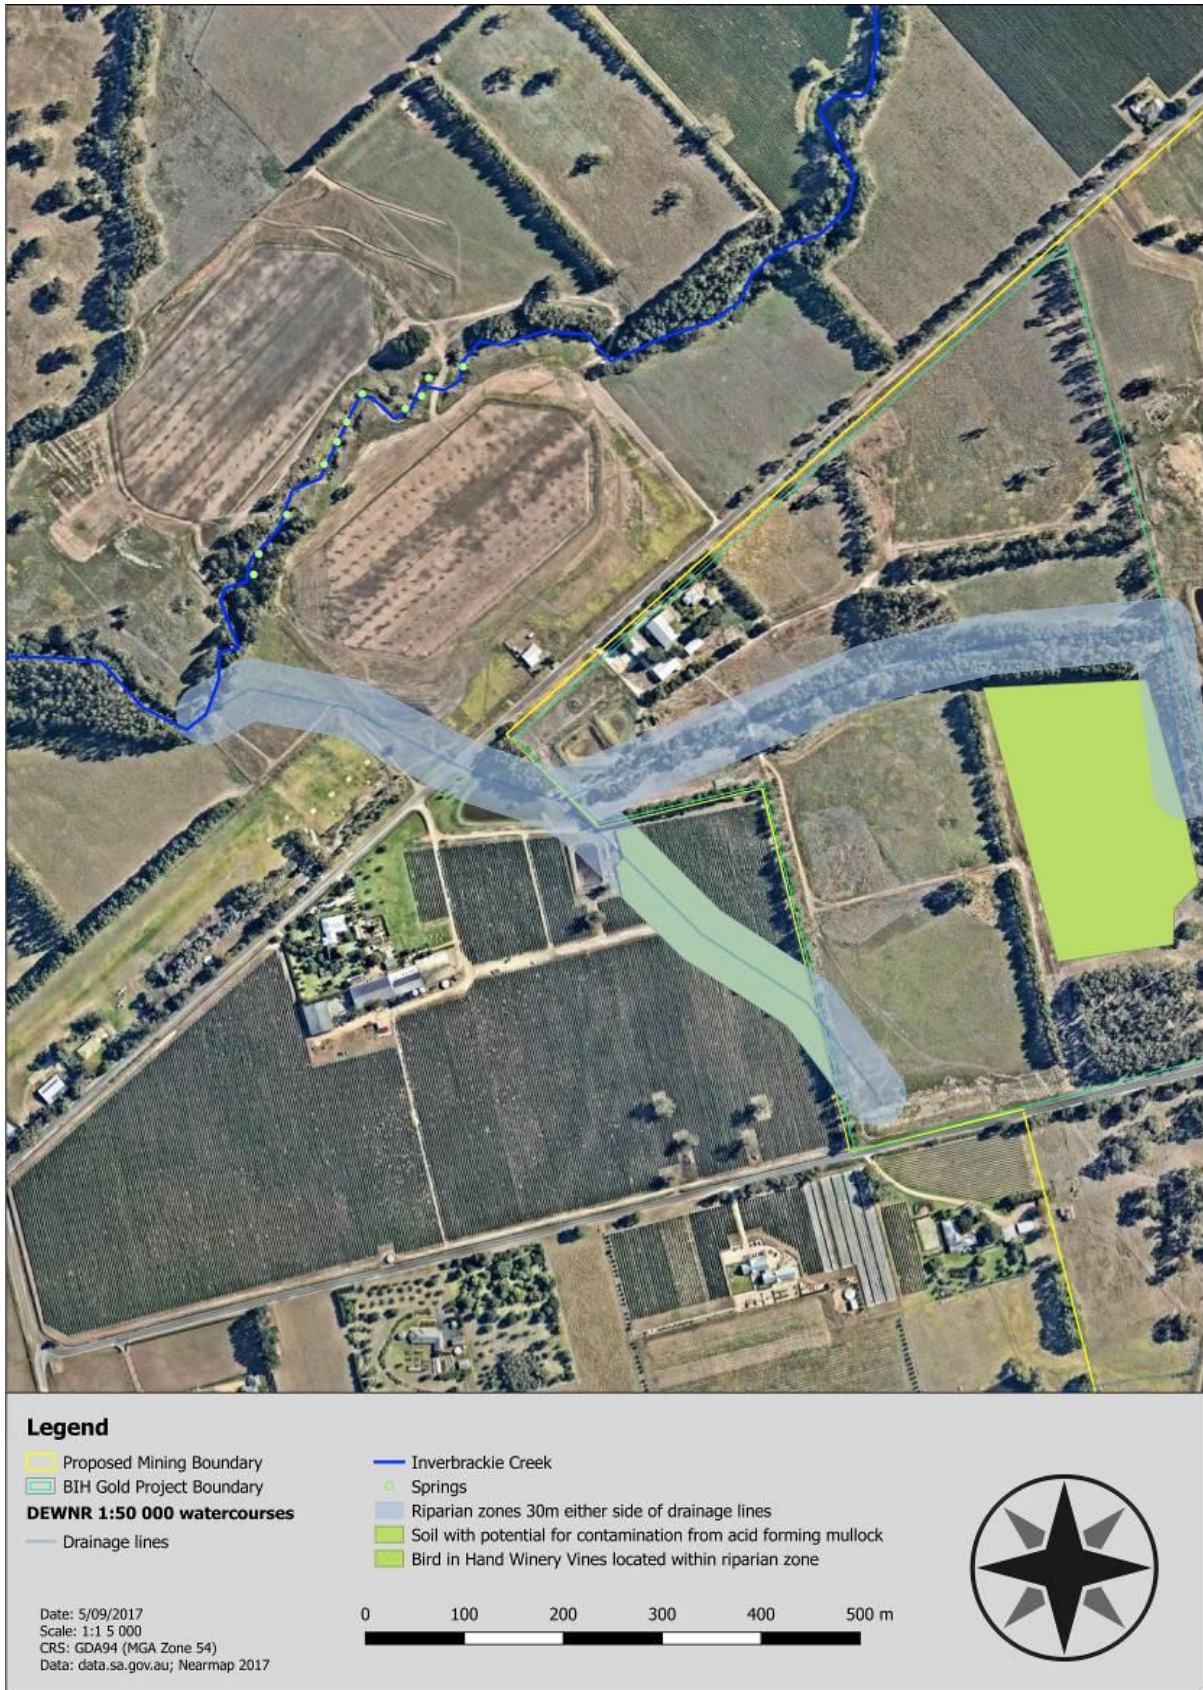
FIGURE 11-23 | IDENTIFIED POTENTIAL SENSITIVE RECEPTORS

Sensitive Receptor	Summary	Impact ID
Surface water ecosystem (Inverbrackie Creek and tributaries)	Part of Inverbrackie Creek is located downstream of the Goldwyn, MAR bores and exploration sites. Springs are located along Inverbrackie Creek – see Figure 11-20	PIE_11_04 PIE_11_05 PIE_11_07 PIE_11_08 PIE_11_13 PIE_11_14 PIE_11_15 PIE_11_16 PIE_11_18 PIE_11_20
Agricultural land (BIH Winery vineyard)	Part of the BIH Winery vineyard is located within the riparian zone, which is downstream of a drainage line which begins in the western paddock of Goldwyn	PIE_11_03
Riparian zones	Riparian zones have been defined as 30m either side of a drainage line	PIE_11_17
Groundwater dependent ecosystems	As defined by the National Groundwater Dependent Ecosystem Atlas – includes Inverbrackie Creek	PIE_11_10
Fauna (listed species)	No listed species have been discovered or are likely to be found within the Inverbrackie Creek system	PIE_11_01 PIE_11_02 PIE_11_19

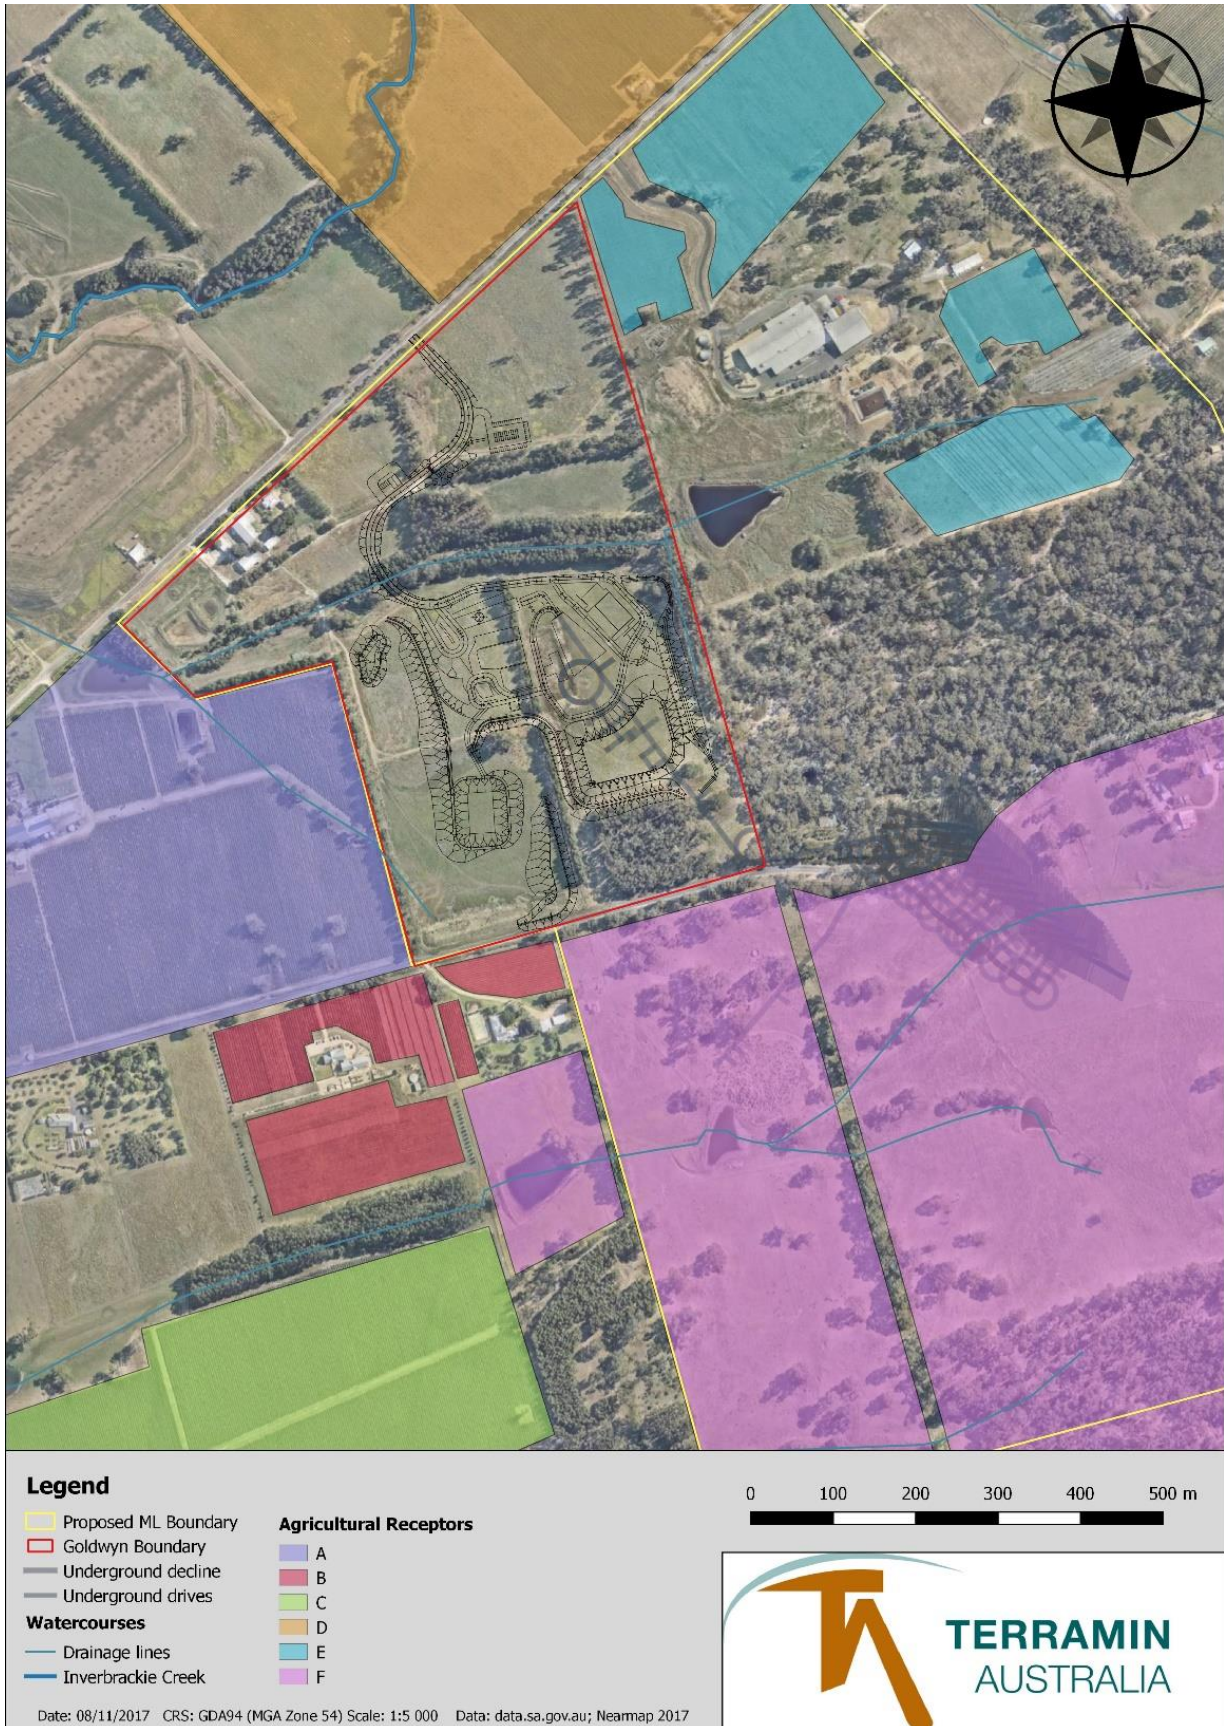
FIGURE 11-24 | IDENTIFIED AGRICULTURAL SENSITIVE RECEPTORS

Surrounding agricultural land	Surrounding agricultural land along riparian areas identified in Chapter 22 and shown in Figure 11-24 (replicated from Chapter 22).	PIE_11_06 PIE_11_09 PIE_11_11 PIE_11_12

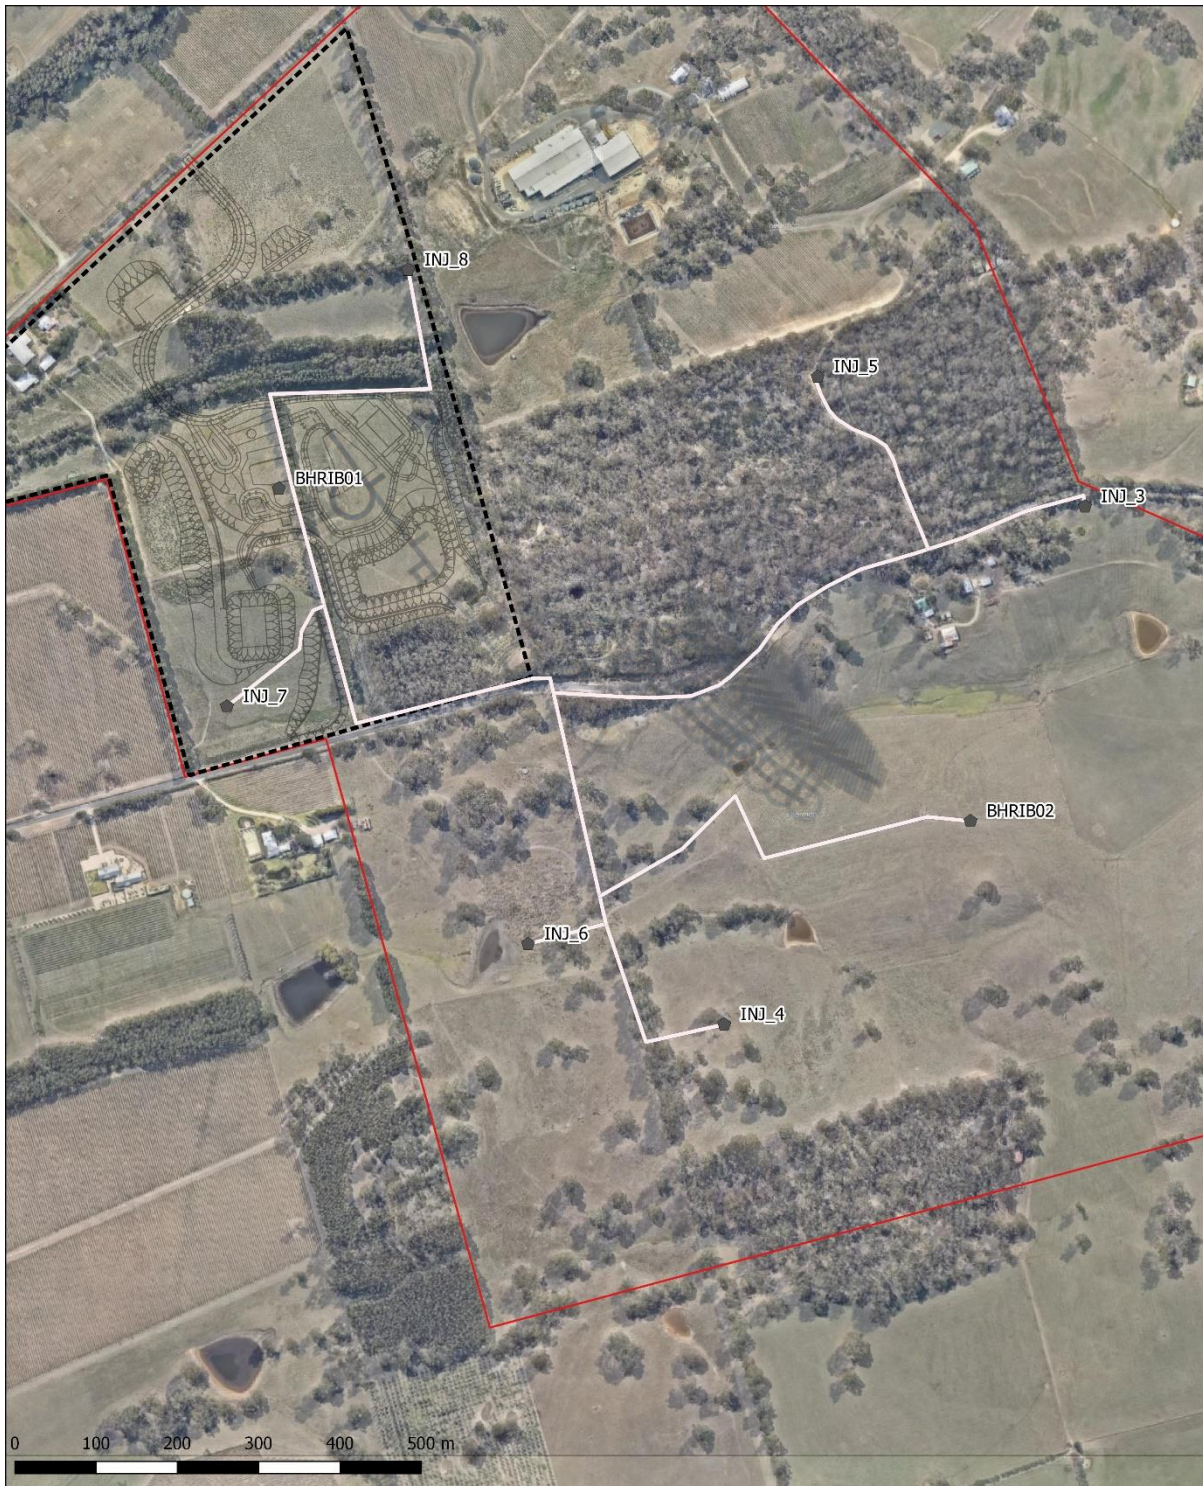
The proposed managed aquifer recharge system (MAR) will require a network of 50mm-110mm diameter pipelines to carry water from the water treatment plant to the MAR bores, as well as from the extraction/depressurisation bores to the reinjection bores for the water that will not require treatment. Where possible, the pipelines will follow fence lines and will be located within easements on properties within the lease. There will be a need to pass the pipelines under the Bird in Hand Road – directional drilling is proposed for this to occur to prevent damage and excavation of the existing road surface.

Proposed pipeline locations are shown in Figure 11-28.

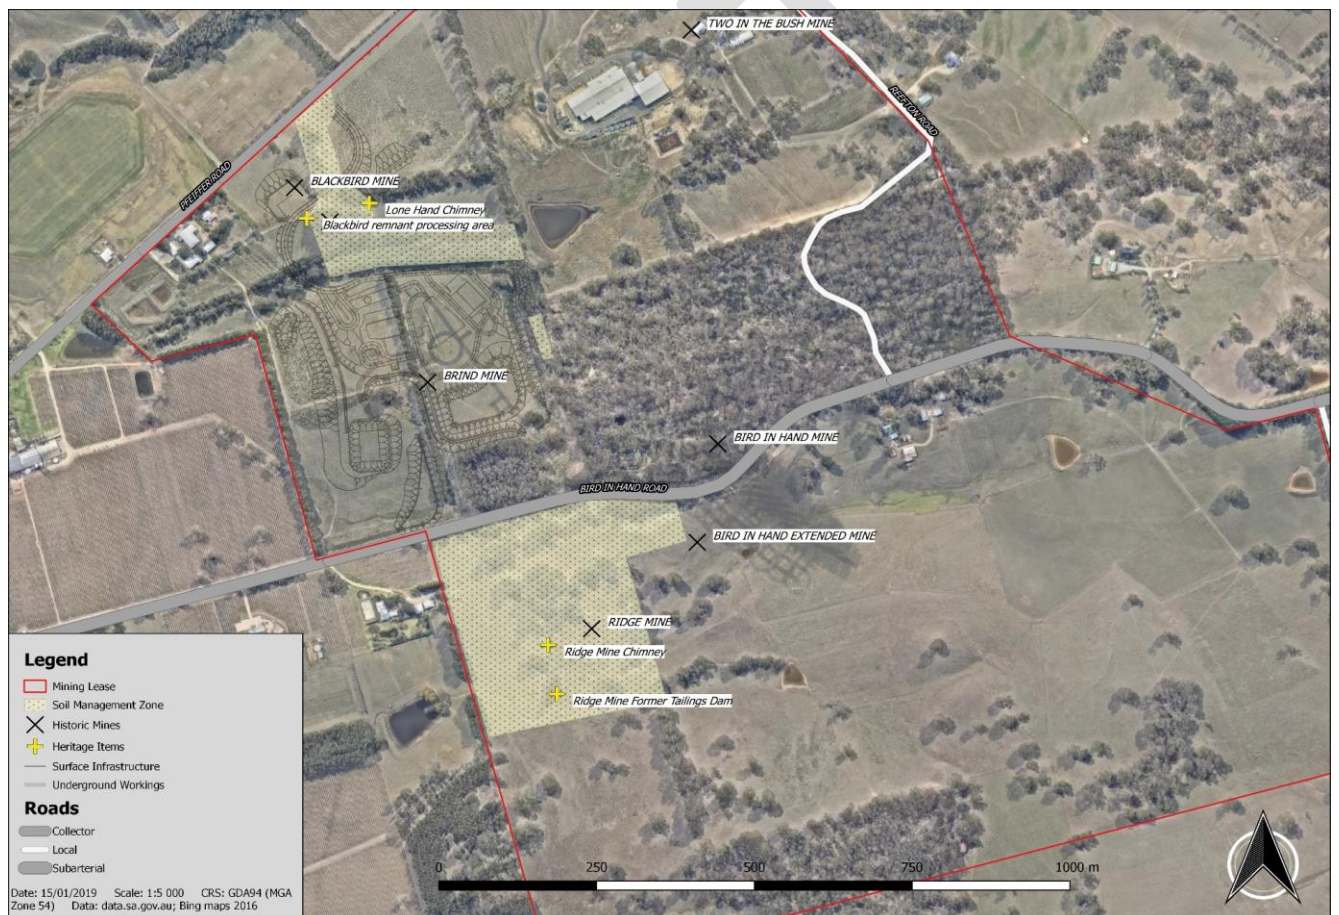
FIGURE 11-29 | EXPLORATION SUBJECT TO SOIL MANAGEMENT ZONE SOUTH OF BIRD IN HAND ROAD

All exploration works are subject to the exploration management plan, outlined in Appendix B7. This includes waste and drill cutting management, erosion control, topsoil management, earthworks and sump requirements, and the requirements which prevent surface drainage lines. All sites and new access tracks must have sediment traps installed down slope to eliminate the risk of sediment travel in heavy rainfall events. These control measures have been used through all approved drilling programs through 2014, 2016 and 2018.

Importantly, the soil management plan, including the unexpected finds protocol prepared by Golder Associates (appendix L4), will apply for all exploration works. Although there is currently no soil test results indicating contamination sources, the soil management zone has been expanded to include all historic workings located on the southern side of Bird in Hand Road – shown in Figure 11-29. Terramin do not expect to access the dam area for exploration.

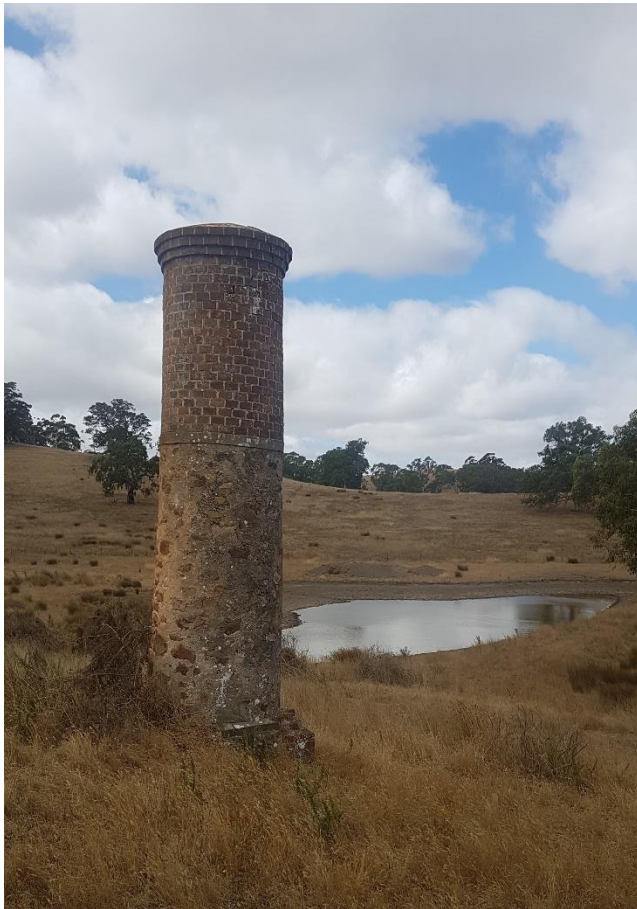
FIGURE 11-30 | RIDGES MINE'S TAILINGS DAM AND CHIMNEY. FACING SOUTH.

There is a concern that metalliferous drainage may exist from former tails and mine waste areas from the historic Ridge Mine. This includes a private landholder stock dam located directly downstream from the historic ridge chimney and downstream from Terramin exploration sites - location shown in Figure 11-30 and Figure 11-31.
