# CHAPTER 12

## LAND AND SOIL

# BIRD IN HAND GOLD PROJECT

## MINING LEASE PROPOSAL

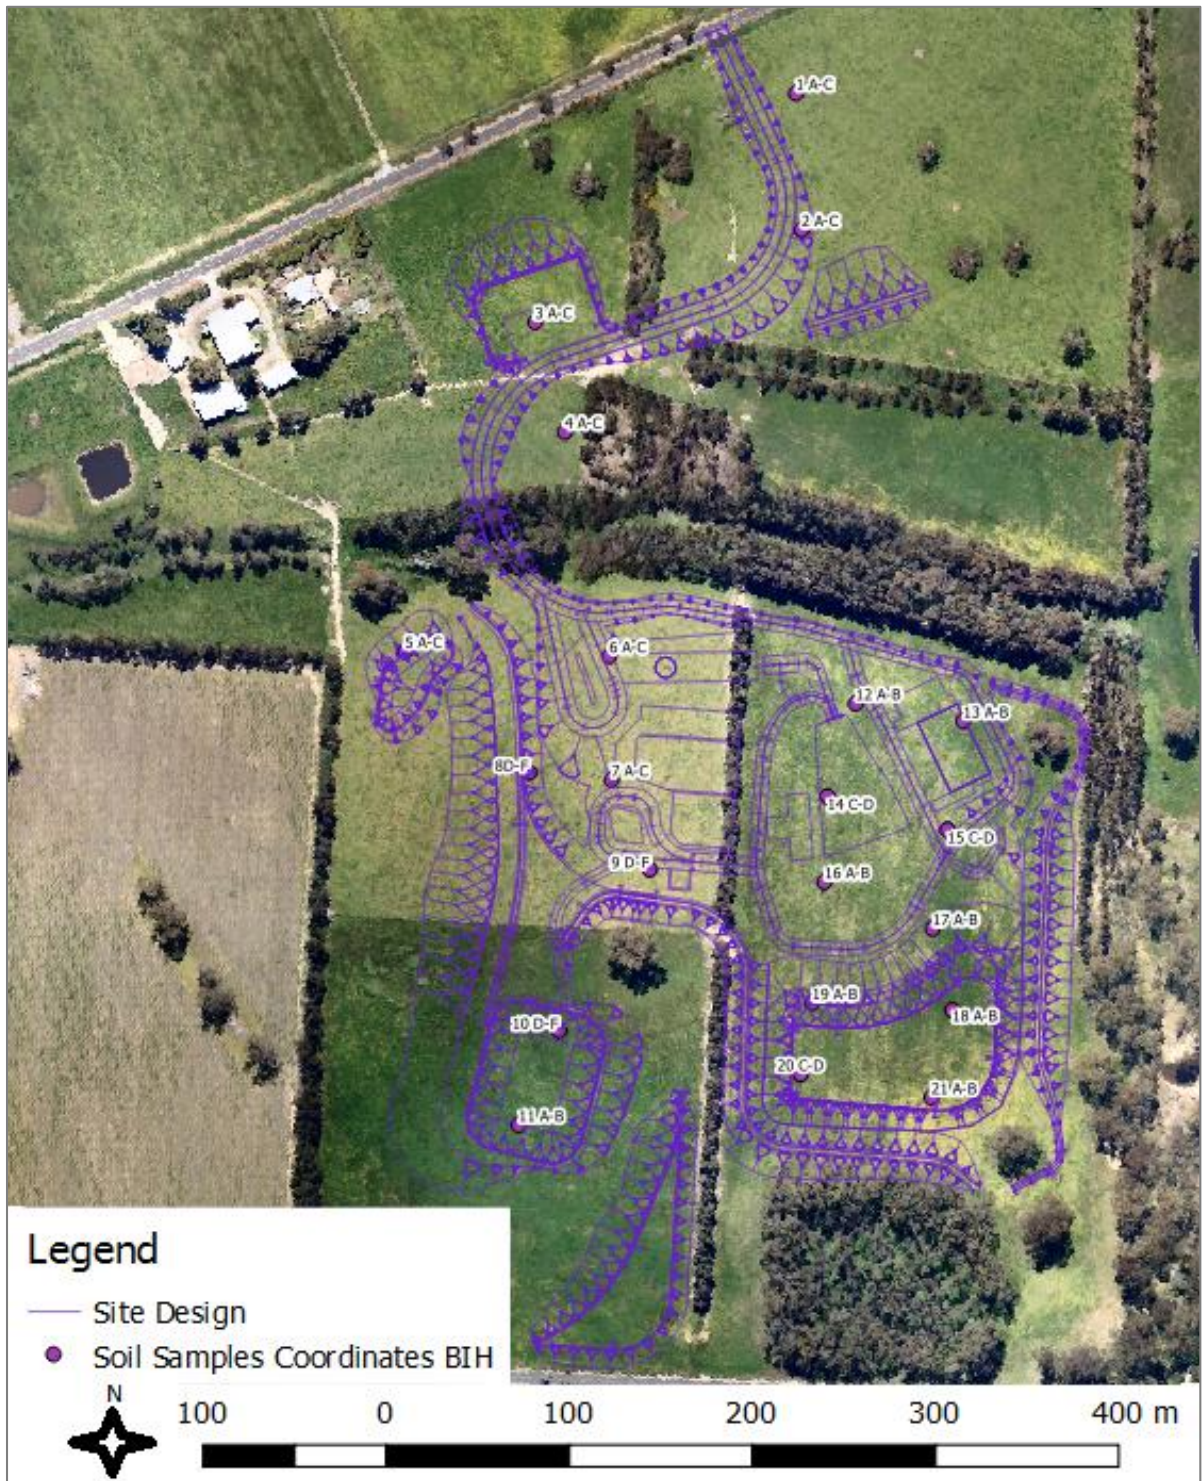
FIGURE 12-5 | EROSION SOIL SAMPLE LOCATIONS

Samples were taken from locations identified in Figure 12-5. The site specific erosion study revealed that the soil is generally classified as clay loam, or sandy clay loam, with instances of silty clay loam, as per the Emerson Class classification system.

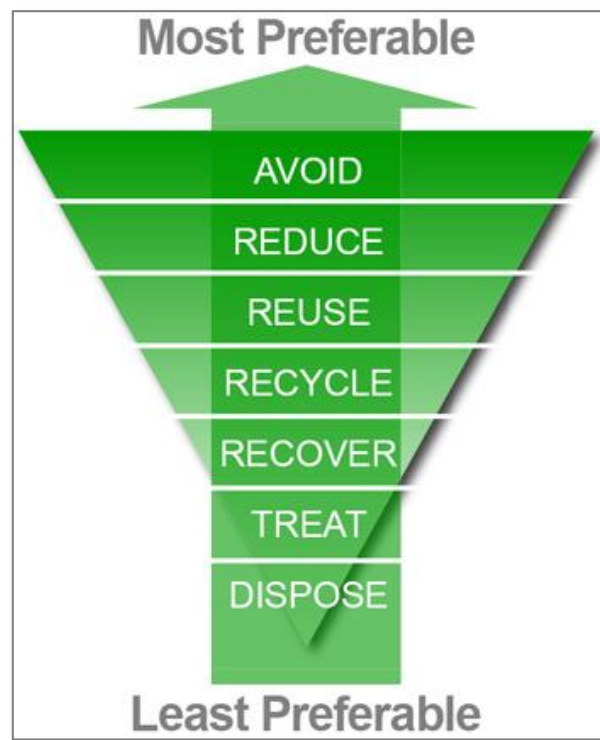
FIGURE 12-6 | HIERARCHY OF CONTROL TO MINIMISE WASTE PRODUCTION AND IMPACT ON THE ENVIRONMENT (ZERO WASTE SA, 2012)

A Waste Management Plan would be included as part of the PEPR to ensure waste is managed, resulting in minimal impact to the environment through a hierarchical approach (Figure 12-6).

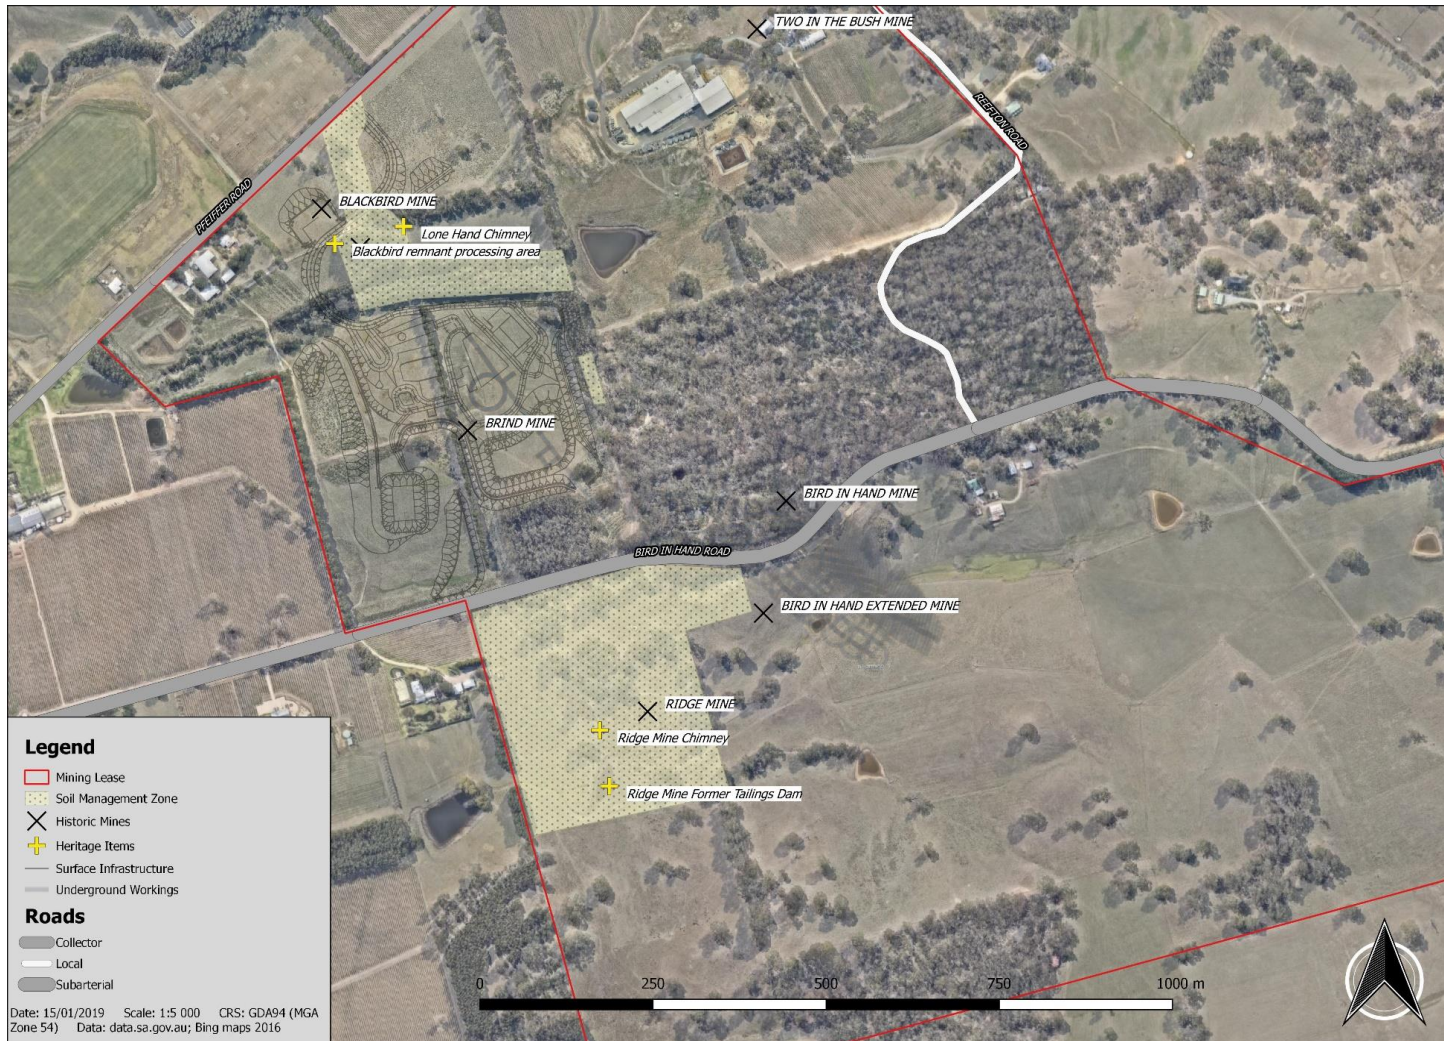
FIGURE 12-7 | EXPLORATION SUBJECT TO SOIL MANAGEMENT ZONE SOUTH OF BIRD IN HAND ROAD

Importantly, the soil management plan including the unexpected finds protocol prepared by Golder Associates (appendix L4) will apply for all exploration works. Although there is currently no soil test results indicating contamination sources, the soil management zone has been expanded to include all historic workings located on the southern side of Bird in Hand Road – shown in Figure 12-7.
