# CHAPTER 19

## VEGETATION AND WEEDS

## BIRD IN HAND GOLD PROJECT

### MINING LEASE PROPOSAL

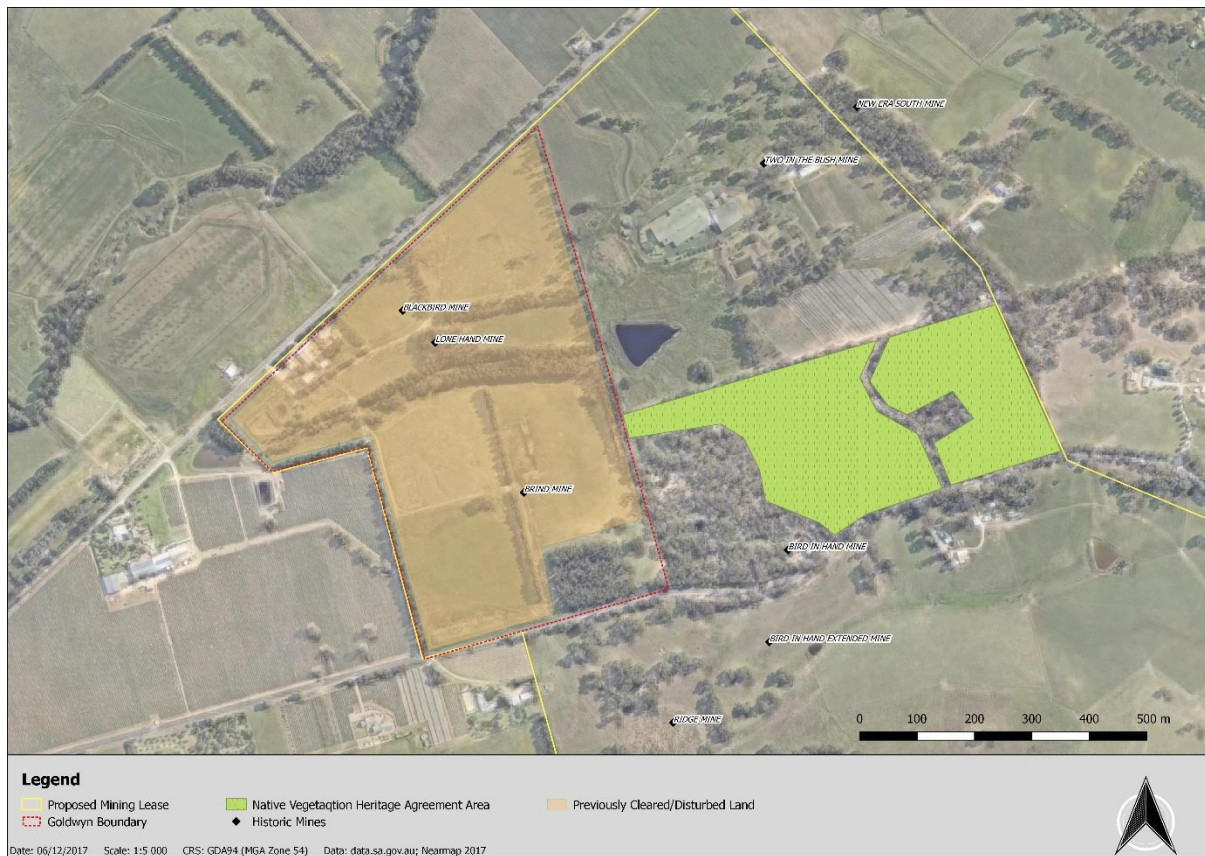
**FIGURE 19-2 | PREVIOUSLY DISTURBED LAND**

The proposed area of disturbance for the BIH Project is contained within the Property Goldwyn. This property has been cleared extensively over the preceding century, and has been used for mining, potato farming, as a dairy, and in the preceding couple of decades, as a cattle grazing property – shown in Figure 19-2.

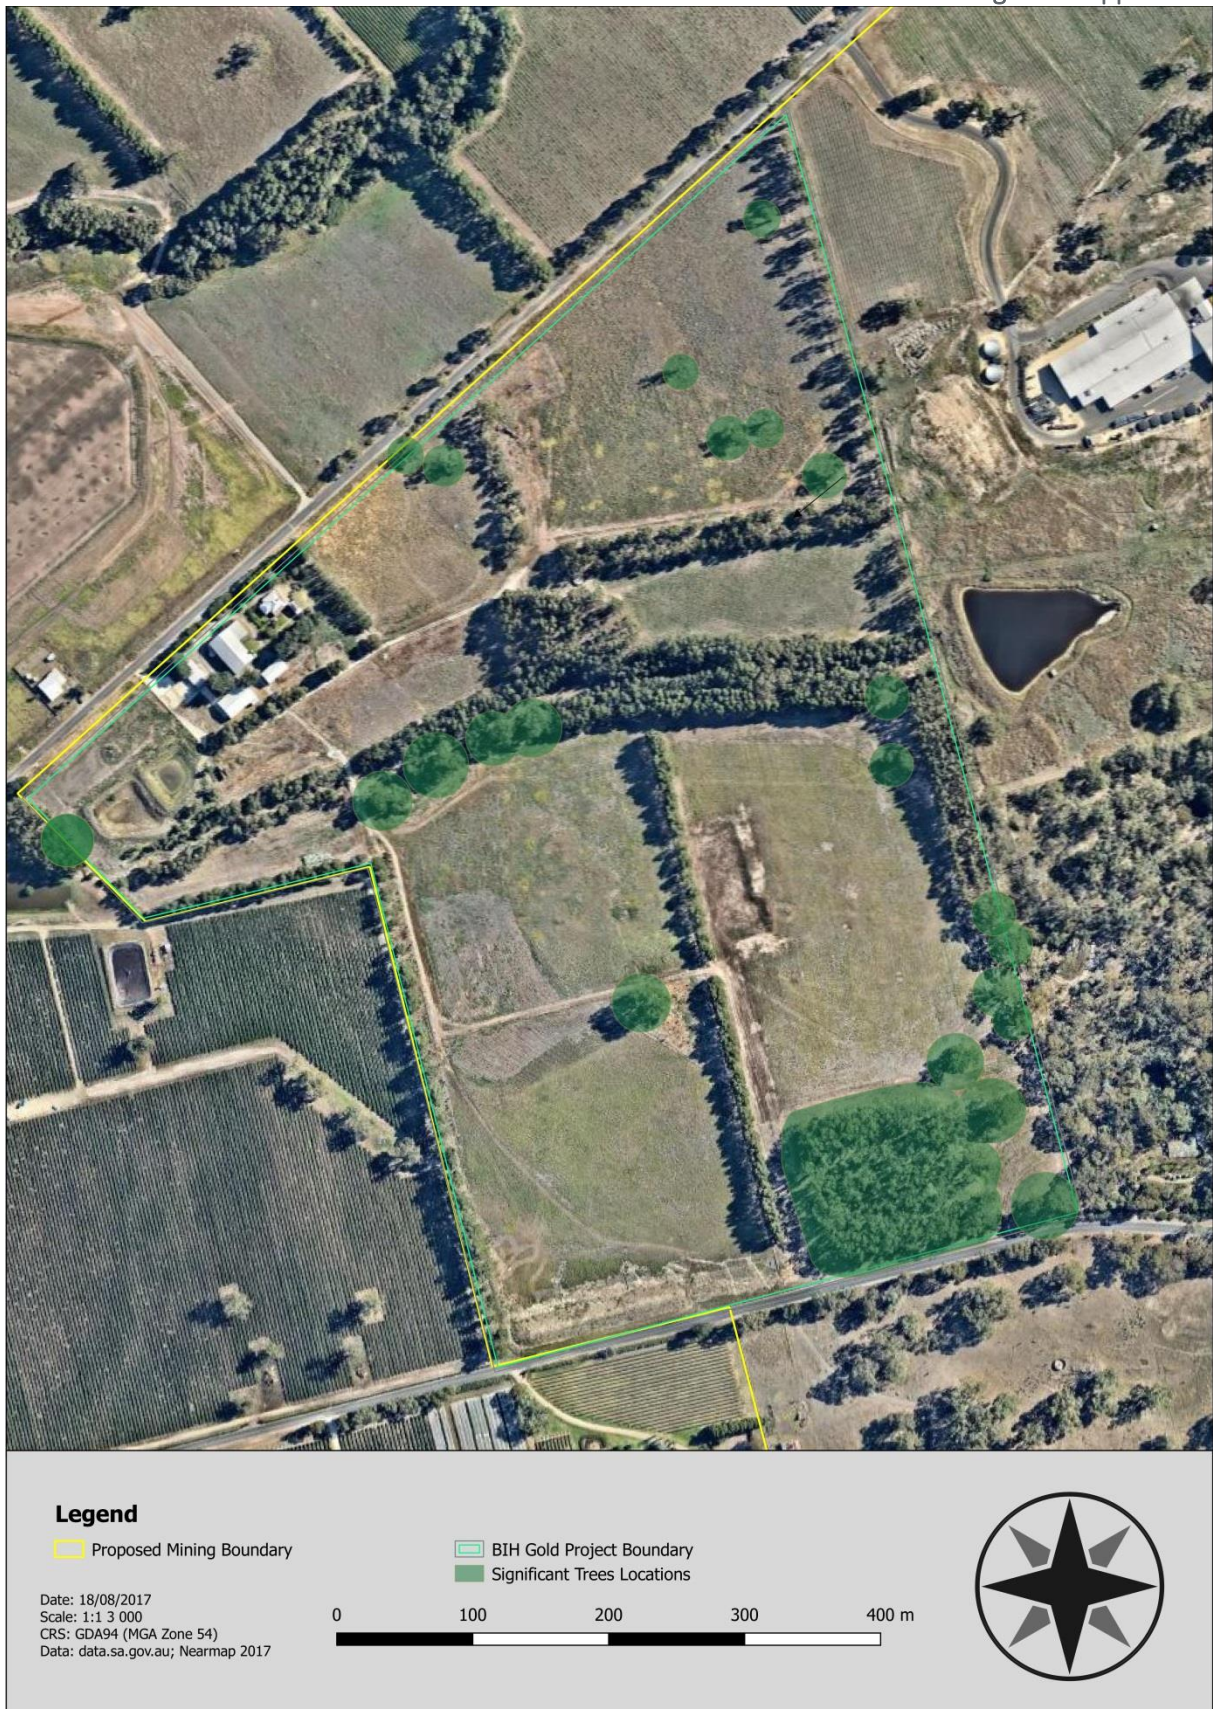
**FIGURE 19-8 | SIGNIFICANT TREES LOCATED WITHIN GOLDWYN**

Significant trees exist within Goldwyn and are located in Figure 19-8.
