CHAPTER 20

HERITAGE

BIRD IN HAND GOLD PROJECT

MINING LEASE PROPOSAL

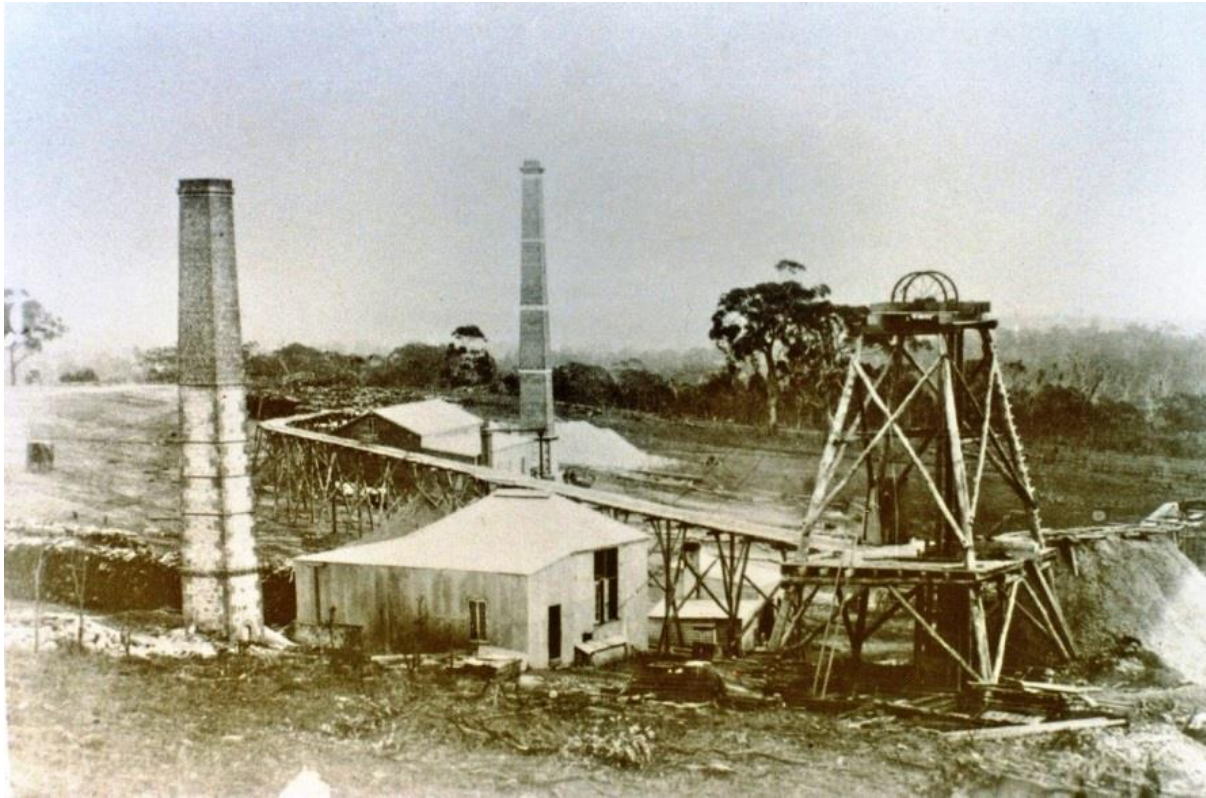
FIGURE 20-1 | BIRD-IN-HAND MINE IN 1884, WITH A VIEW LOOKING WEST TOWARDS THE WINDING HOUSE AND THE TRAMWAY TO THE 20 HEAD STAMP BATTERY (TERRAMIN, 2016).

At the BIH in May 1883, a new 20-head battery powered by a 40hp steam engine from Martin & Company of Gawler was erected (see Figures 10 & 11) (Drew, 2011, p. 26; Fradd & Morris, 2015, p. 10; McLean, 2007a). This was the largest battery erected in South Australia up till then. A small steam engine was also installed at the Main Shaft for hauling and operating pumping equipment, although this was finally found insufficient for getting ground water out of the mine. An elevated tramway about 120m long was built from the landing brace at the Main Shaft to convey ore to the battery house.

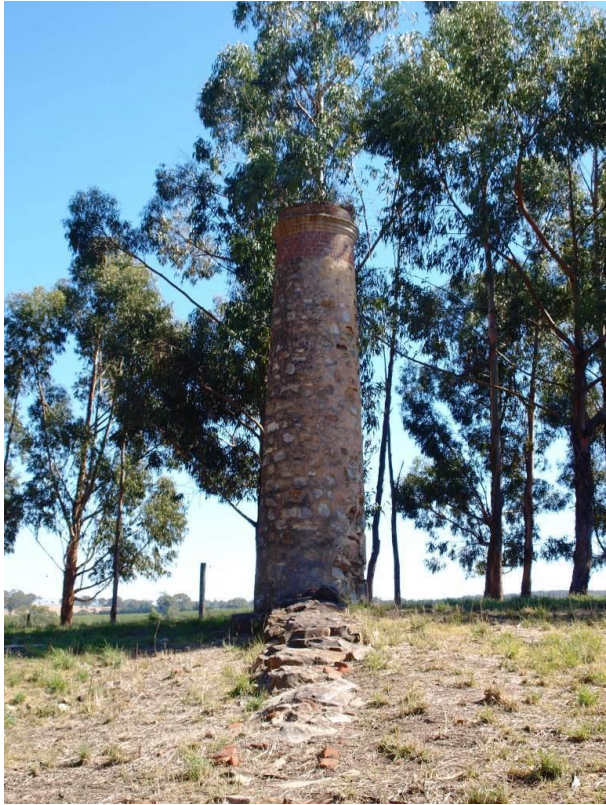
FIGURE 20-2 | LONE HAND CHIMNEY STACK, 8TH MARCH 2016.

The Lone Hand Chimney is located approximately 200m north of the proposed construction blasts. The Lone Hand Chimney is currently experiencing background levels of air overpressure (described in Chapter 17) which are well in excess of the 125 db(L) which is the level the two surface construction blasts would produce. For this reason, there is no credible S-P-R relationship between the chimney and air-overpressure. In regards to vibration, Terramin have investigated other heritage structures near mining projects in Australia. The most similar is the 1860s Cadia Engine House and Chimney, at Newcrest's Cadia Valley Mine in NSW (listing number 00779). Terramin would proposed to limit ground vibration to 15mm/s at the Chimney, as Newcrest have, which reflects the most conservative peak particle velocity for unreinforced or light framed structures, as outlined in British Standard BS7385-2. Authoritative investigations outlined in Australian Standard 2178.2 *Explosives – Storage and Use*, appendix J suggest that the guide values and assessment methods given in BS 7385-2 are applicable to Australian conditions (AS2187.2 - 2006, p. Appendix J). For this reason, Terramin consider impacts to the Lone Hand Chimney to be **negligible**. Impacts to the Ridge Chimney are not plausible based on these standards, as the Ridge Chimney is located where approximately 2mm/s is predicted through the construction blasts.
