Bird In Hand Gold Project Strategic Visual Amenity Plan (SVAP)

**15.019 Bird In Hand Gold Project
Strategic Visual Amenity Plan (SVAP)**

Oxigen Landscape Architects
98-100 Halifax Street
ADELAIDE SA 5000
Telephone: (08) 7324 9600
www.oxigen.net.au

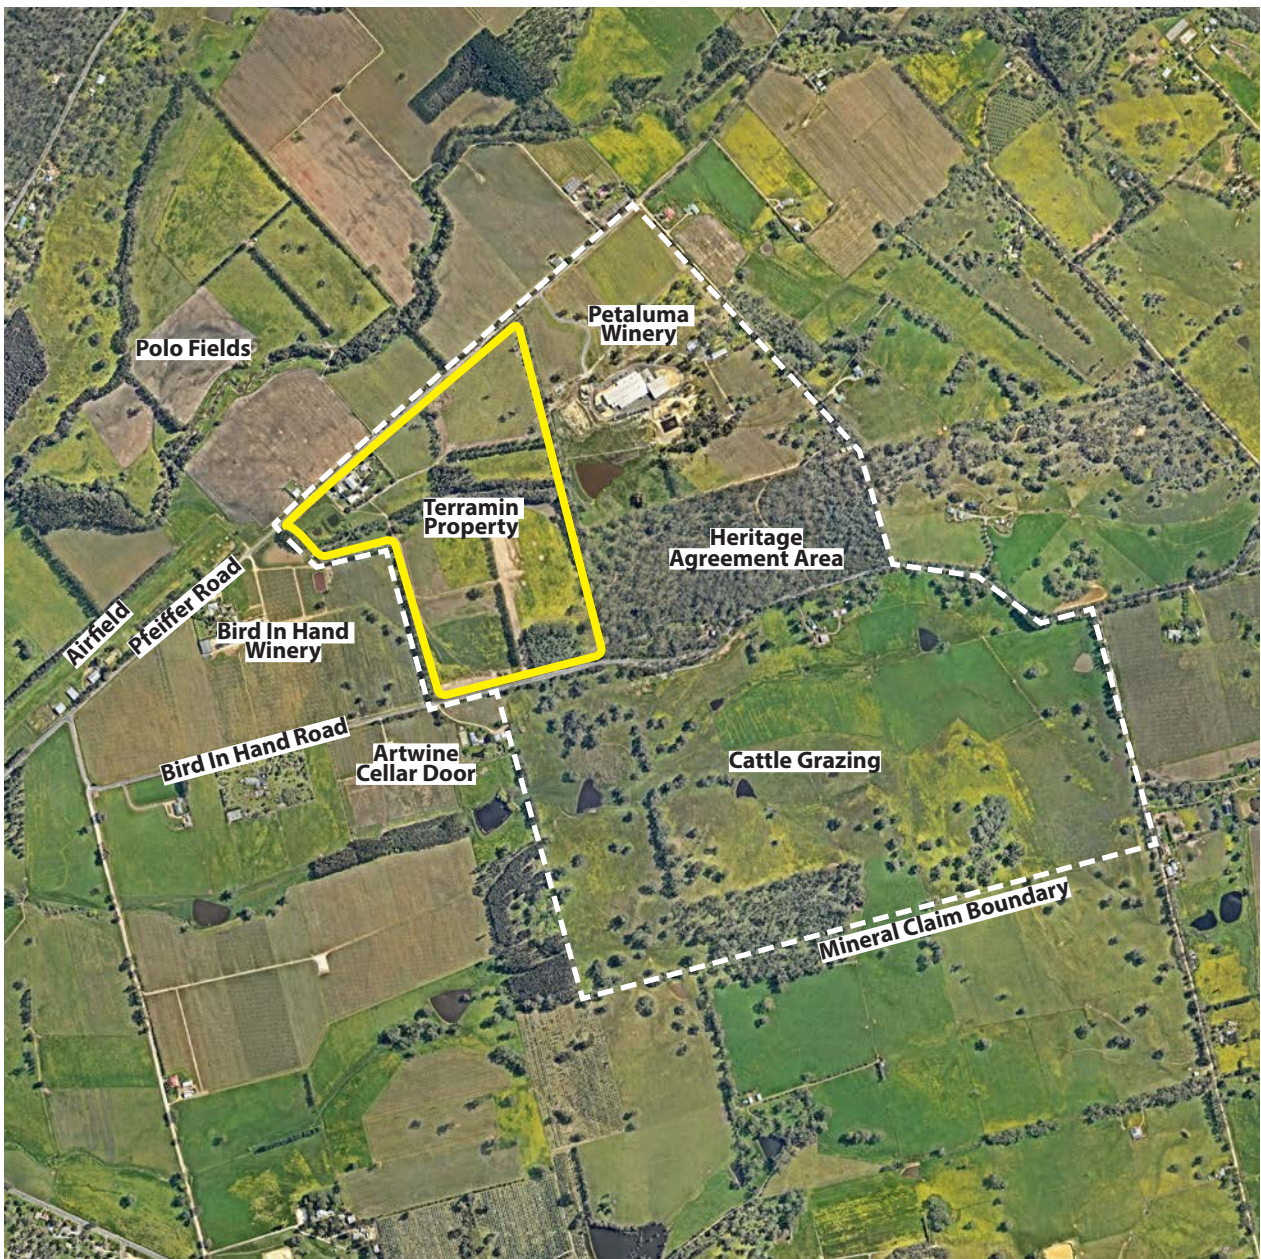
Terramin's property is bounded by wineries and cellar doors on the eastern, southern and western boundaries with recently constructed polo fields to the north. A polo clubhouse is proposed on the northern side of the Inverbrackie Creek but at the time of writing is yet to be constructed.

Figure 2: Property Boundary

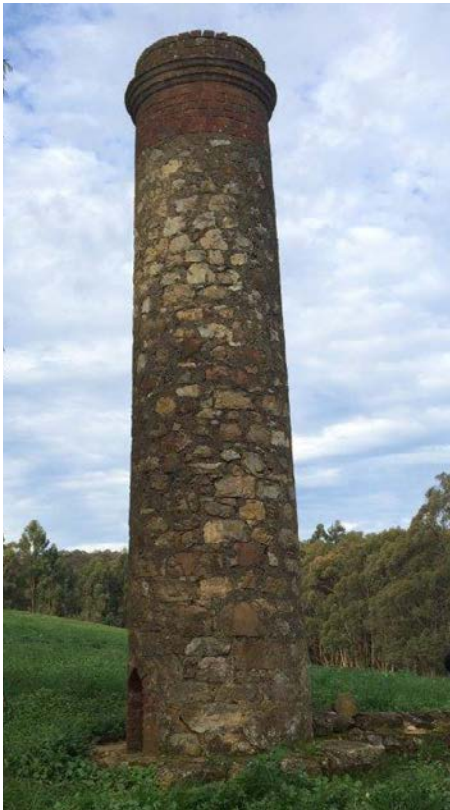
State Heritage Listed Chimney + Flue (Lone Hand Site)

An existing historic chimney is a relic from the former Lone Hand Gold Mine and is a listed State Heritage item number #12863. The chimney provides a visual link to historic mining within the surrounding area and is in a visually sound condition. The heritage listing recognises the importance of the mining and mineral processing heritage of the property and was confirmed in 1987.

The chimney is a visually prominent brick and stone structure; however, views from Pfeiffer Road and Bird In Hand Road to the chimney are obscured by vegetation and landform. Terramin have advised that the chimney is to be retained and a construction buffer of 25 metres established.

The State Heritage listed chimney is retained with a 25 metre protection buffer.

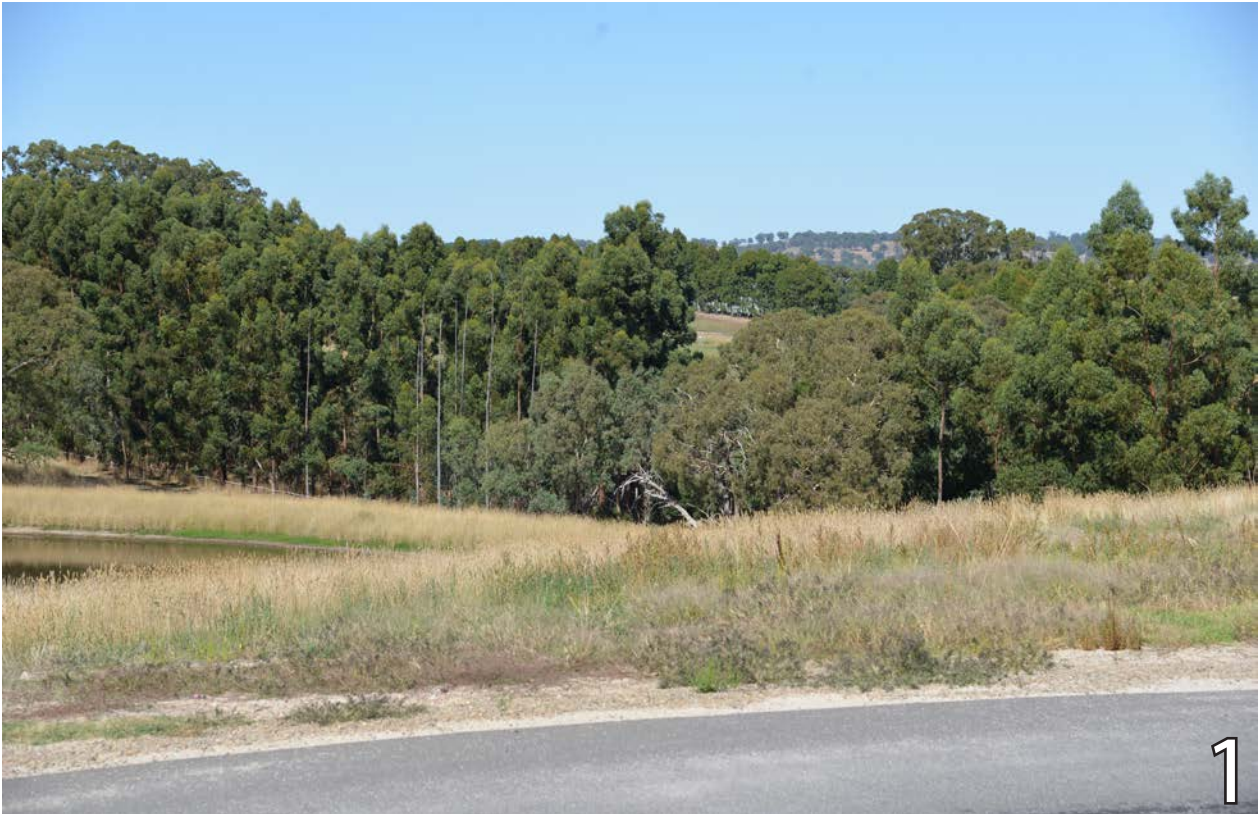
Viewpoint 1

Altitude 460m Above Sea Level
 Latitude 34 degrees 57' 10.32" S
 Longitude 138 degrees 54' 21.13" E

- This viewpoint is from an internal Petaluma Winery access road within the winery's storage and operations area.
- The foreground is of seasonal grass cover adjacent to a storm water dam.
- An established boundary planting buffer provides a visual screen for the project operations site.
- Select views of the north eastern section of the operations site are exposed between gaps in the existing tree canopy.
- This viewpoint is not in a publicly accessible area.
- The Petaluma cellar door is at the opposite end of the Petaluma property and is screened by the existing building.

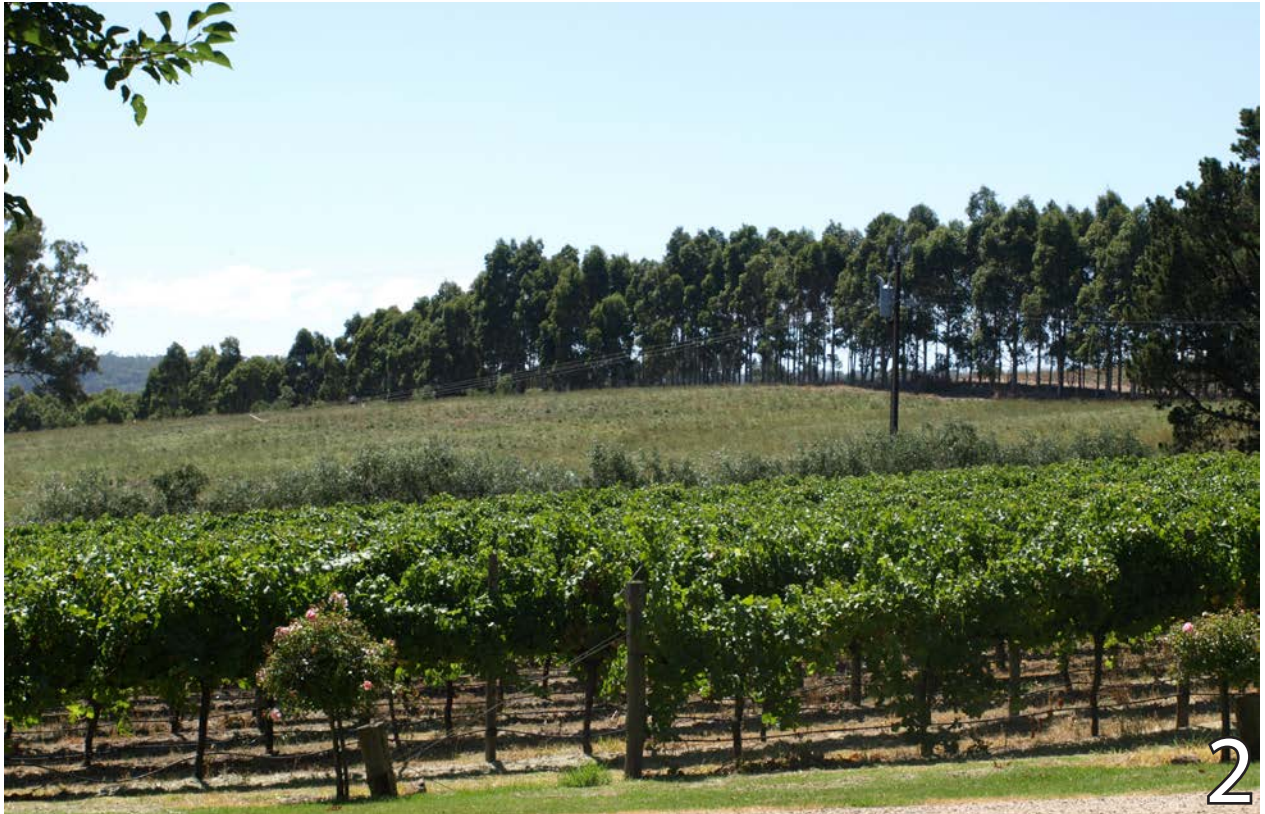
Viewpoint 2

- The property at 86 Bird In Hand Road is in an elevated position and is exposed to views on the southern side of the operations site.
- An outdoor entertaining area and verandah provide viewpoints of the site with a foreground of vines and perimeter olive hedge.
- Recent earth mounding and revegetation on the project site are currently below the viewshed; however, the shrub layer and trees are expected to grow into the foreground view over time.

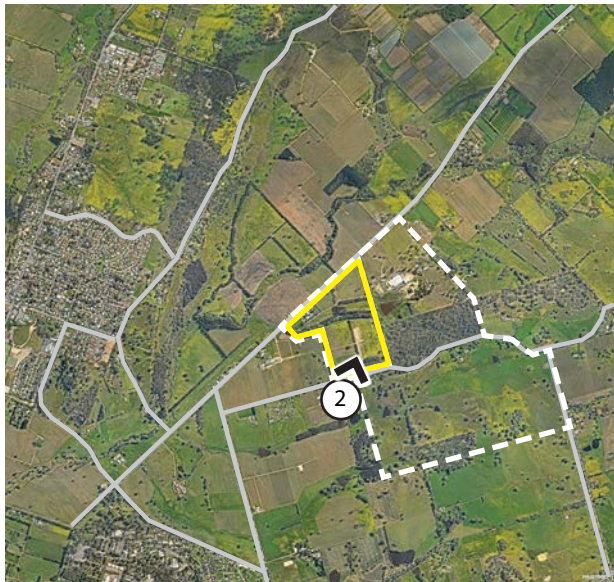
Altitude 412m Above Sea Level
 Latitude 34 degrees 57' 34.0" S
 Longitude 138 degrees 54' 07.1" E

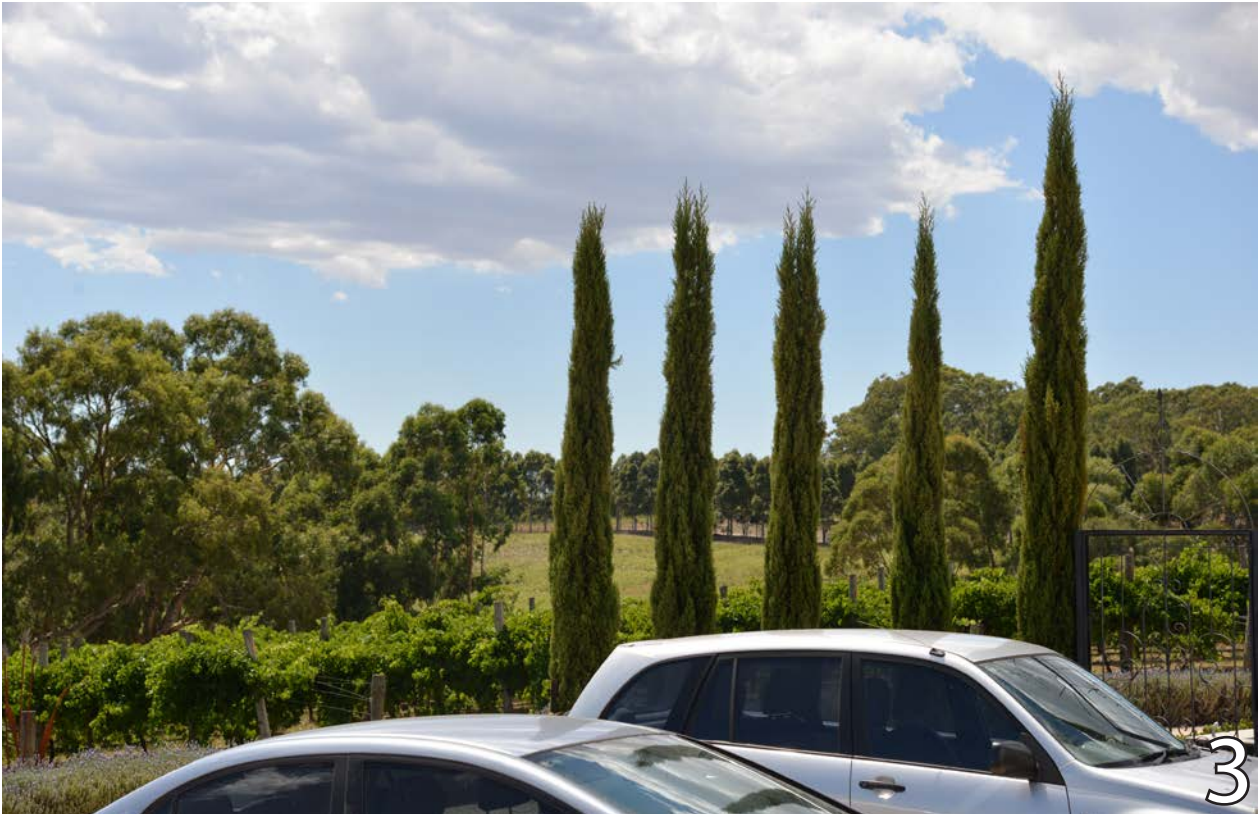
Viewpoint 3

- Artwine operate an art gallery and cellar door with north facing views towards the adjacent Bird In Hand Winery.
- Existing trees within the Artwine carpark perimeter and Bird In Hand Road verge provide partial north eastern screening towards the operations site.
- The elevated cellar door verandah raises the potential public viewing height above the grapevines within the foreground.

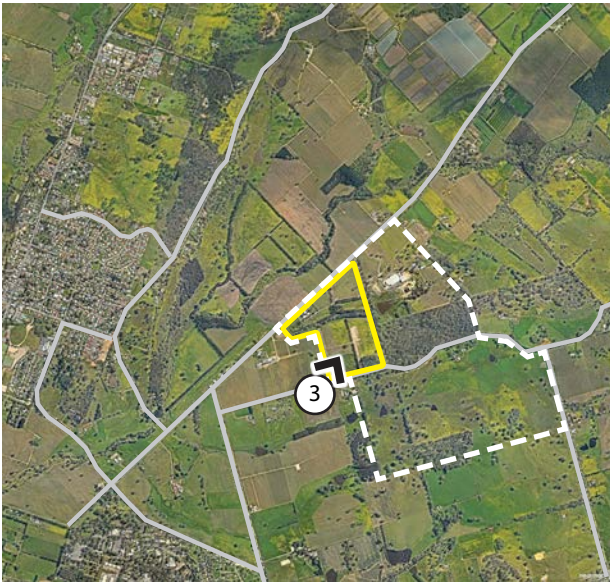
Altitude 400m Above Sea Level
 Latitude 34 degrees 57' 35.63" S
 Longitude 138 degrees 53' 59.59" E

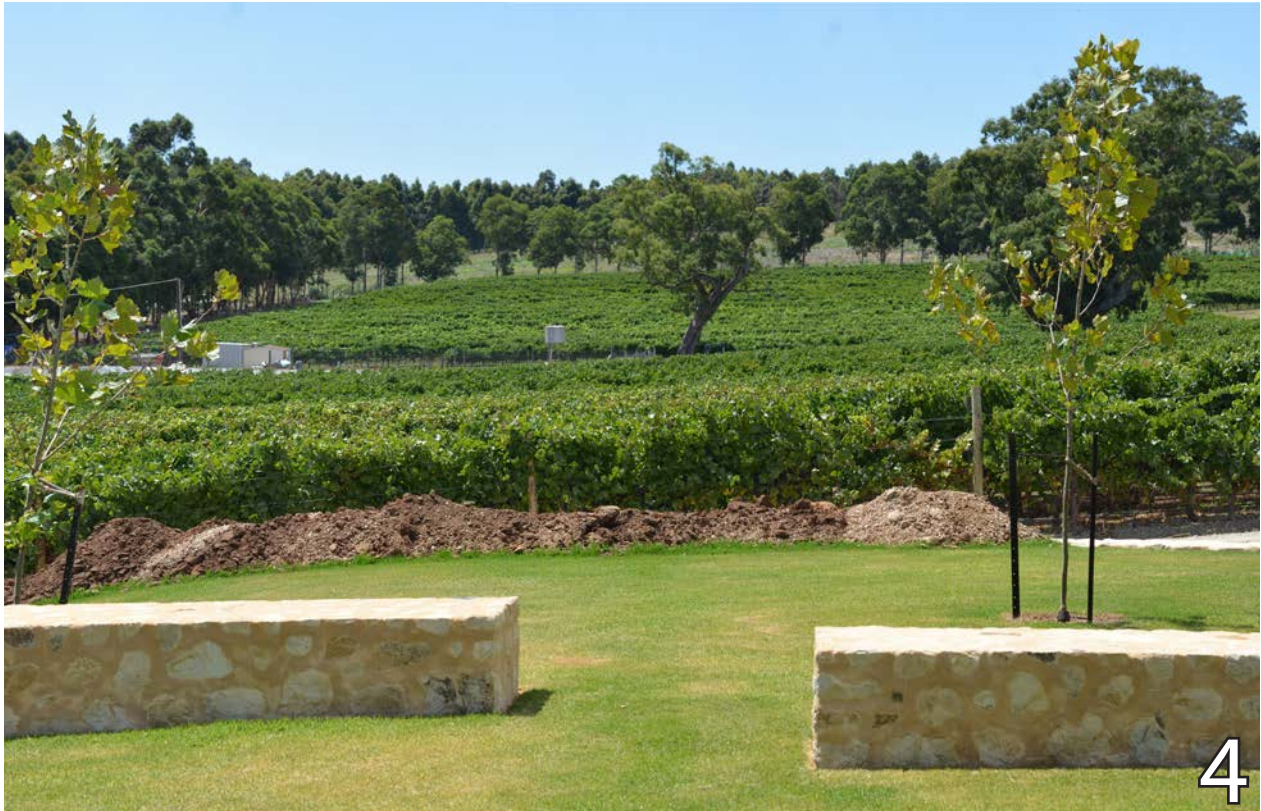
Viewpoint 4

- Bird in Hand Winery operate a cellar door and temporary outdoor event space with an eastern view towards the operations site.
- The cellar door exit pathway faces the operations site with existing vines in the foreground and a row of existing boundary trees providing mid level screening.
- Currently there are exposed views of the Terramin property beneath the existing tree canopy onto the western side of the operations site. Recent under-planting of the existing tree rows with a range of native shrubs is expected to provide an additional vegetated screen upto 3 metres high underneath the existing tree canopy.

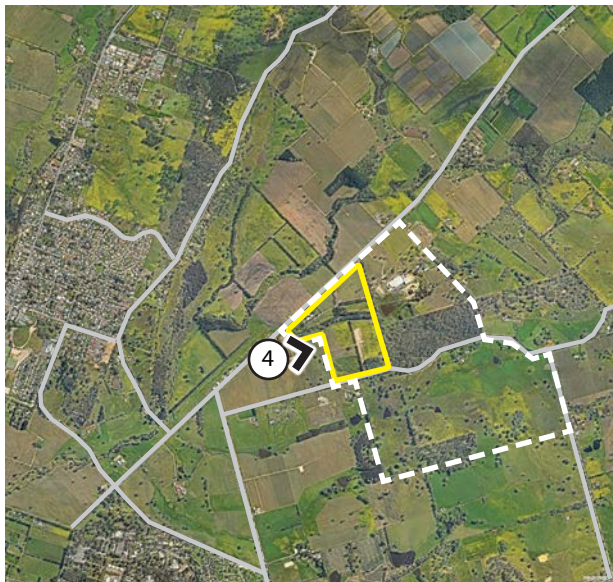
Altitude 395m Above Sea Level
 Latitude 34 degrees 57' 24.98" S
 Longitude 138 degrees 53' 46.57" E

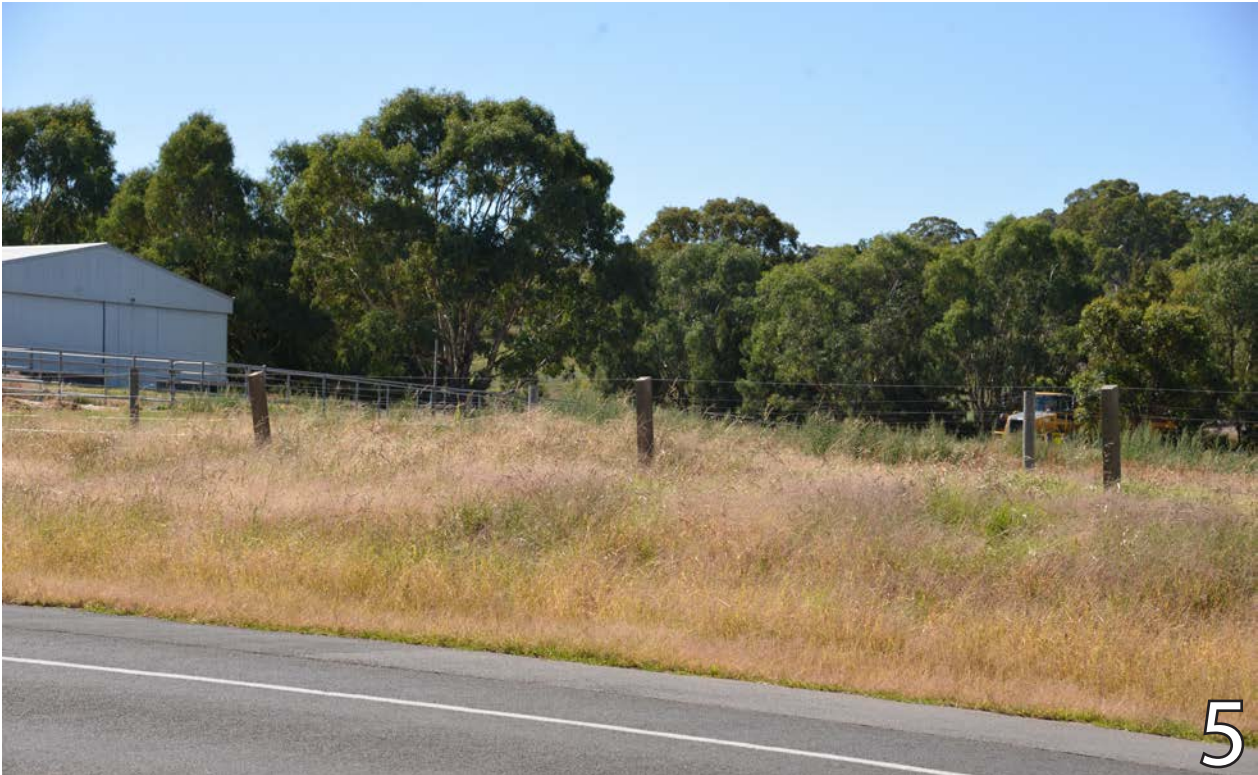
Viewpoint 5

- Pfeiffer Road provides limited views of the operations site.
- Views are restricted to the foreground dairy dams and canopy trees within the creek corridor.

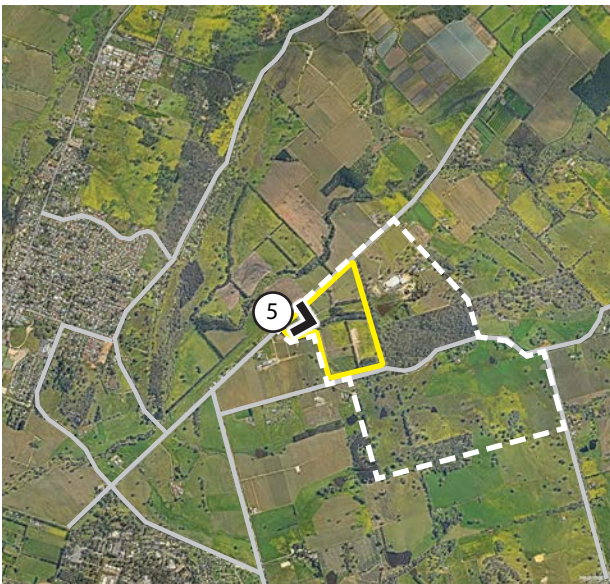
Altitude 394m Above Sea Level
 Latitude 34 degrees 57' 15.58" S
 Longitude 138 degrees 53' 51.41" E

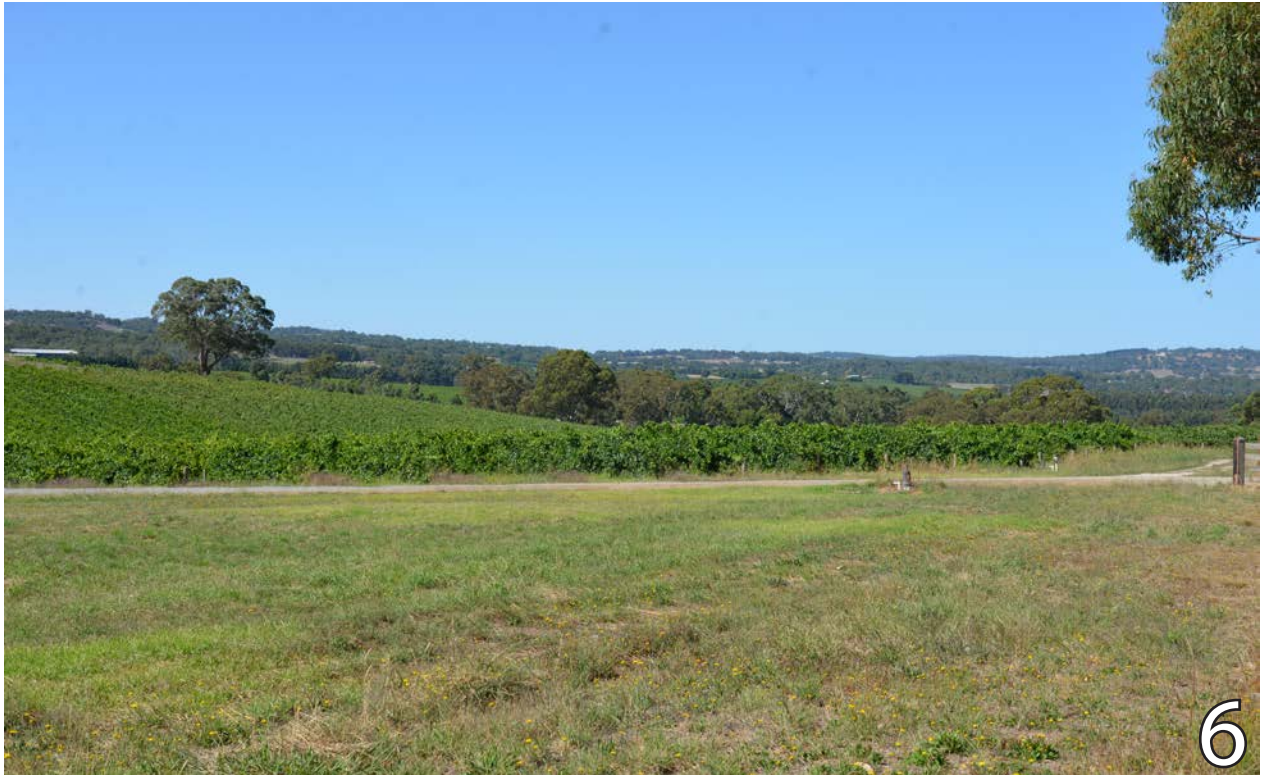
Viewpoint 6

- Long range views from the Ridge Road verge are limited due to established roadside vegetation and built form along the south-eastern side of the road.
- The viewing distance is over 2 kilometres and the relatively small gaps in roadside vegetation greatly reduces the effective viewing angle of views of the Terramin property.
- The southern section of Ridge Road is generally within cut and therefore views of the property are obscured by landform.
- The 80km/h speed limit on Ridge Road reduces the time duration in which the property is viewed to moving traffic.

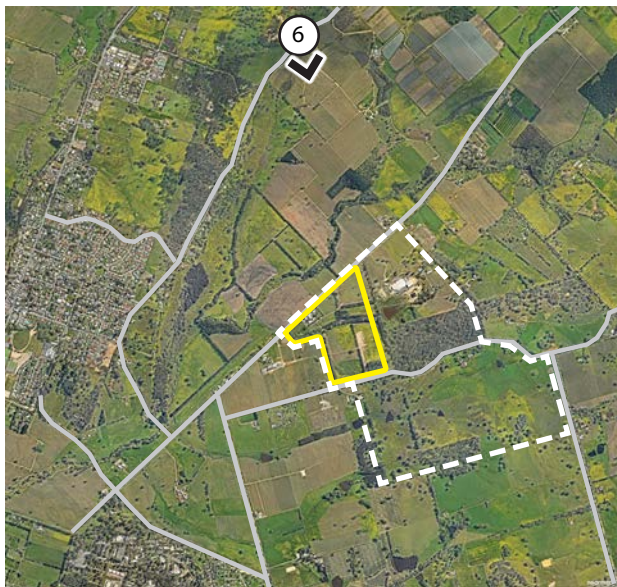
Altitude 426m Above Sea Level
 Latitude 34 degrees 56' 8.55" S
 Longitude 138 degrees 53' 53.94" E

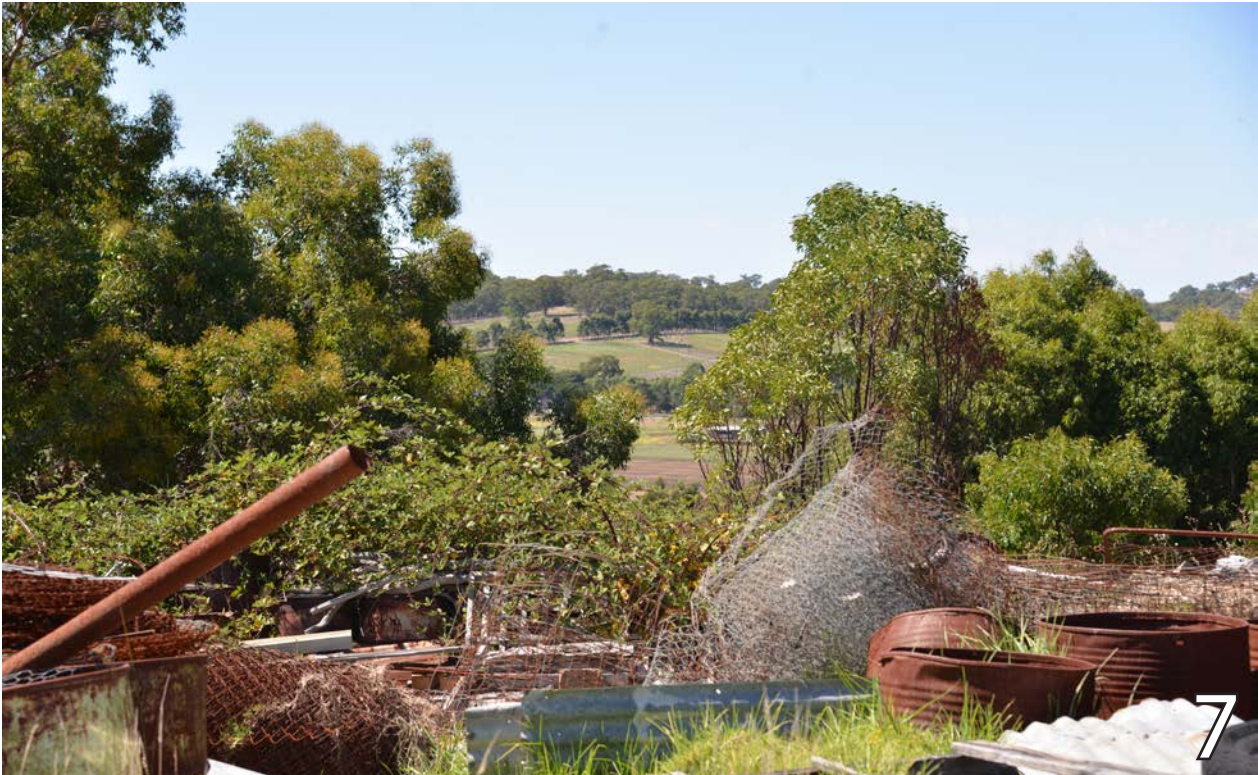
Viewpoint 7

- Views of the operations site are possible from select locations within the backyard of 82 Ridge Road.
- Existing vegetation at the rear of the property screens views of the operations areas from an outdoor entertaining area and swimming pool.

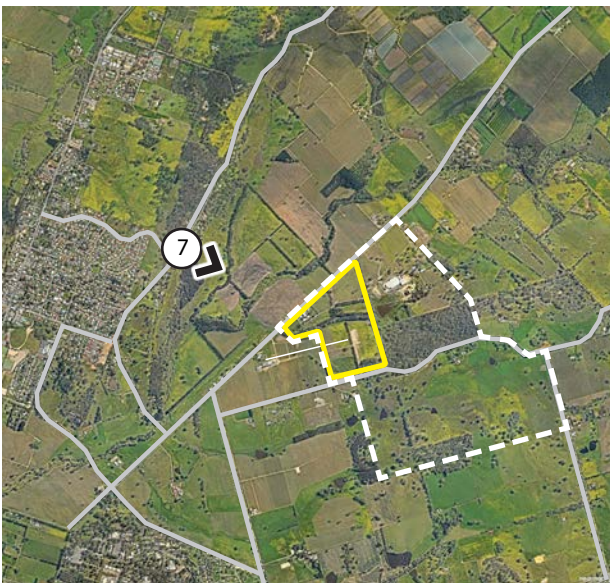
Altitude 417m Above Sea Level
 Latitude 34 degrees 56' 59.66" S
 Longitude 138 degrees 53' 22.46" E

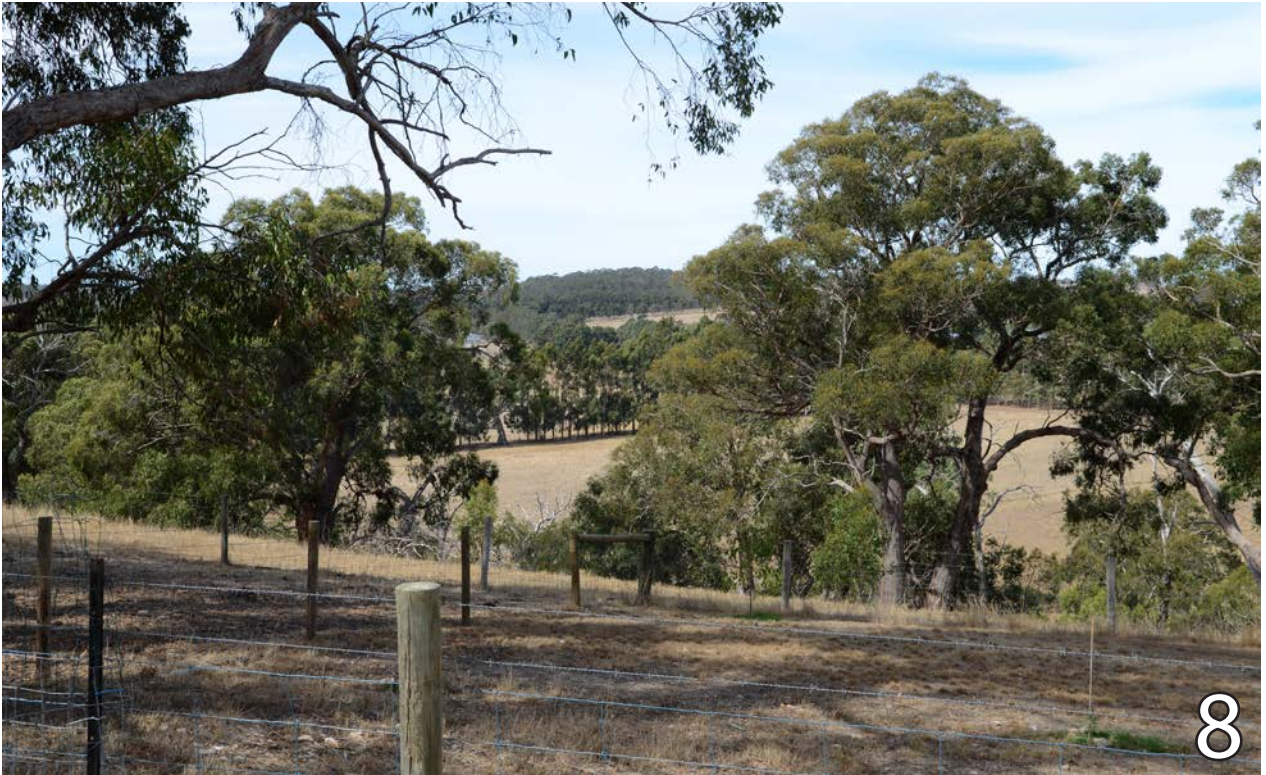
Viewpoint 8

Altitude 402m Above Sea Level
 Latitude 34 degrees 57' 22.69" S
 Longitude 138 degrees 53' 11.24" E

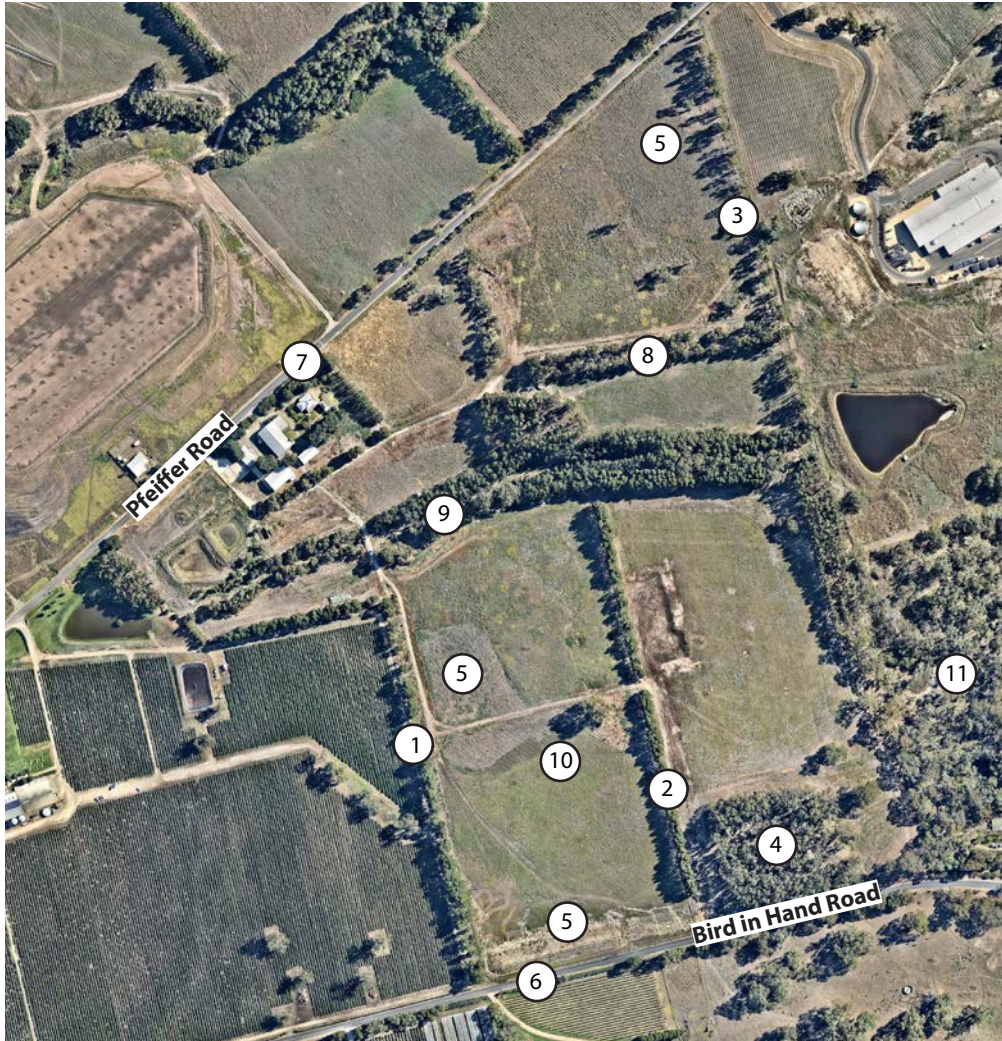
Figure 7: Notable Vegetation

Existing mature vegetation screens views of the operations site from multiple directions and elevations. Tall canopy trees include Spotted Gum (*Corymbia maculata*), River Red Gum (*Eucalyptus camaldulensis*) and S.A. Blue Gum (*Eucalyptus leucoxylon subsp. leucoxylon*). Retention of trees as natural assets assists in screening the property during the establishment phase and throughout the operational period of the mine.

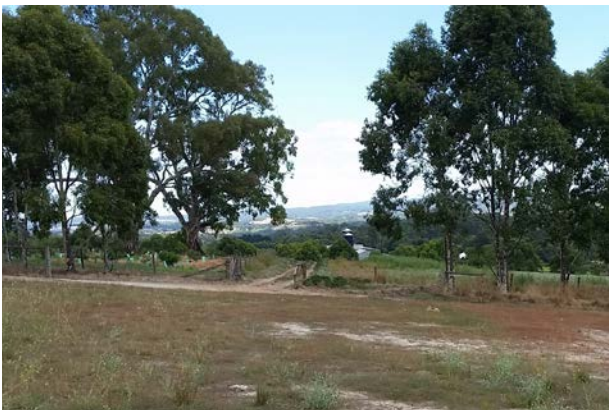
Planting of local native species in winter 2016 is now at approximately 1 metre in height and is expected to provide further effective screening of the property within 3-5 years.

Revegetation understorey establishment (2016)

New aquatic species planting is proposed for the mine water dam and storm water swales to integrate new water bodies within the surrounding landscape. Review of the initial planting success and species range of tubestock planted in 2016 is recommended to inform future plantings on landscape bunds.

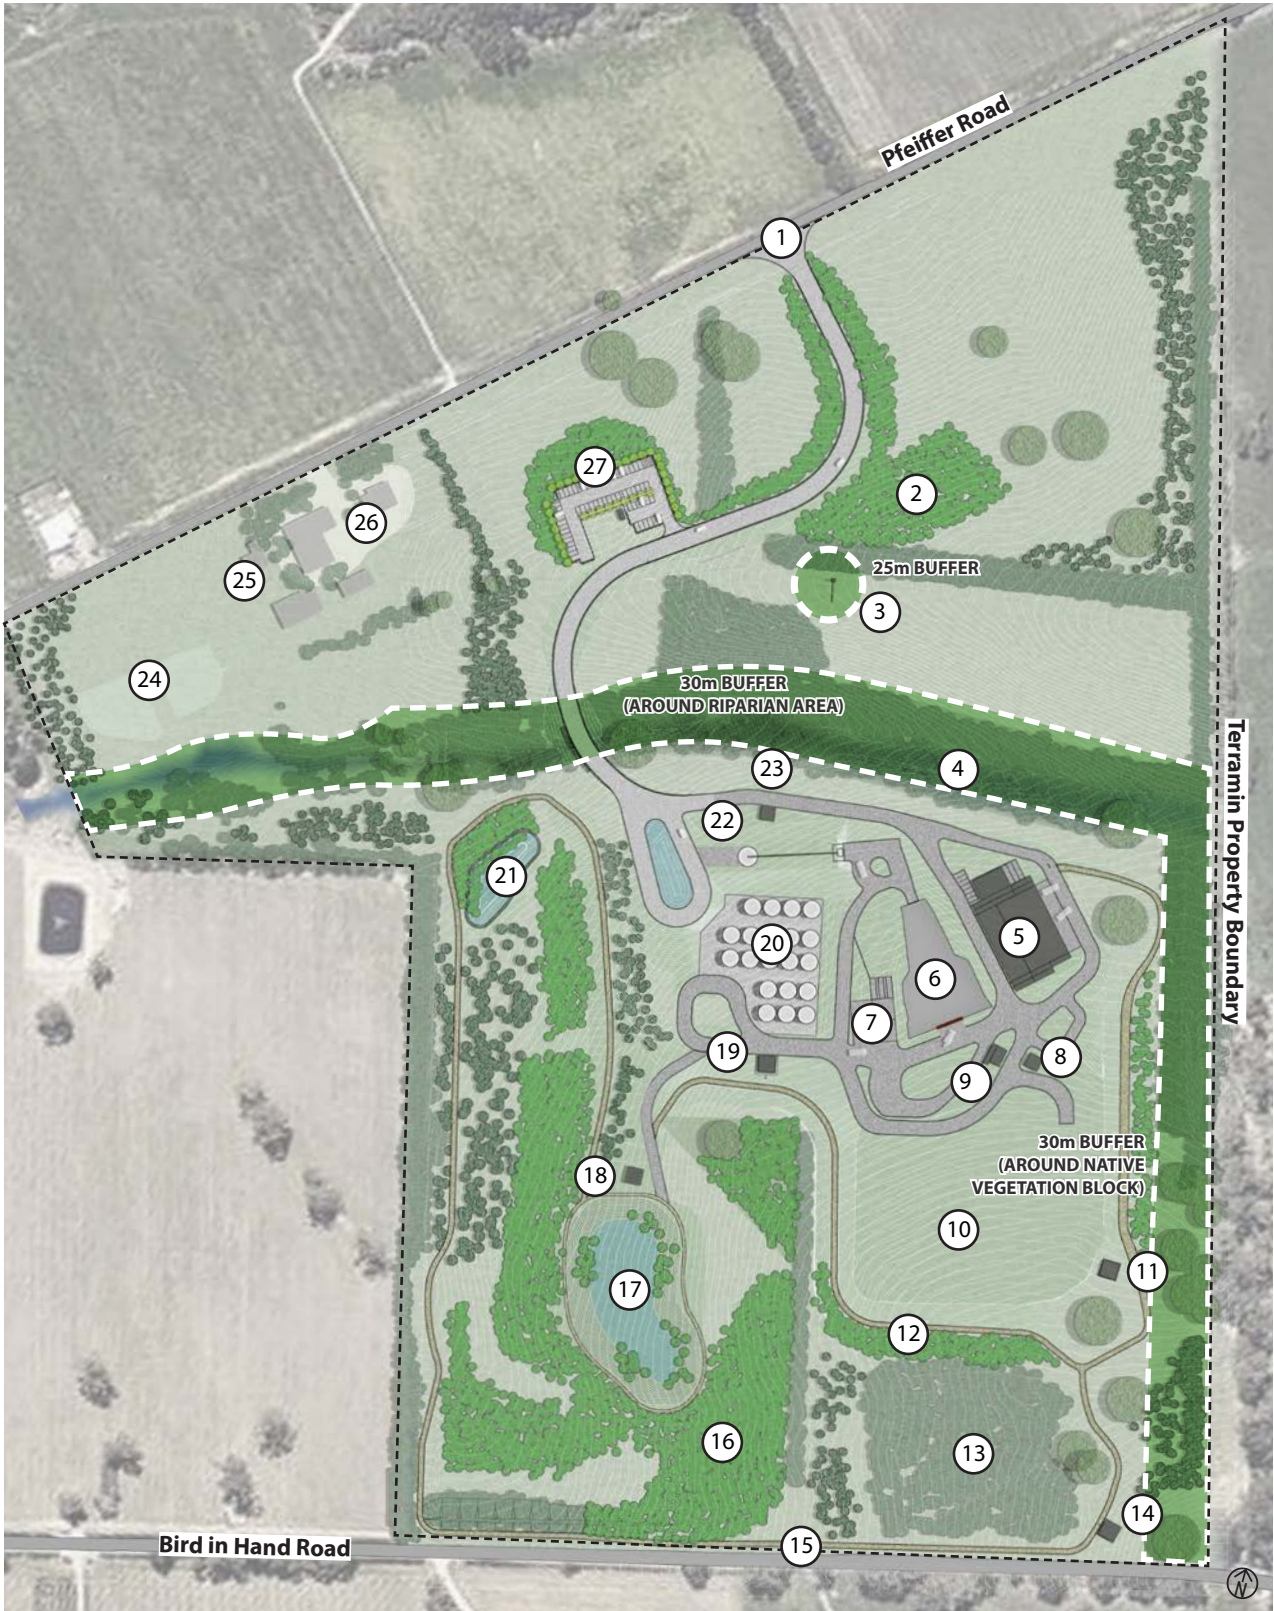
The Site Master Plan is derived from the Site Layout Plan produced by Tonkin Engineering.

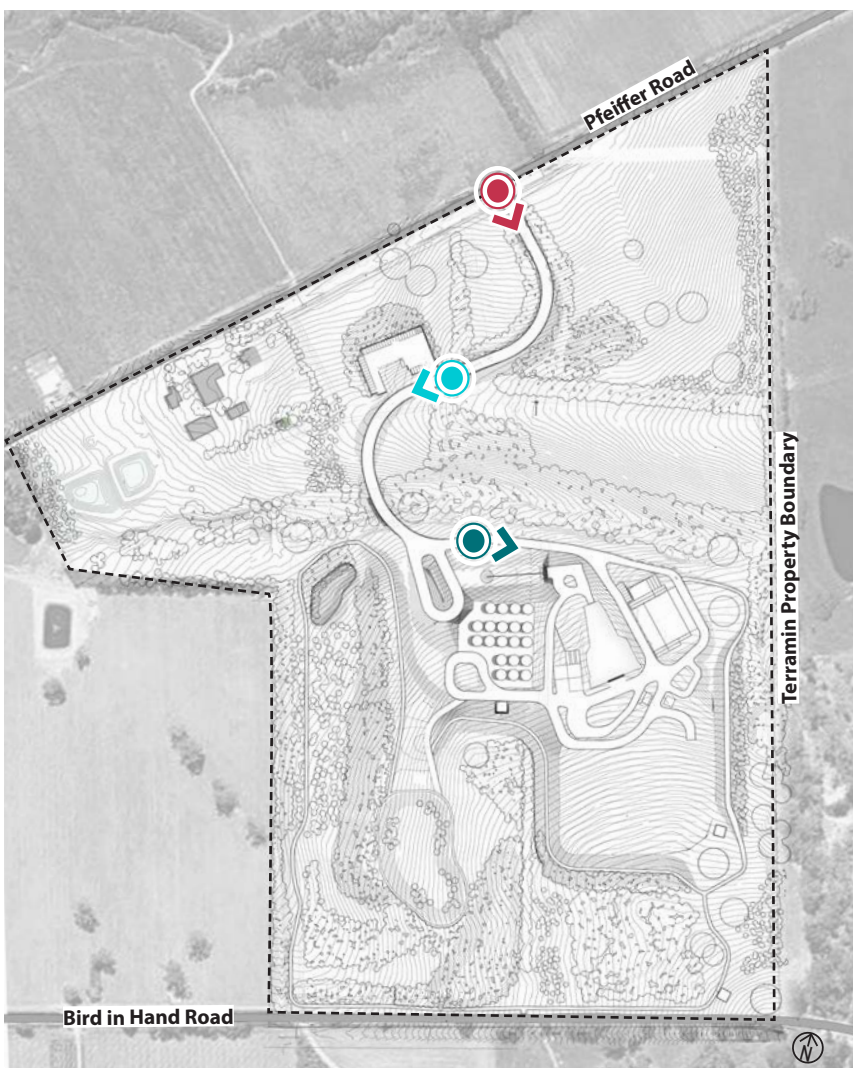
A new vehicle entry point provides access from Pfeiffer Road to the property. Public and staff parking is proposed during business hours with controlled pedestrian turn styles for staff access to the operations area. A proposed shuttle bus moves staff to and from the operations area.

Automatic security gates provide controlled access to the mine entrance and operations area for transport trucks.

*Elements are shown diagrammatically and not to scale.

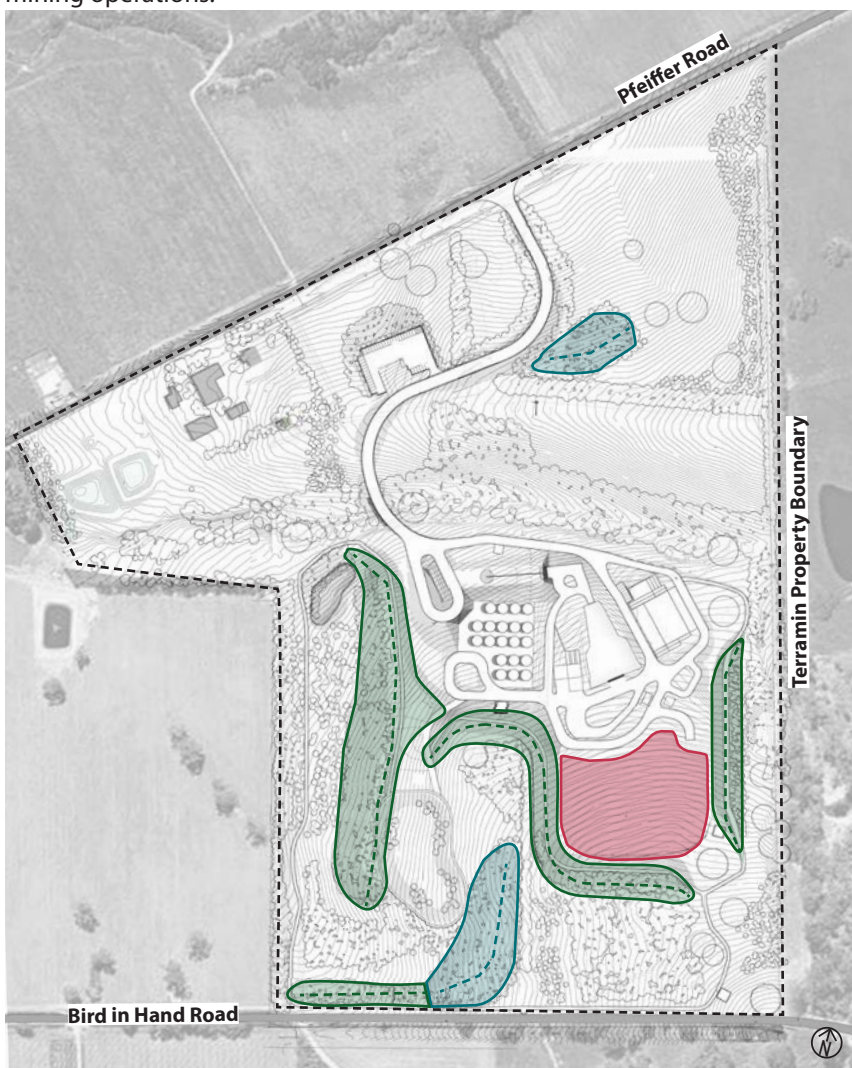
The Integrated Mullock Landform is a dynamic storage of surplus rock before being reused to infill the mine voids. The height and extent of fill material changes over time with the final landform intended to be revegetated following completion of mining operations.

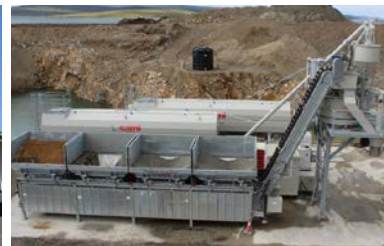
Concrete batching plant

The operations area is within cut to provide a relatively flat working platform for operational activity. Operations and maintenance vehicles access the workshop, fuel store and batching plant with transport trucks loading at the 'Run Of Mine' Silo.

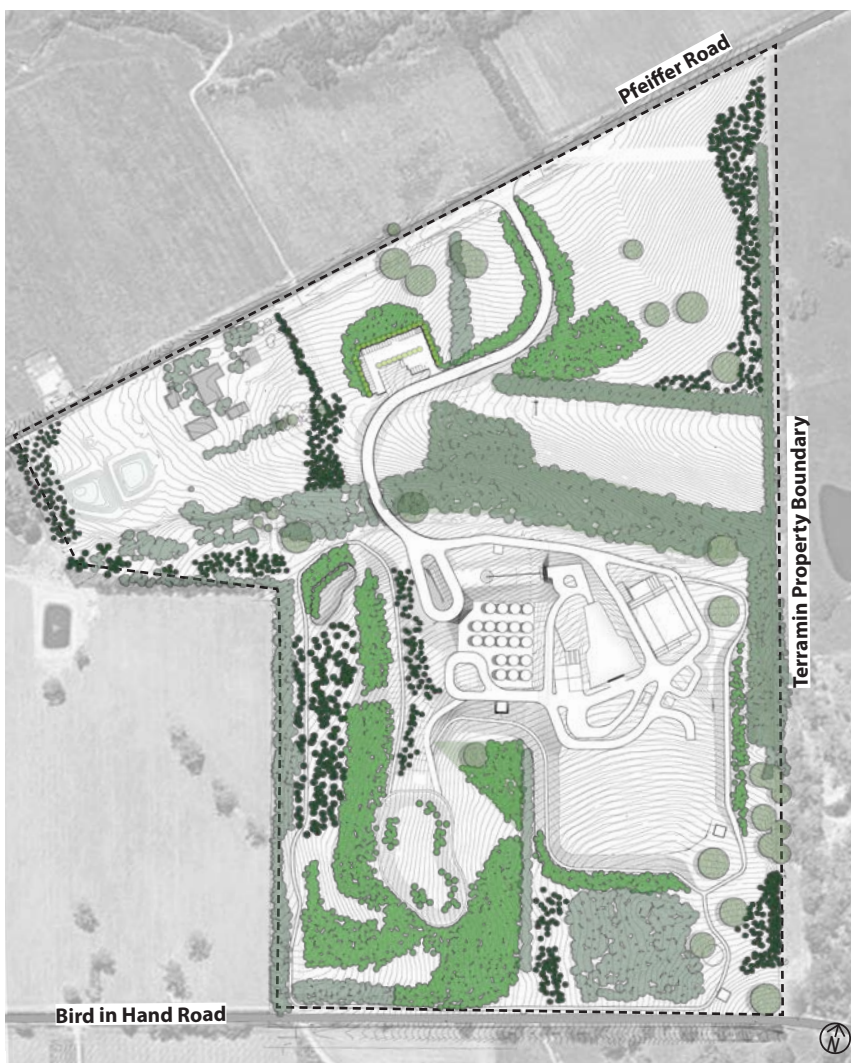
Retained existing perimeter vegetation provides screening of activities and maintains biodiversity. Recent revegetation planting transform former paddocks to open native woodland and provide trees and shrubs to the landscape bunds.

Creepline vegetation is retained with a new heavy vehicle crossing located to avoid established trees.

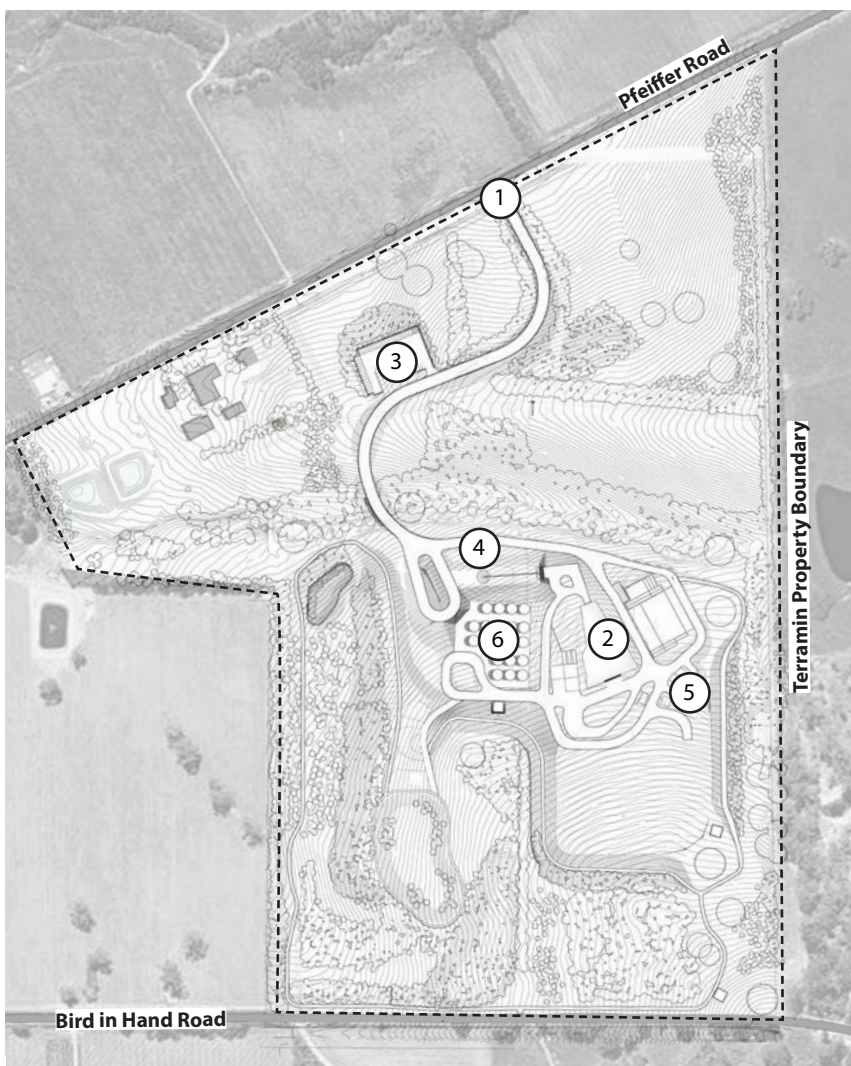
Lighting of the entry road, car park, operations area and water treatment plant are expected to be permanent fixtures. Temporary lighting for ventilation shafts and the integrated mullock landform is expected to be required when activity is occurring. The State Heritage listed chimney is retained with a 25 metre protection buffer.

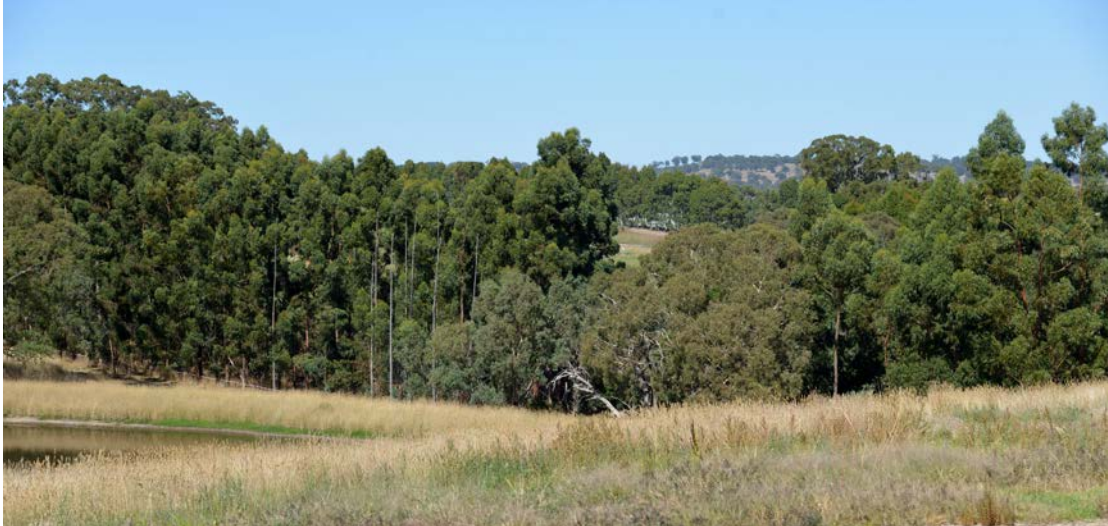
Existing View (2017)

- Site views through gap in existing tree canopy towards an open paddock with seasonal grass cover.

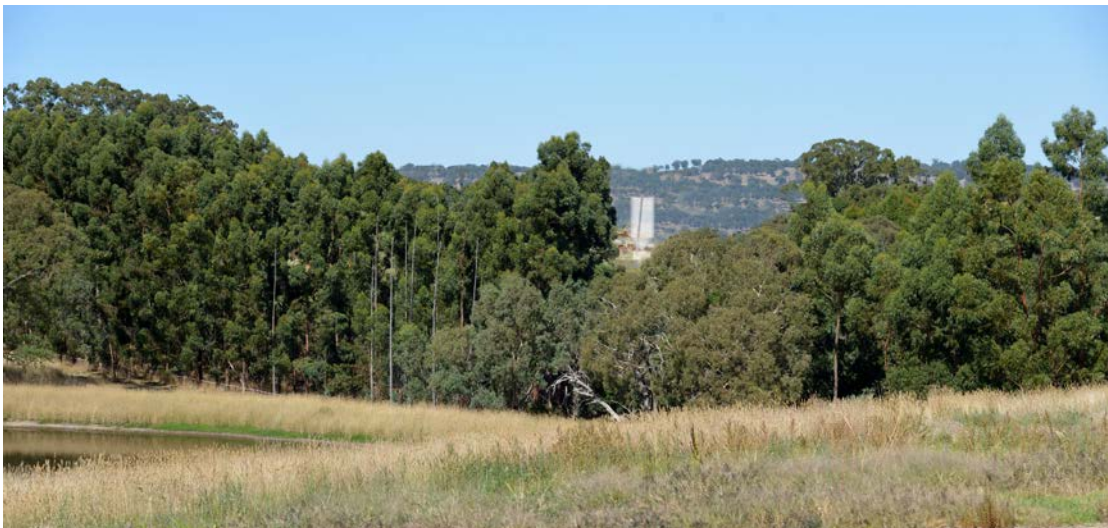
End of Construction (Worst Case)

- Construction hoarding / fencing in place.
- No planting.
- Silo in view.
