Bird In Hand Gold Project Strategic Visual Amenity Plan (SVAP)

**15.019 Bird In Hand Gold Project
Strategic Visual Amenity Plan (SVAP)**

Oxigen Landscape Architects
98-100 Halifax Street
ADELAIDE SA 5000
Telephone: (08) 7324 9600
www.oxigen.net.au

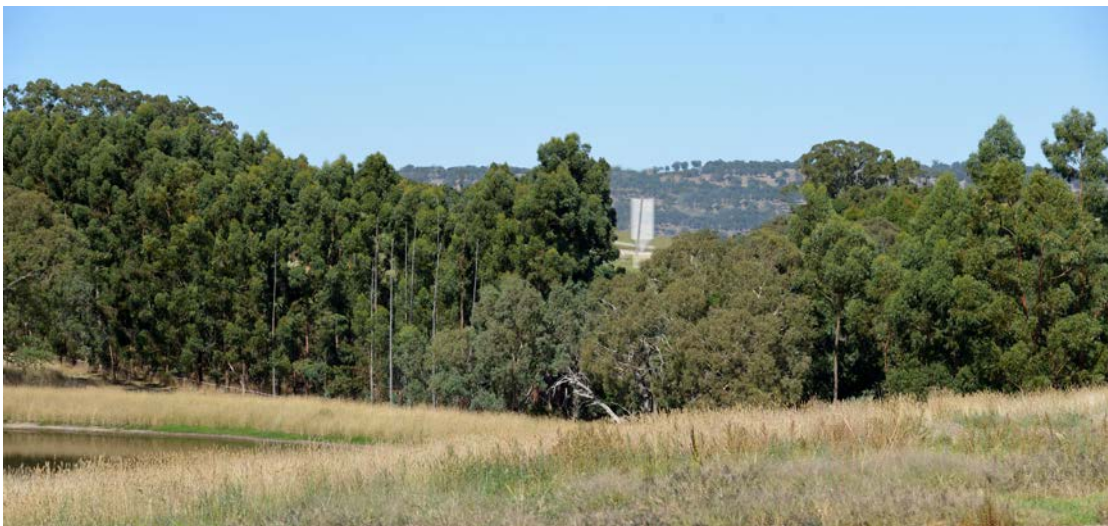
Operations View

- Run of Mine silo visible above tree canopy.
- Silo colour to be confirmed and shown for illustration purposes only. Final colour subject to community input.
- Loading zone and foreground are partially visible through the tree canopy.
- Initial plantings installed

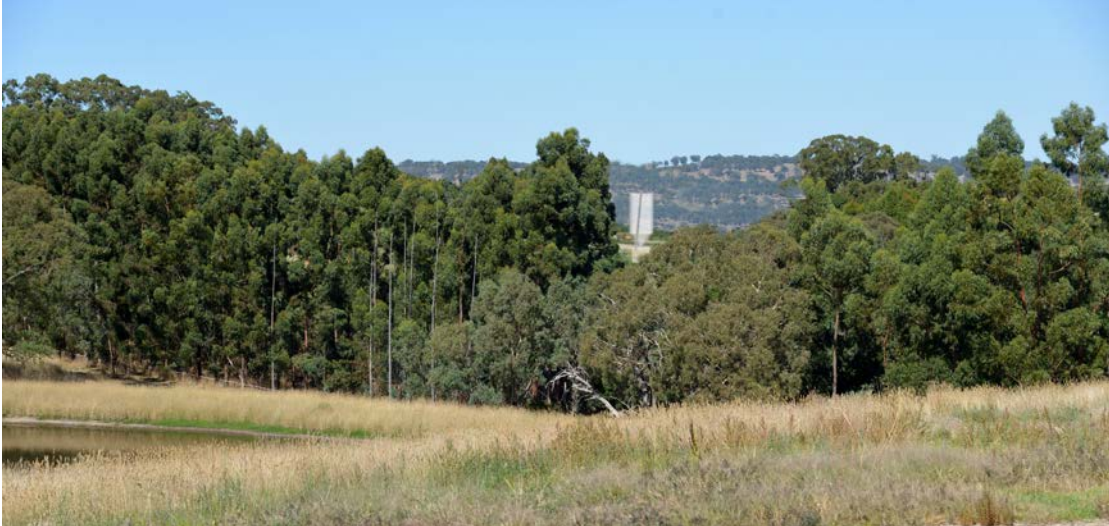
1 Year Vegetation Growth

- Native shrubs, groundcovers established.

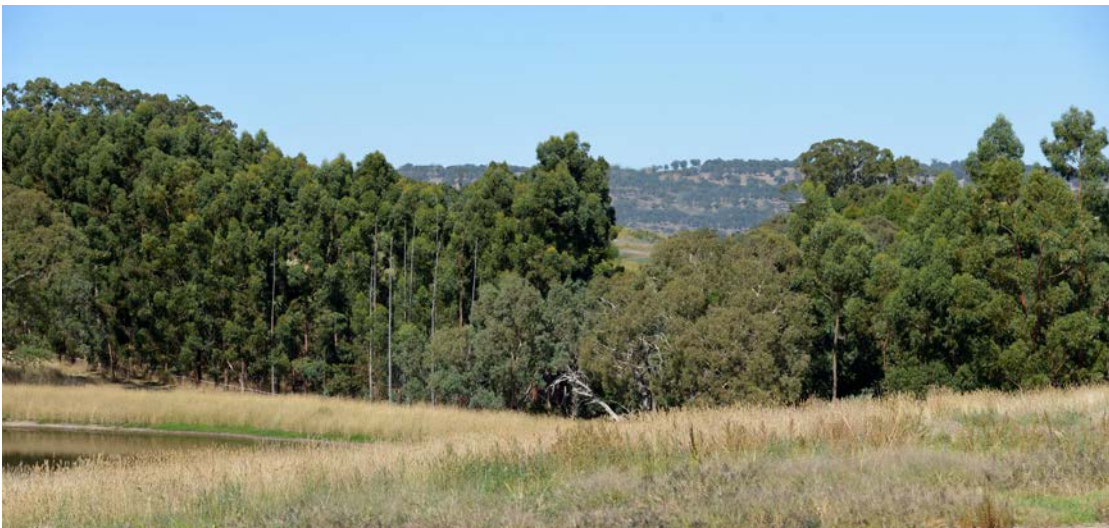
Closure View

- Run of Mine silo is removed.
- Silo area is regraded for water control and topsoil reused from site.
- Native trees established further.

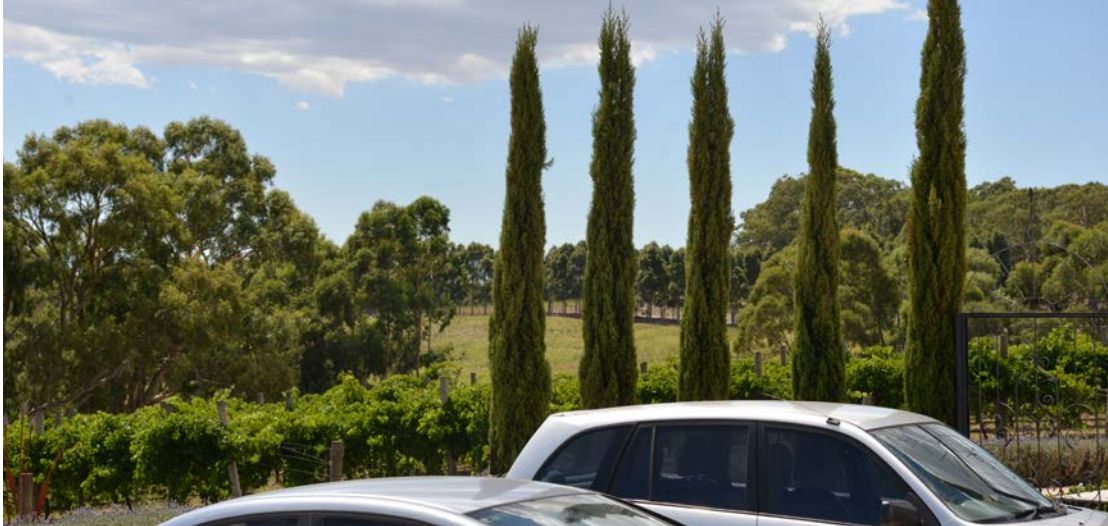
Existing View (2017)

- Site views framed by cellar door carpark trees.
- Open grassed paddock and existing tree line is visible.

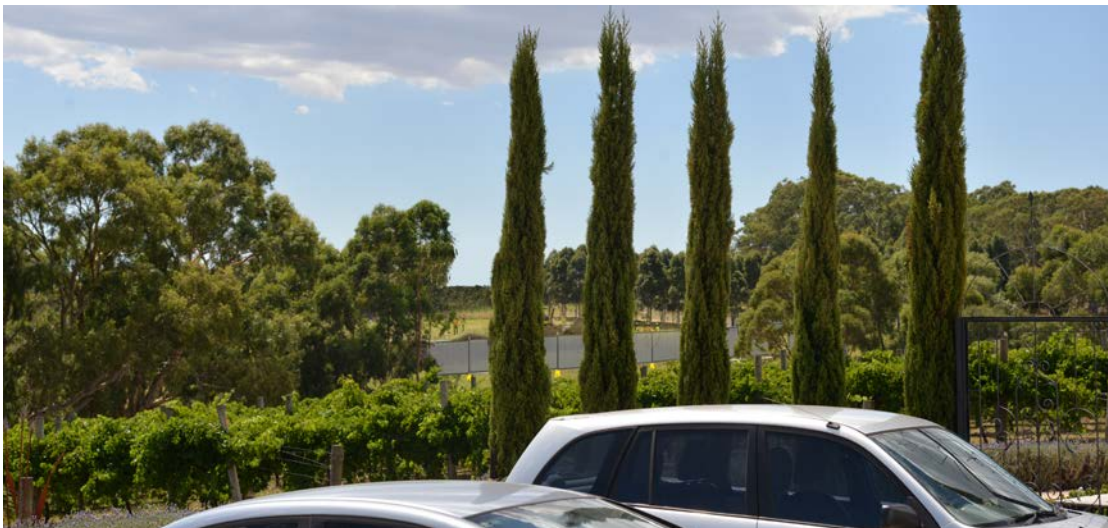
End of Construction (Worst Case)

- Construction hoarding / fencing in place.
- No planting.

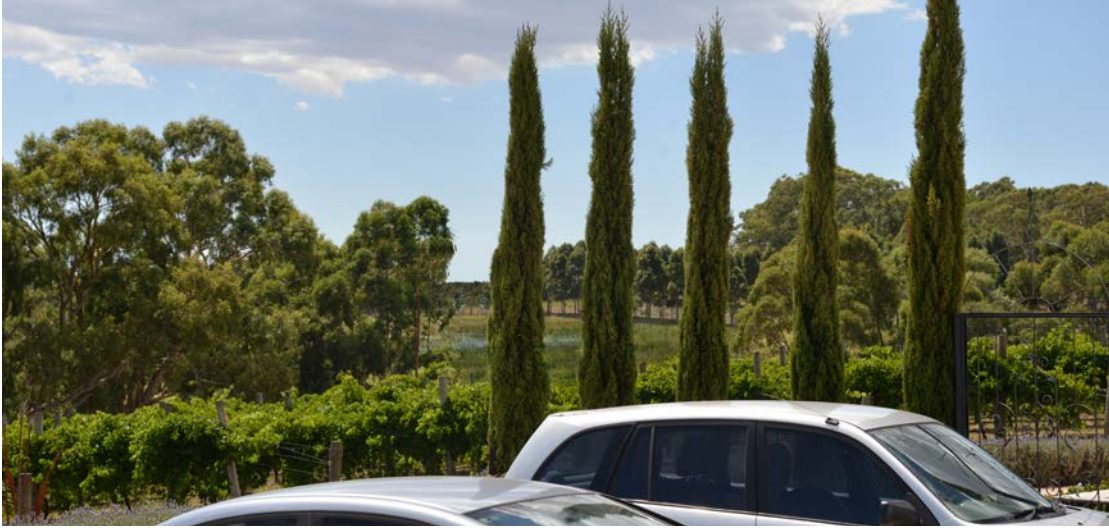
1 Year Vegetation Growth

- Batter planting and adjacent re-vegetation partially obscuring dam edge.

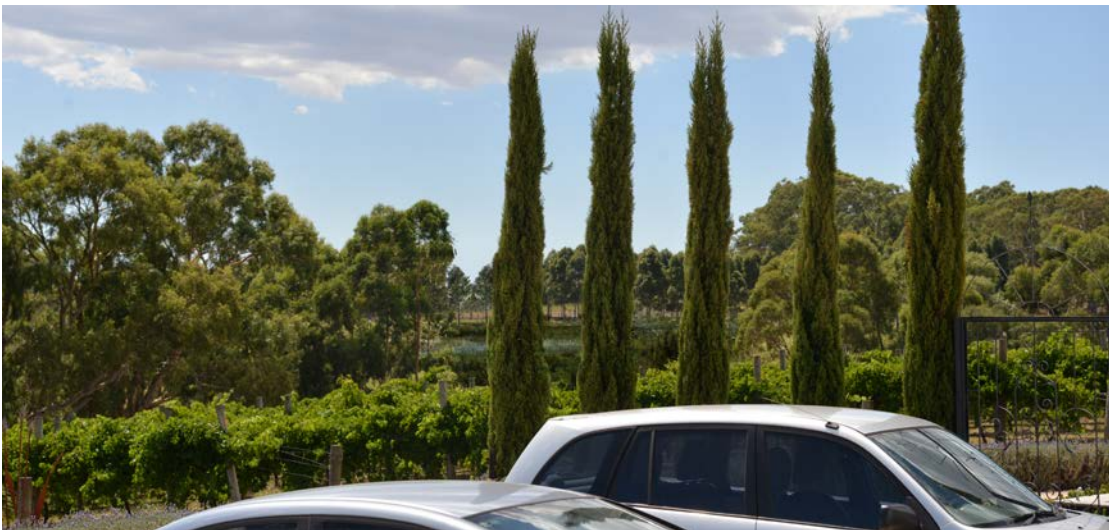
Closure View

- Water storage dam with minimal water.
- Native shrubs, ground-covers + trees established further.

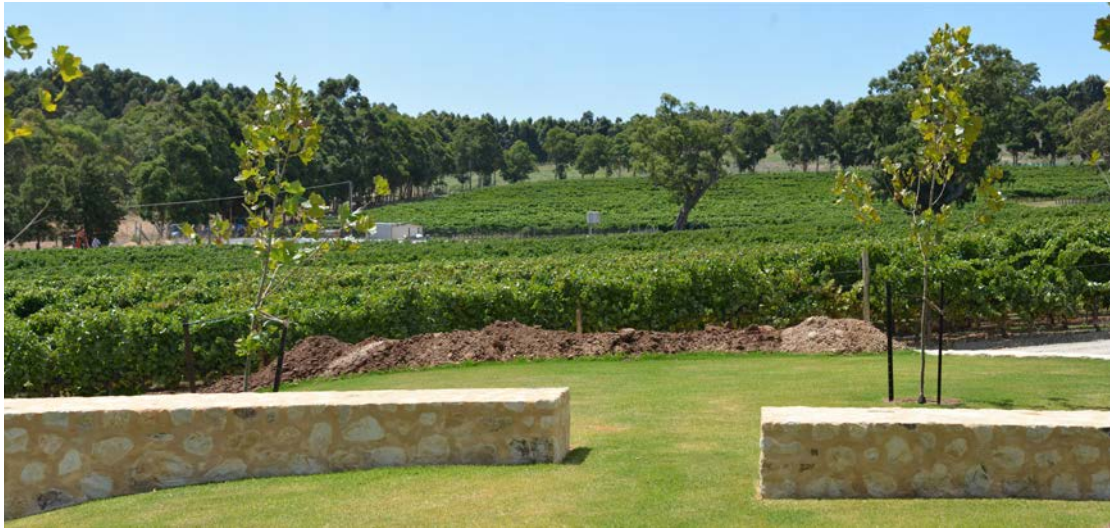
Existing View (2017)

- Site views under the existing perimeter tree canopy.
- Recent re-vegetation in adjacent paddock and perimeter tree rows starting to be visible.
- Foreground colour and depth perception changes with seasonal vine leaf cover.

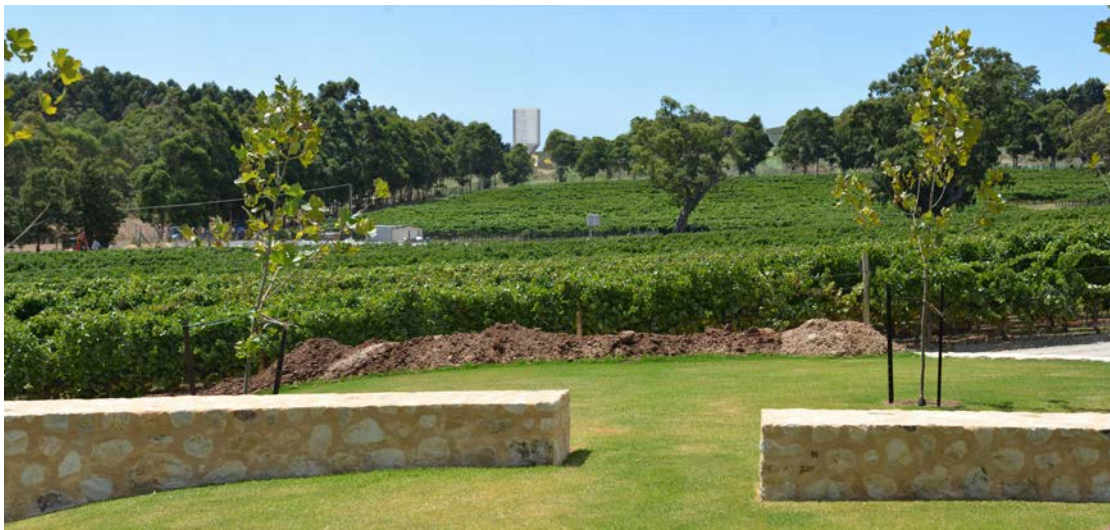
End of Construction (Worst Case)

- Construction hoarding / fencing in place.
- No planting.
- Silo in view.

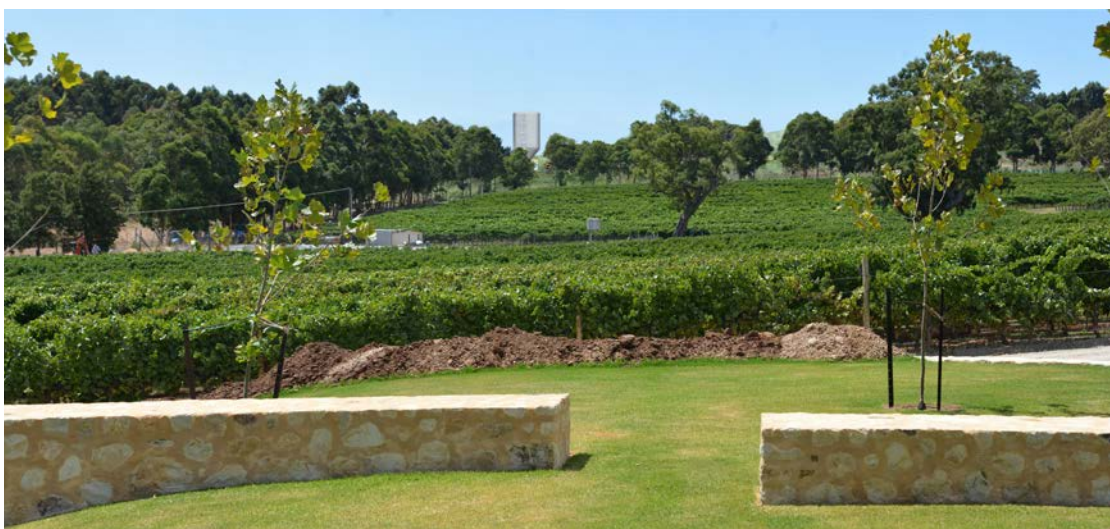
Operations View

- Run of Mine silo visible above tree canopy.
- Silo colour to be confirmed and shown for illustration purposes only. Final colour subject to community input.
- Initial plantings established.

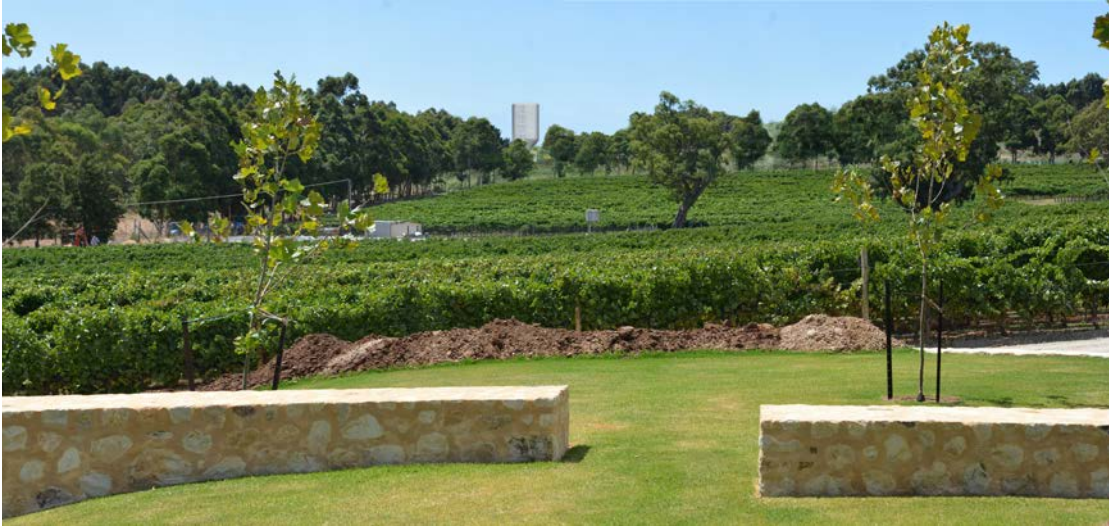
1 Year Vegetation Growth

- Re-vegetation at perimeter partially obscures views into the site.

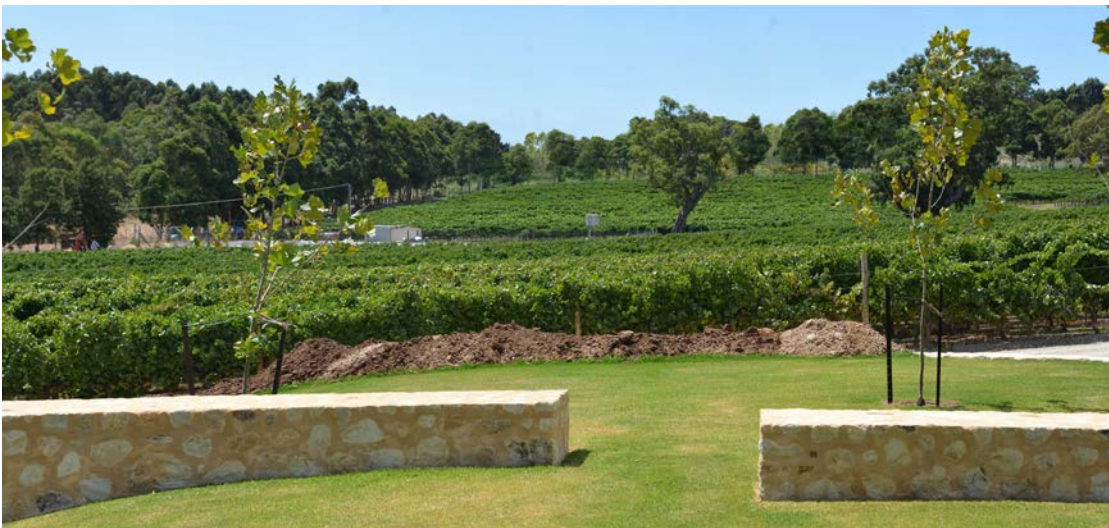
Closure View

- Run of Mine silo is removed.
- Native shrubs, ground-covers + trees established

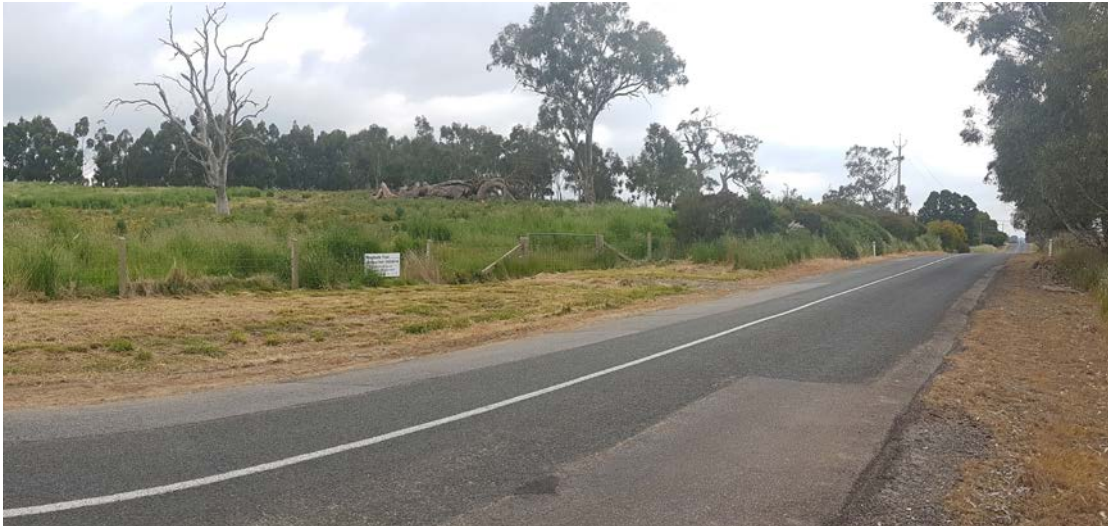
Existing View (2017)

- Farm gate and rubble entry verge.
- Seasonal grass cover in verge.
- Views to open paddock.

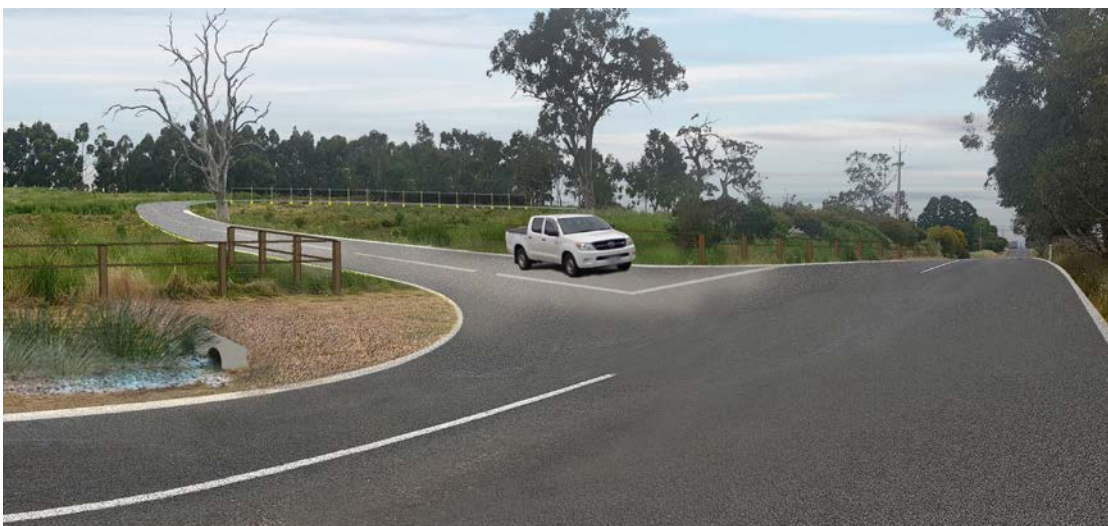
End of Construction (Worst Case)

- New entry road to allow vehicle turn path.
- New fence around entry (similar to Polo Club).
- Stormwater infrastructure and scour protection in verge.
- Road and verge linemarking.
- Construction hoarding / fencing still in place.
- No planting within construction zone.

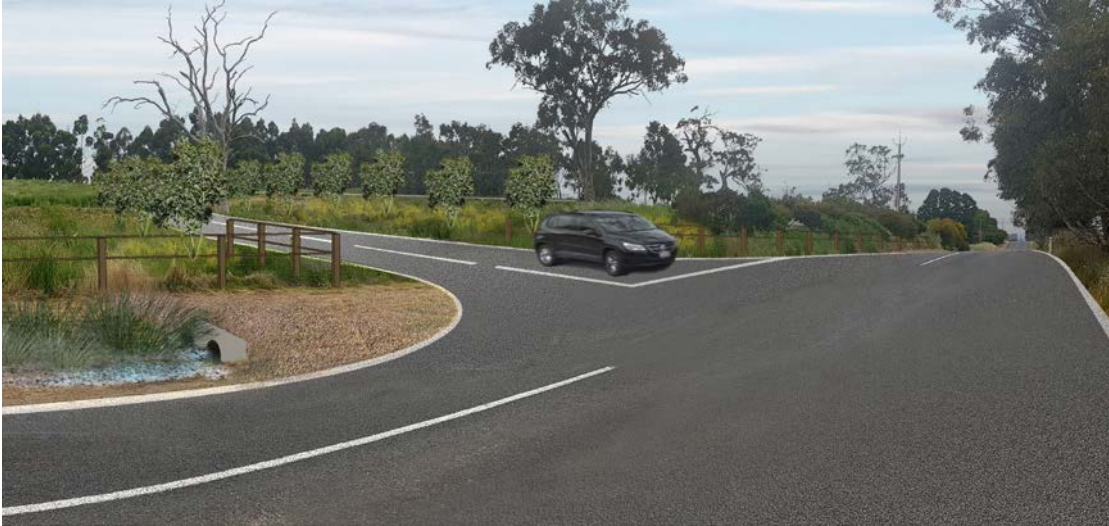
Operations View

- Shade tree avenue established.
- Initial plantings established.

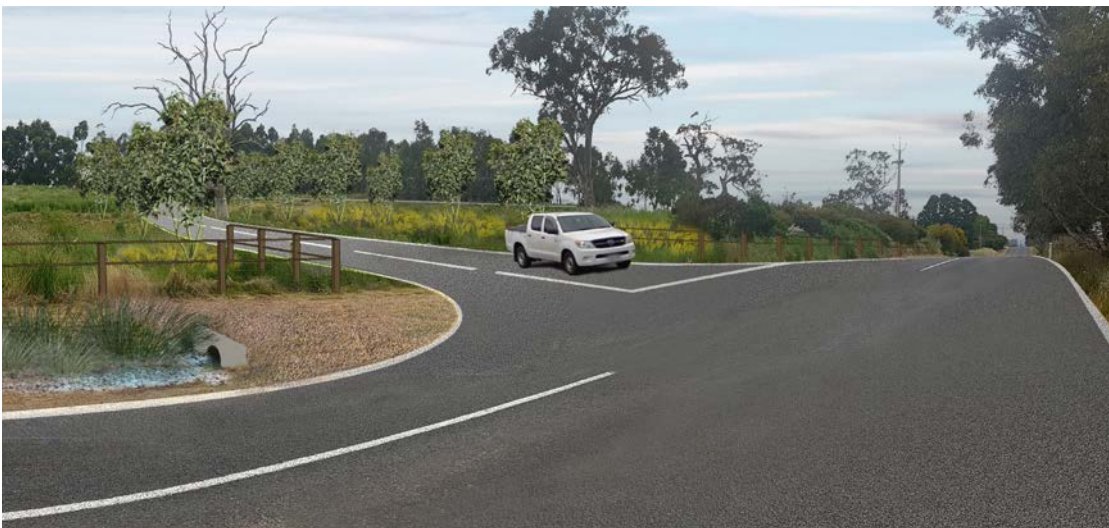
1 Year Vegetation Growth

- Native shrubs, groundcovers + trees

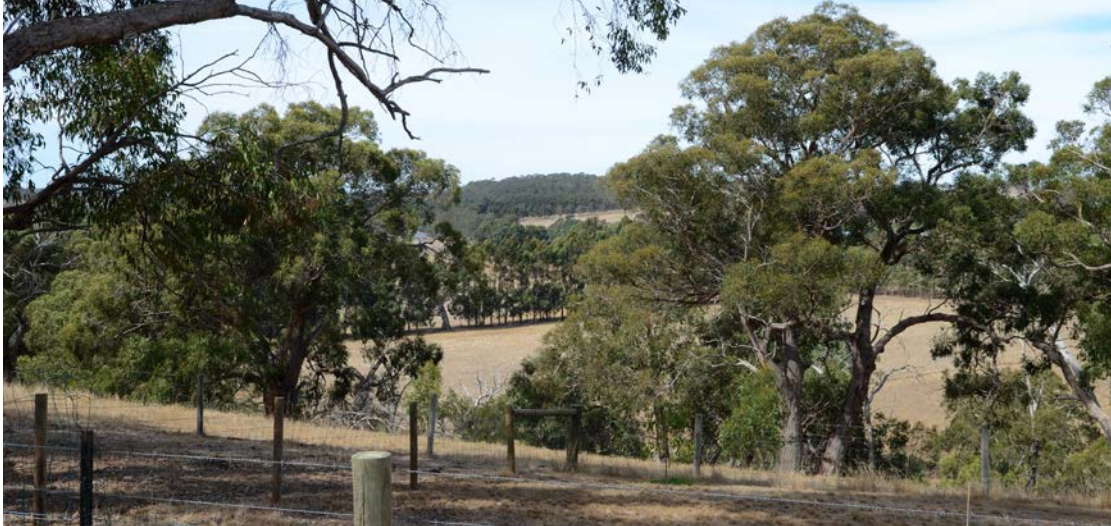
5A Ridge Rd

Closure View

- Entry road and storm water infrastructure retained for future land-use.
- Further tree growth.

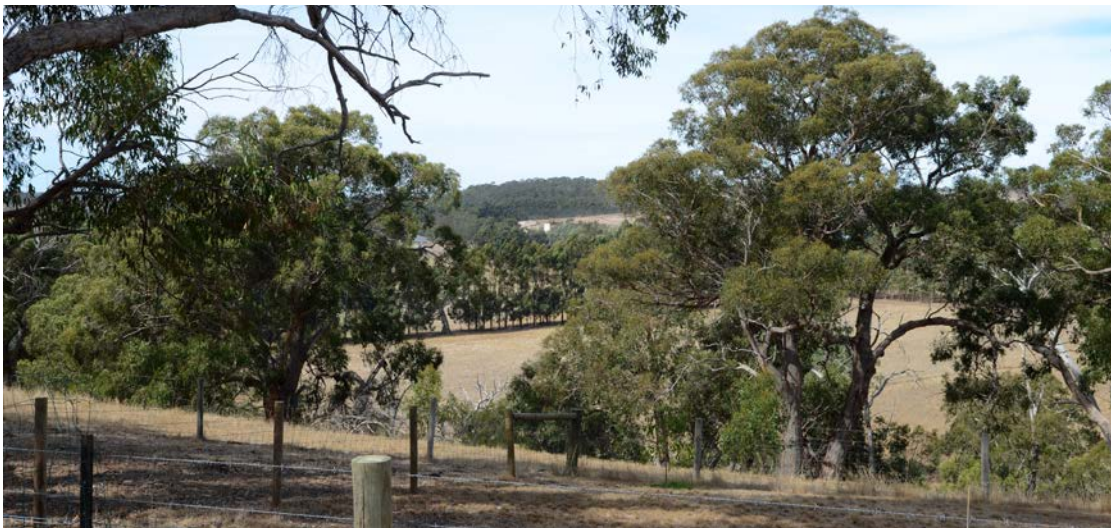
Existing View (2019)

- View through existing large trees to site.

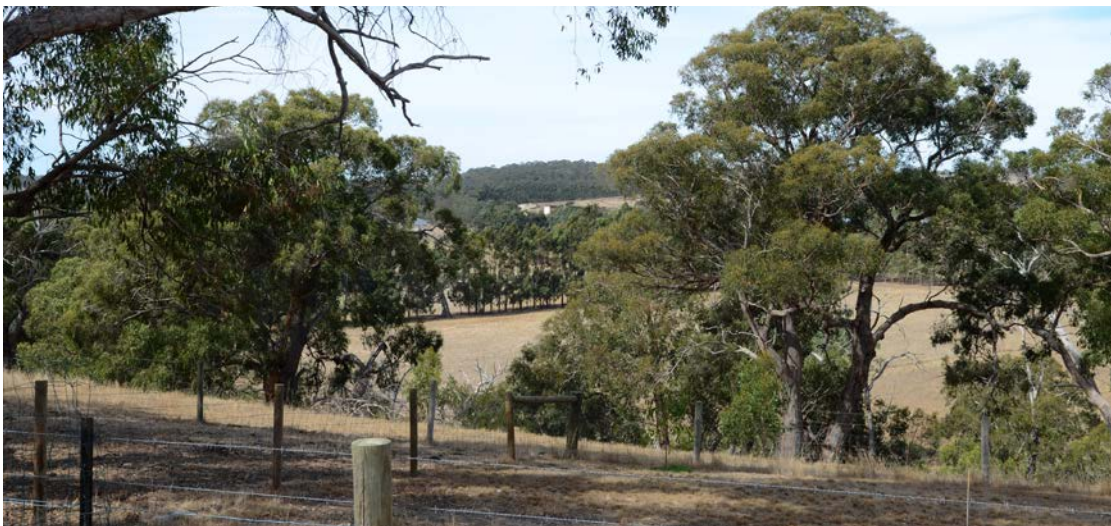
Operations View

- Run of Mine silo visible above tree canopy.
- Initial plantings established.

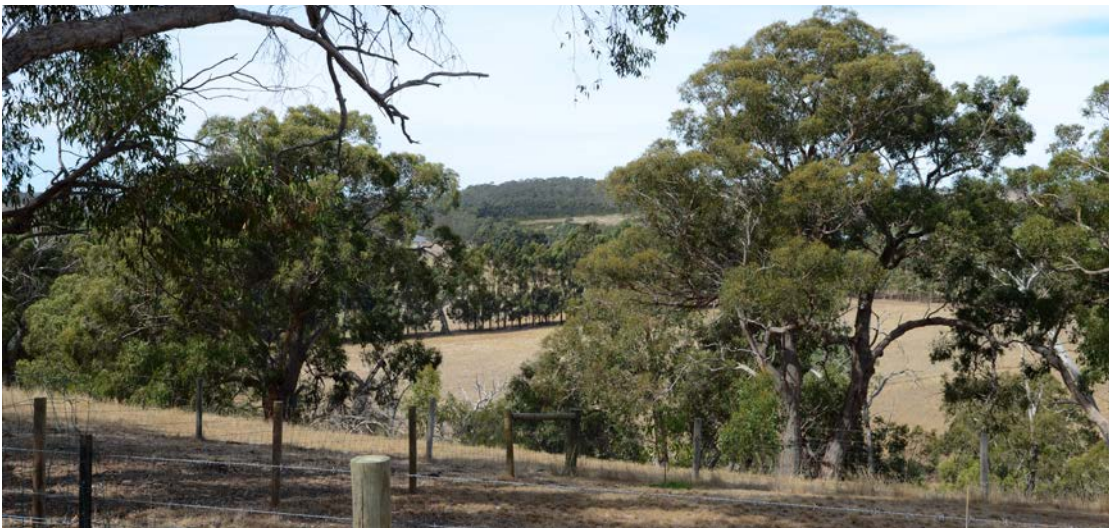
1 Year Vegetation Growth

- Re-vegetation at perimeter partially obscures views into the site.

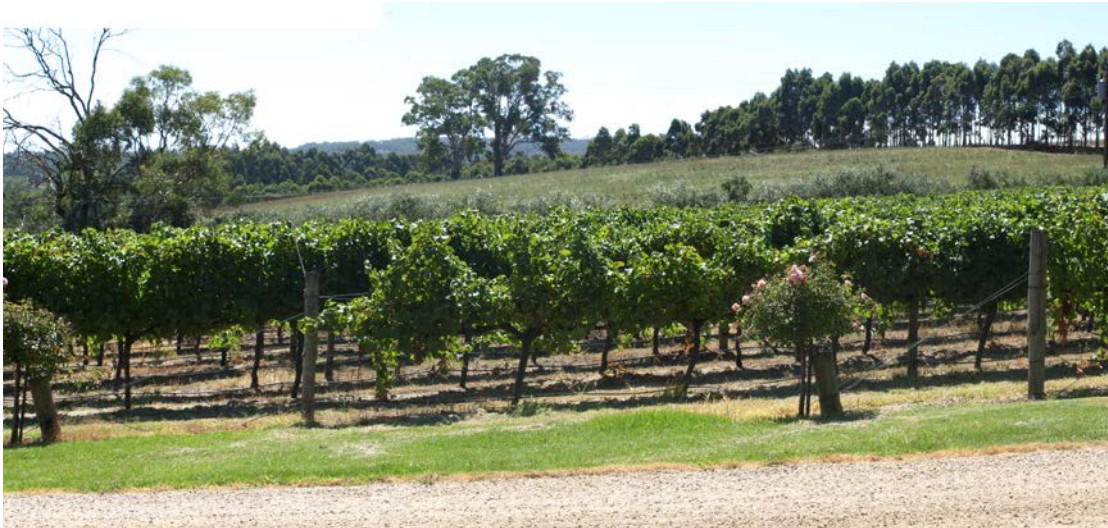
86 Bird In Hand Rd

Closure View

- Run of Mine silo is removed.
- Native shrubs, ground-covers + trees established further.

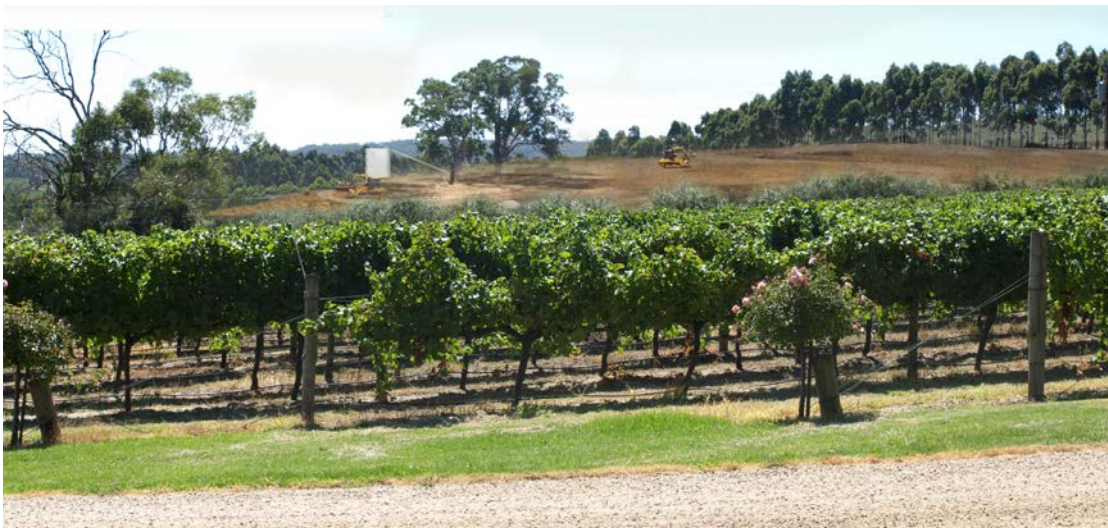
Existing View (2017)

- View through existing large trees to site.

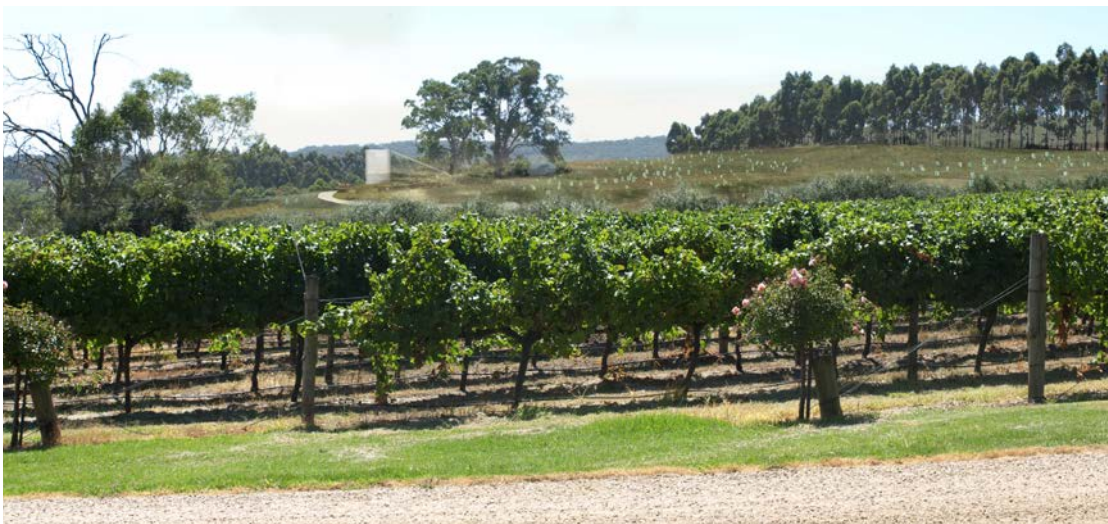
End of Construction (Worst Case)

- Silo in view in the distance.
- Silo colour to be confirmed and shown for illustration purposes only. Final colour subject to community input.

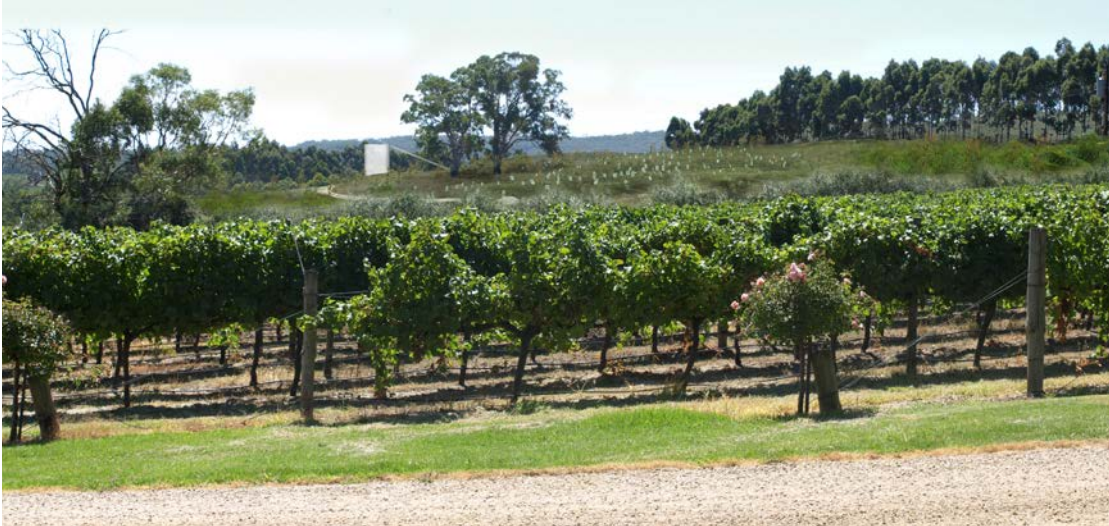
Operations View

- Run of Mine silo visible above tree canopy.
- Initial plantings established.

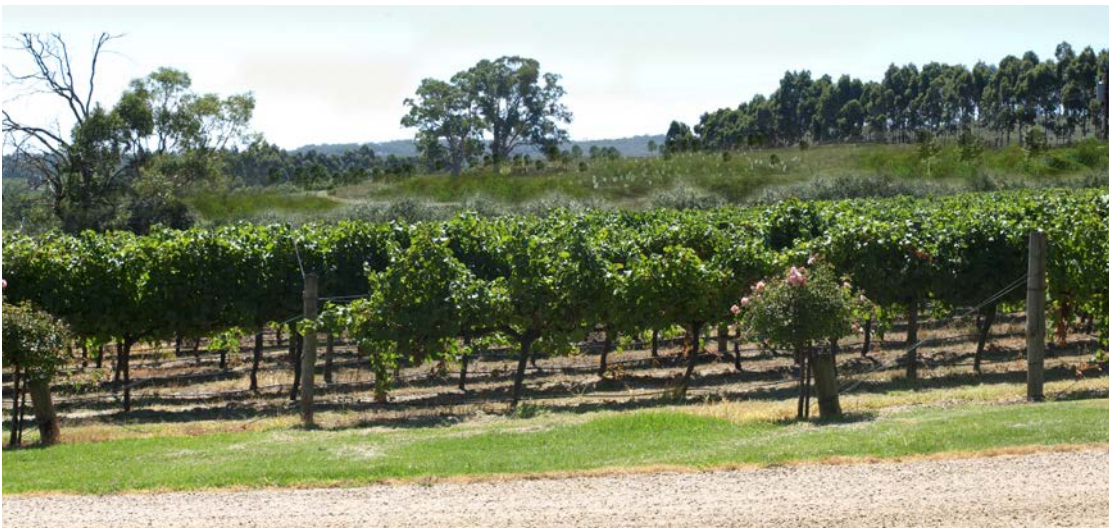
1 Year Vegetation Growth

- Re-vegetation at perimeter partially obscures views into the site.

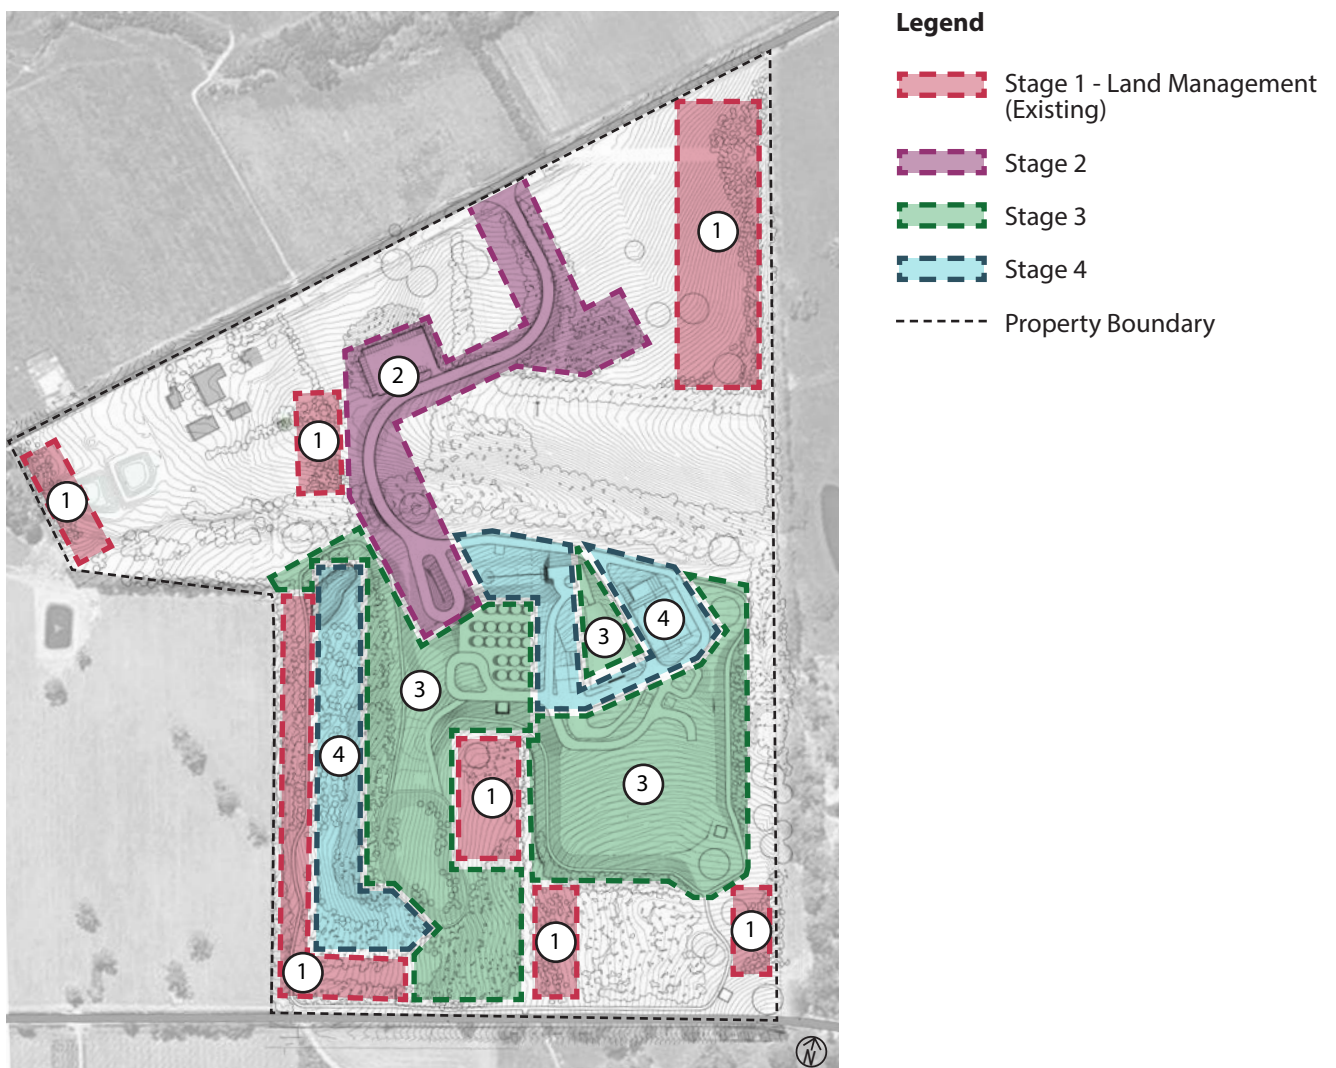
Figure 11: Implementation Plan

The implementation phase is anticipated to commence following the successful granting of the plan for environment protection and rehabilitation (PEPR).

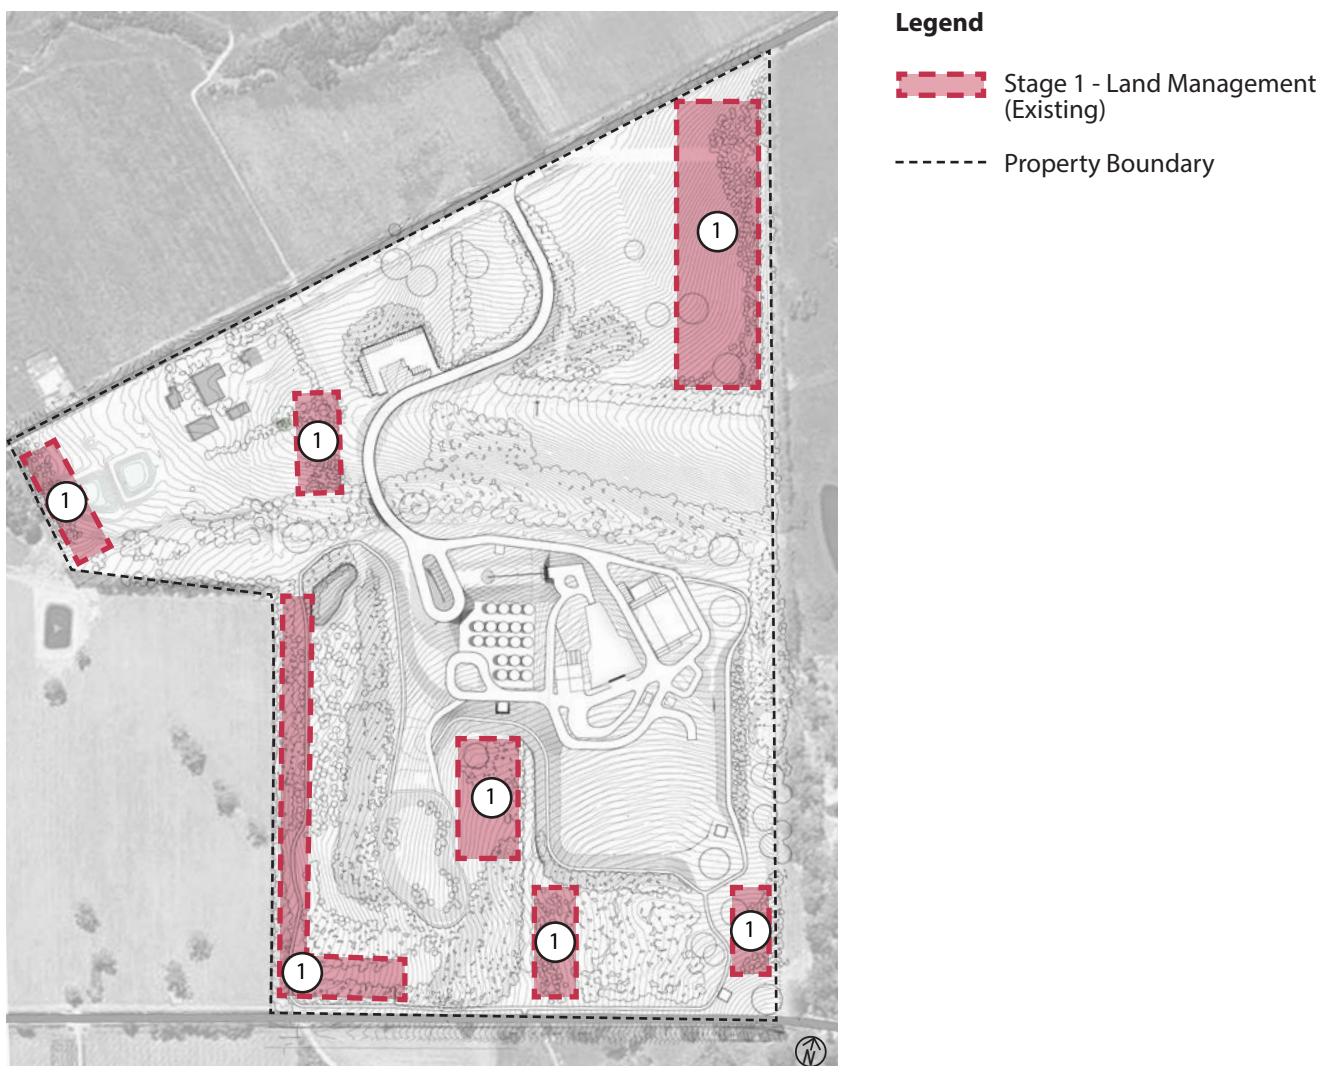
Figure 12: Stage 1 - Early Works Locations

Stage 1 works include preliminary site investigations, test drilling and ground water sampling. In 2016 multiple areas of revegetation were established to supplement existing tree coverage and to revegetate former open paddocks.

Successful native plant species are expected to inform the palette of subsequent plantings of strategic, amenity and revegetation planting zones.

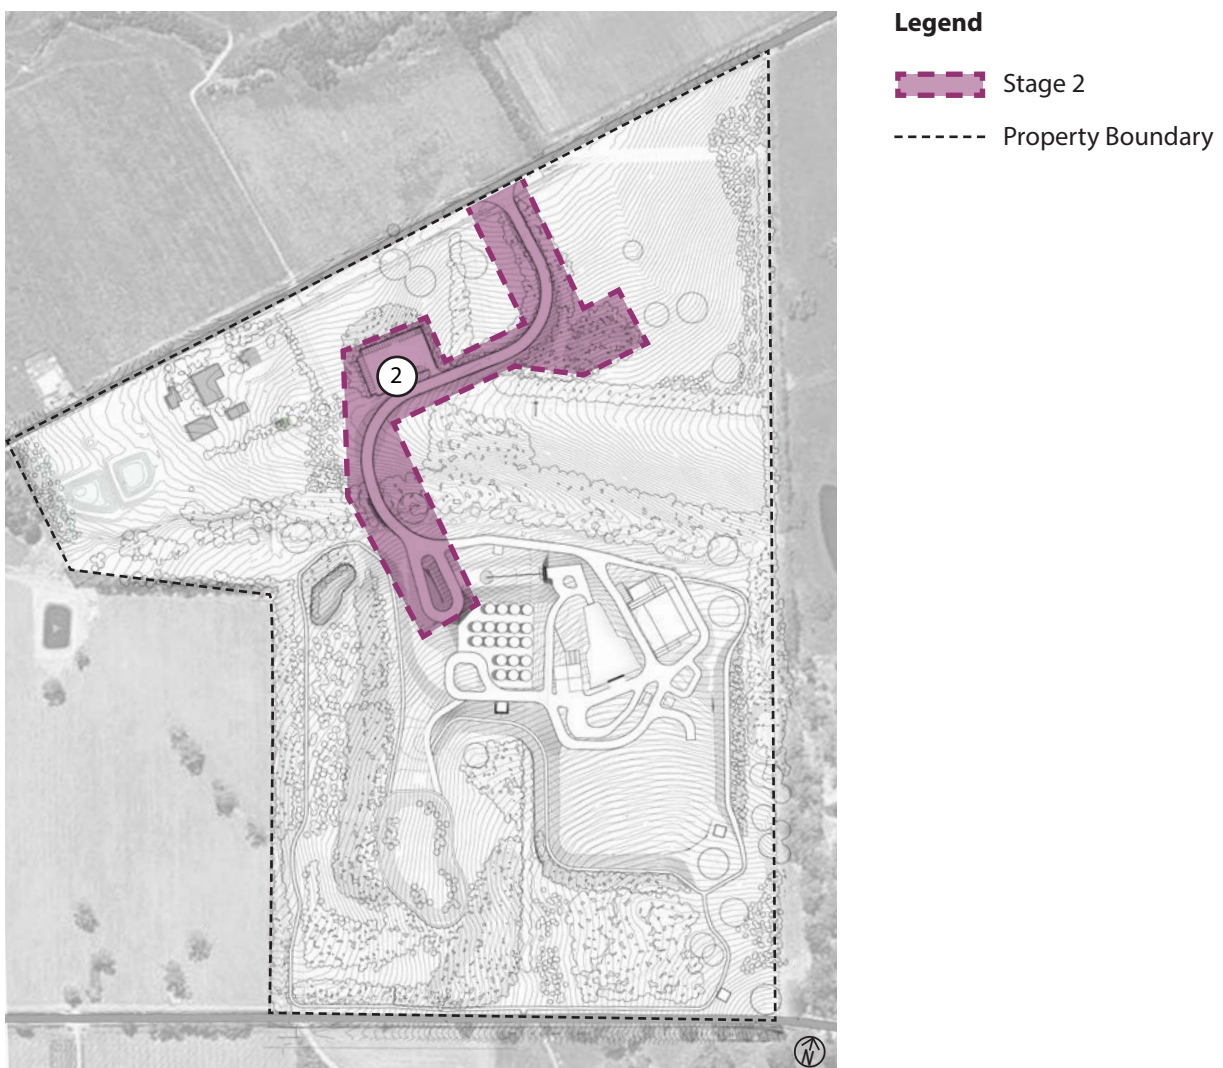
Figure 13: Stage 2 Works

Material gained from excavations is proposed to be reused for the initial formation of earth bunds around the operations area perimeter. Revegetation is proposed for disturbed surfaces and earth bund batters.

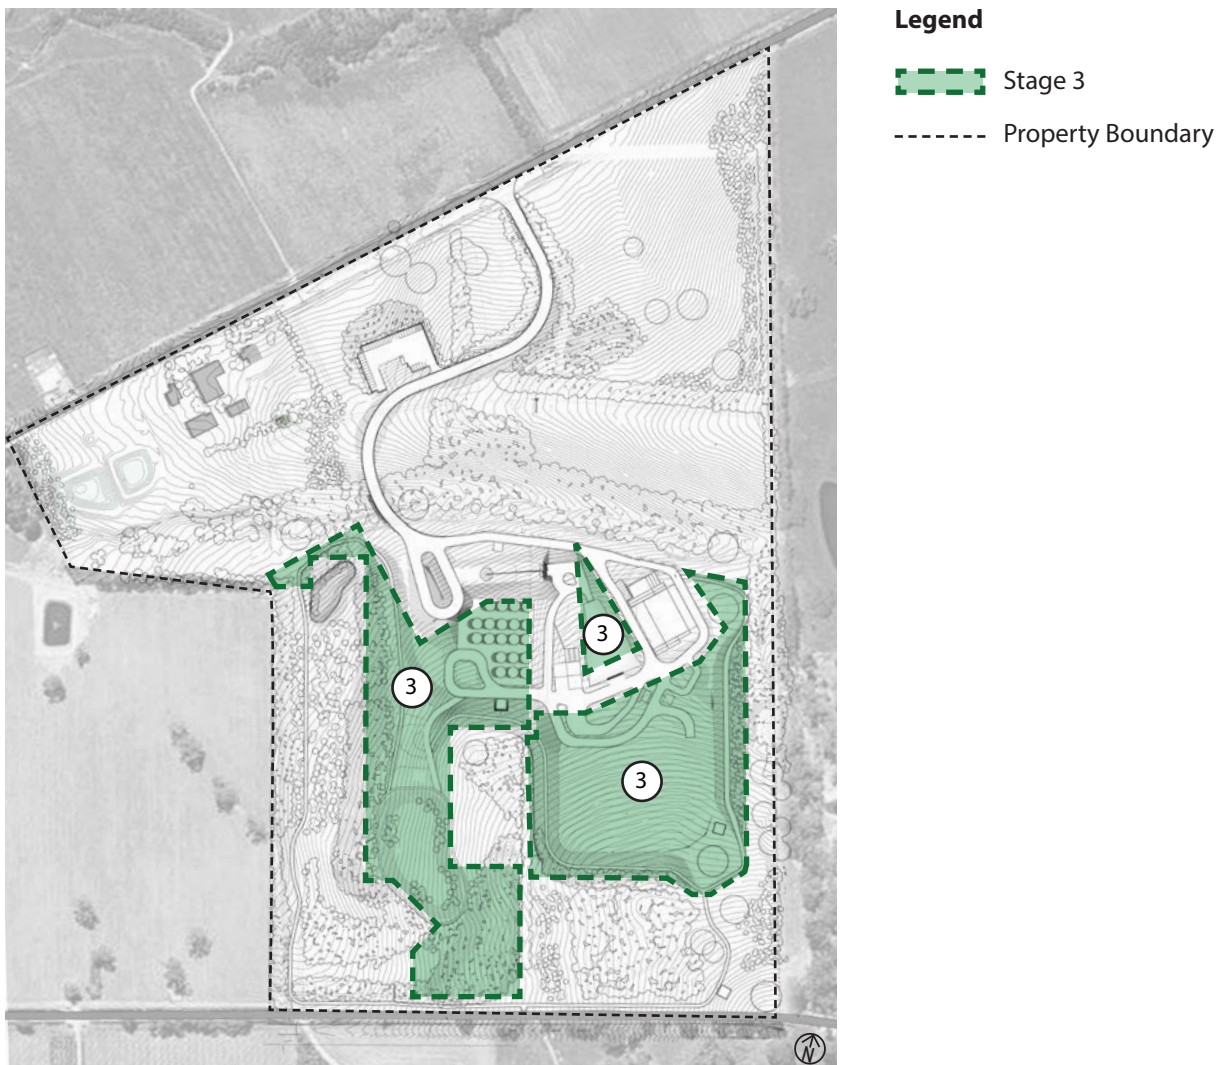
Figure 14: Stage 3 Works

Planting techniques are proposed to be reviewed according to the final batter grades and extension of the early works revegetation.

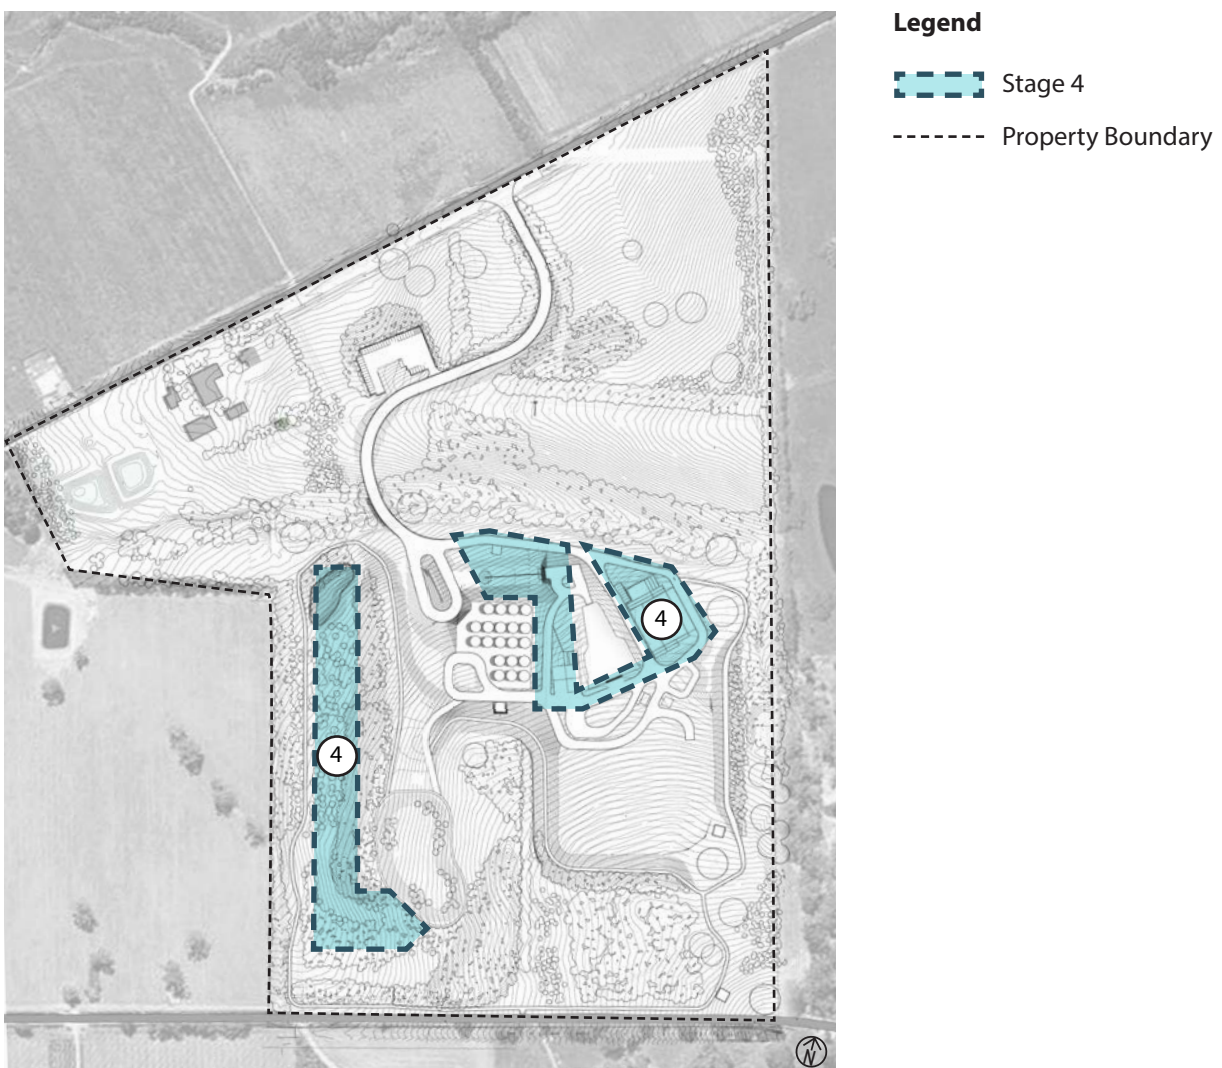
Figure 15: Stage 4 Works

Revegetation of the open space between the earth bund and perimeter trees is proposed to further screen views from the western side of the property and connect new planting with the early works revegetation.
