Bird In Hand Gold Project Strategic Visual Amenity Plan (SVAP)

**15.019 Bird In Hand Gold Project
Strategic Visual Amenity Plan (SVAP)**

Oxigen Landscape Architects
98-100 Halifax Street
ADELAIDE SA 5000
Telephone: (08) 7324 9600
www.oxigen.net.au

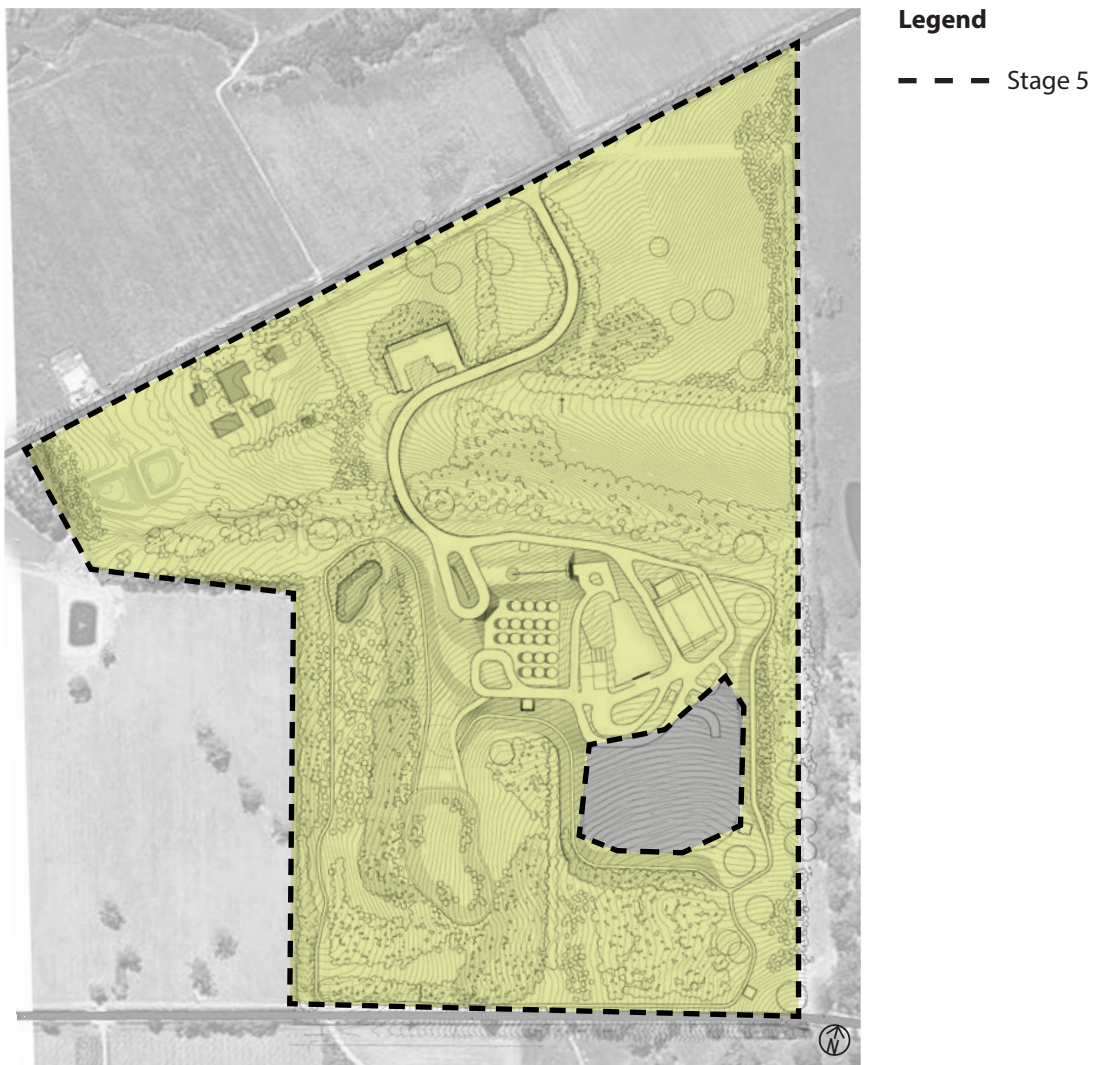
Figure 16: Stage 5 - Final Establishment

Landscape maintenance, weed control and replacement planting is proposed to continue during the operations phase.
